PPS - Jefferson High School - Grandstand Assessment

ABHT Project #11516

June 29, 2016

EXECUTIVE SUMMARY

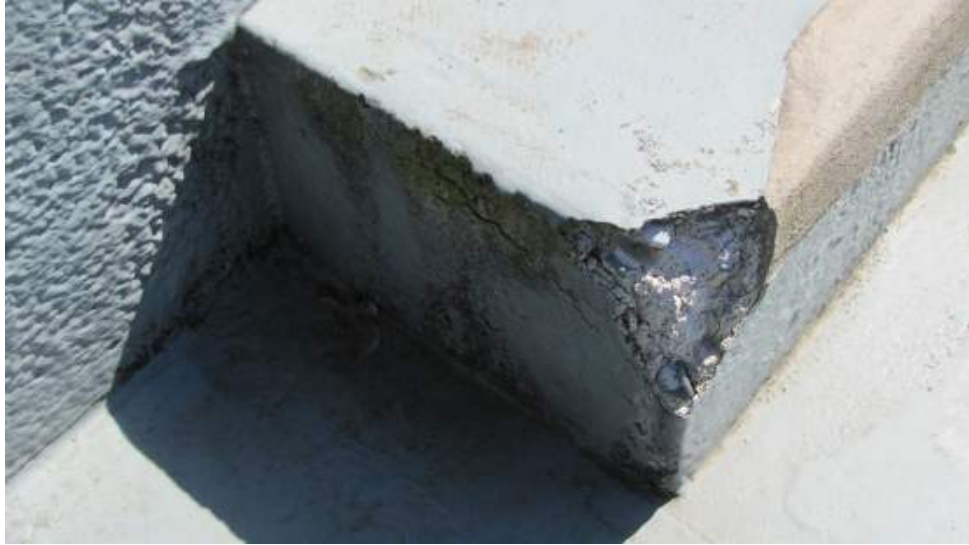
FIGURE B1A: MAJOR SPALLING IN CONCRETE

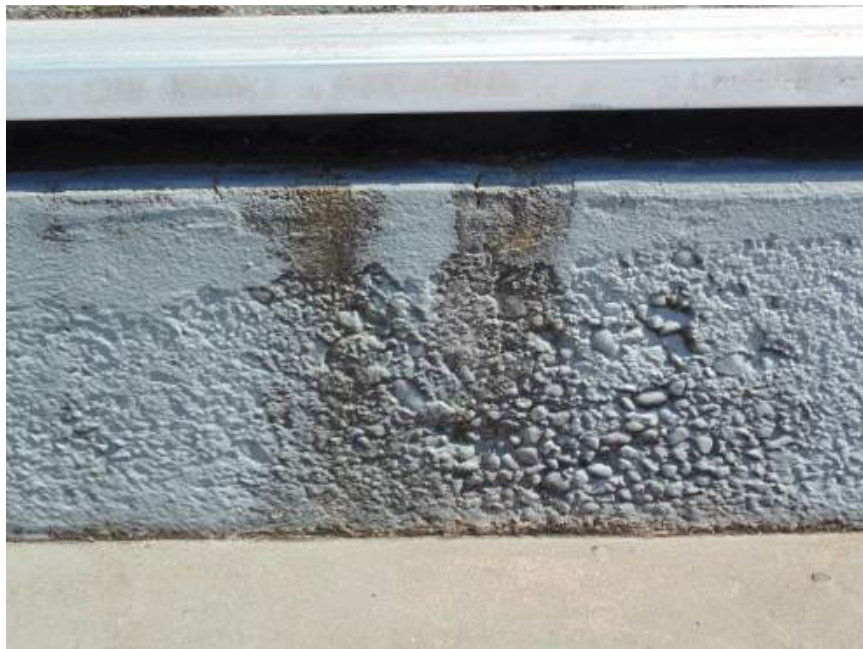
FIGURE B1B: MINOR SPALLING IN CONCRETE

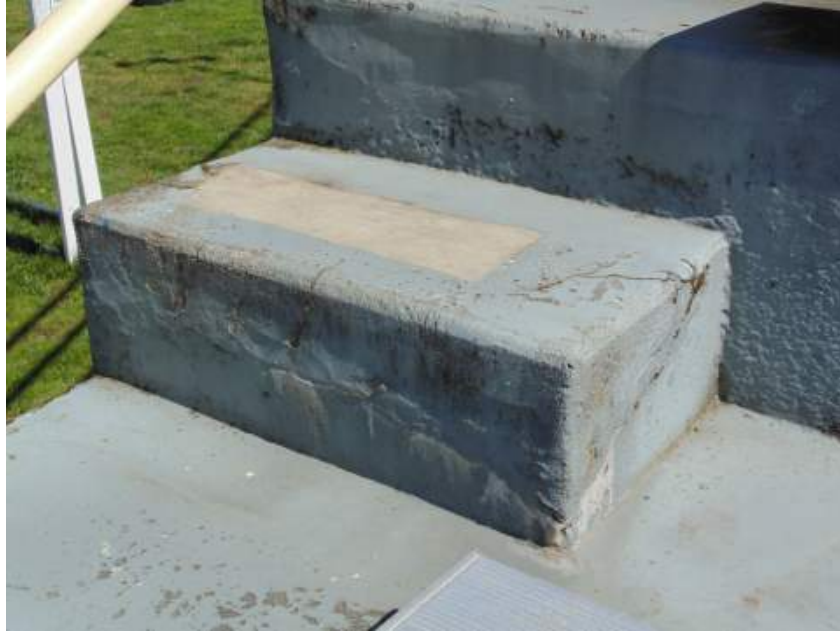
FIGURE B2A: MAJOR CRACKING IN CONCRETE

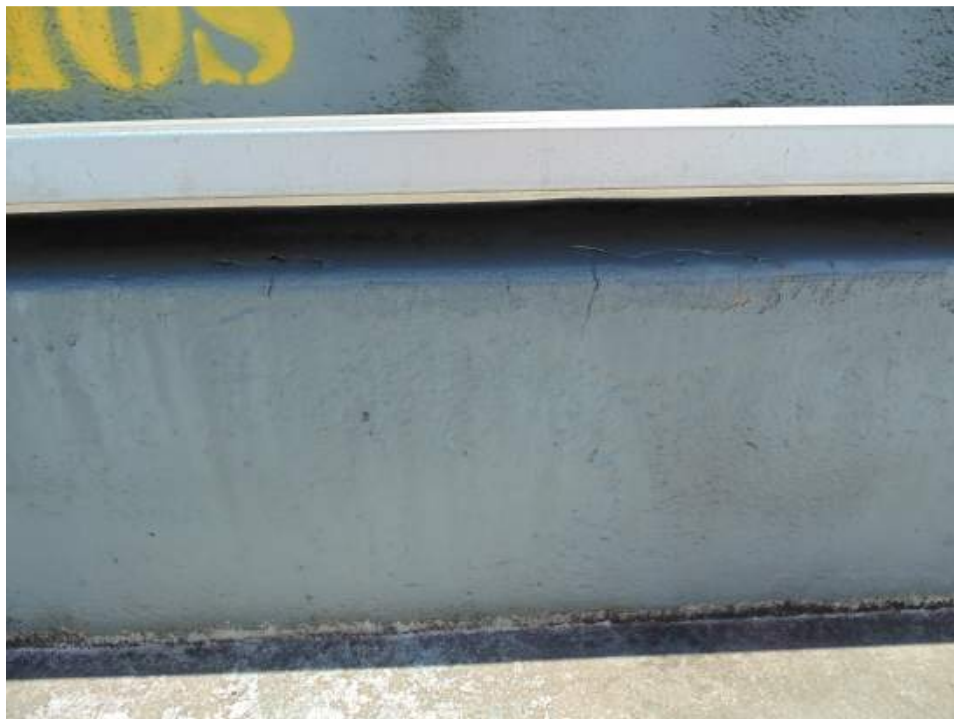
FIGURE B2B: MINOR CRACKING/SURFACE DETERIORATION IN CONCRETE

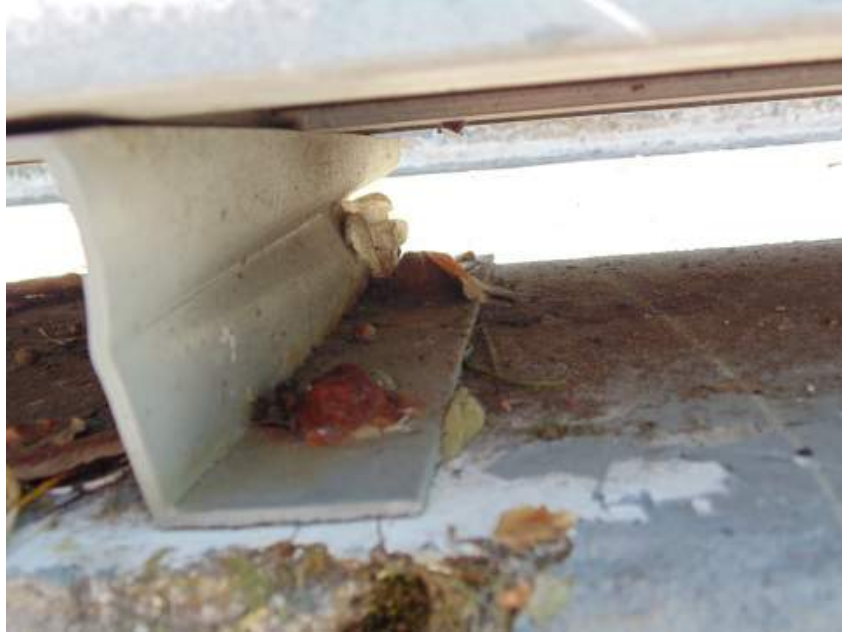
FIGURE B3: RUSTED ANCHOR BOLTS

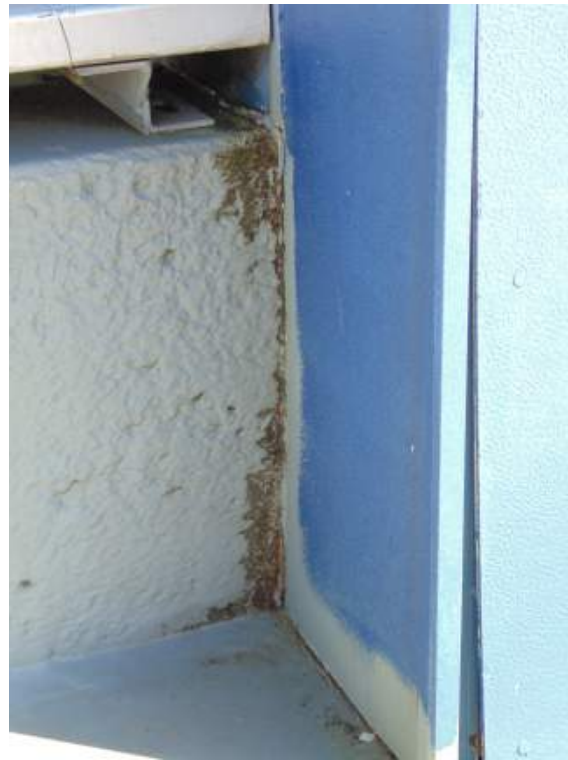
FIGURE B4: MISSING BOLT AT SEAT BRACKET

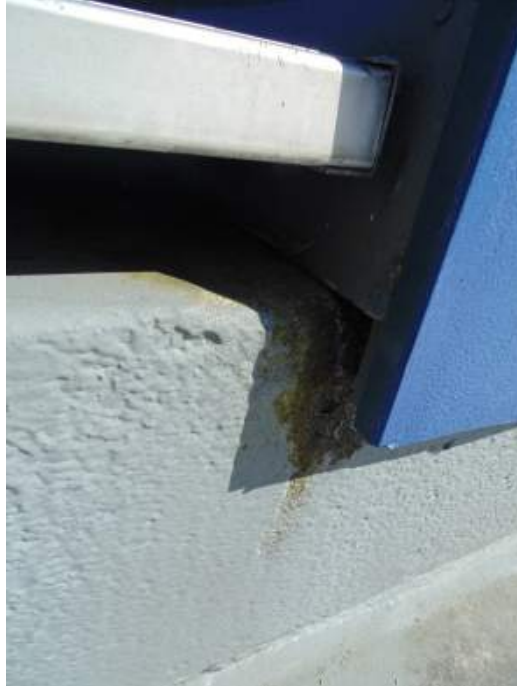
FIGURE B5: RUST AT PRESS BOX

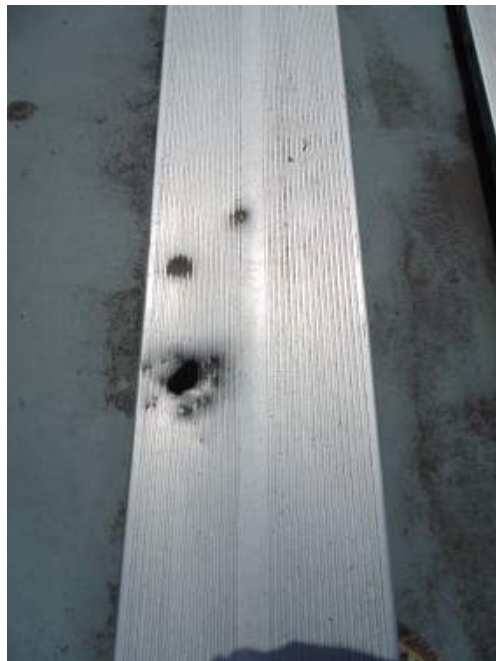
FIGURE B6: DAMAGED METAL BENCH

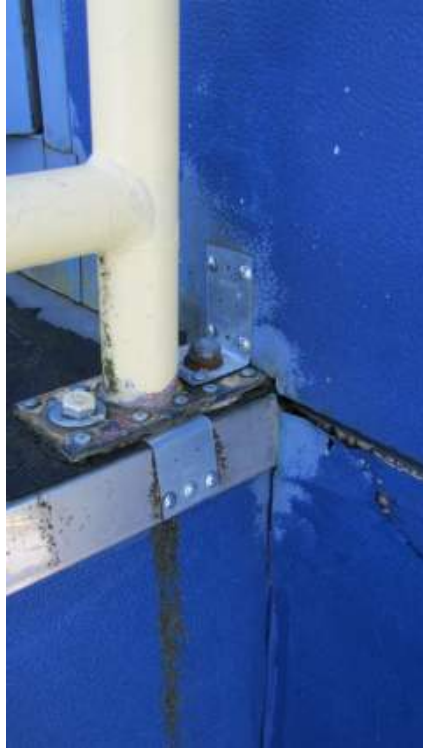
FIGURE B7: RUSTED STEEL CONNECTIONS

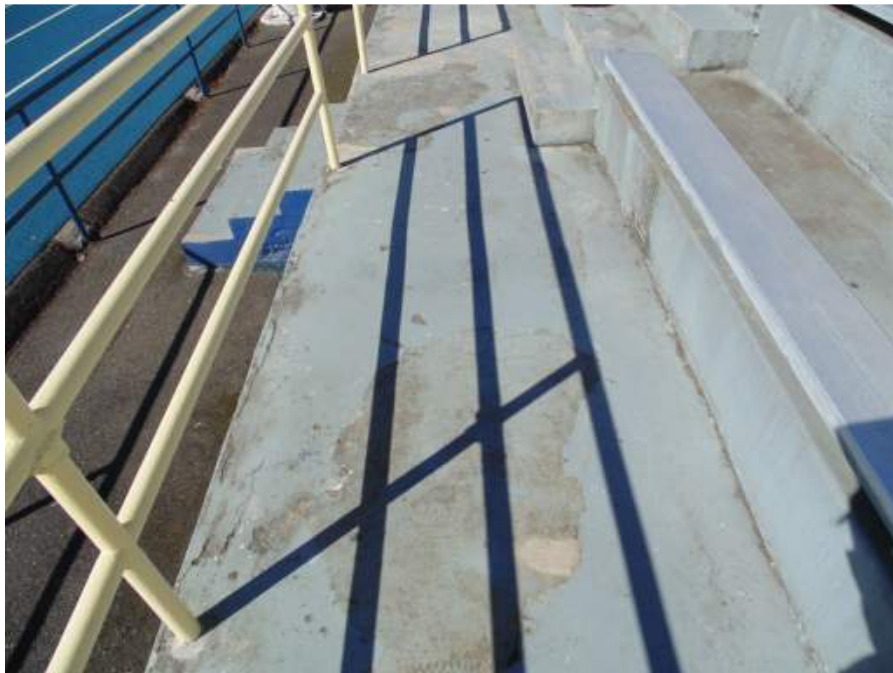
FIGURE B8: DAMAGED/MISSING FINISH

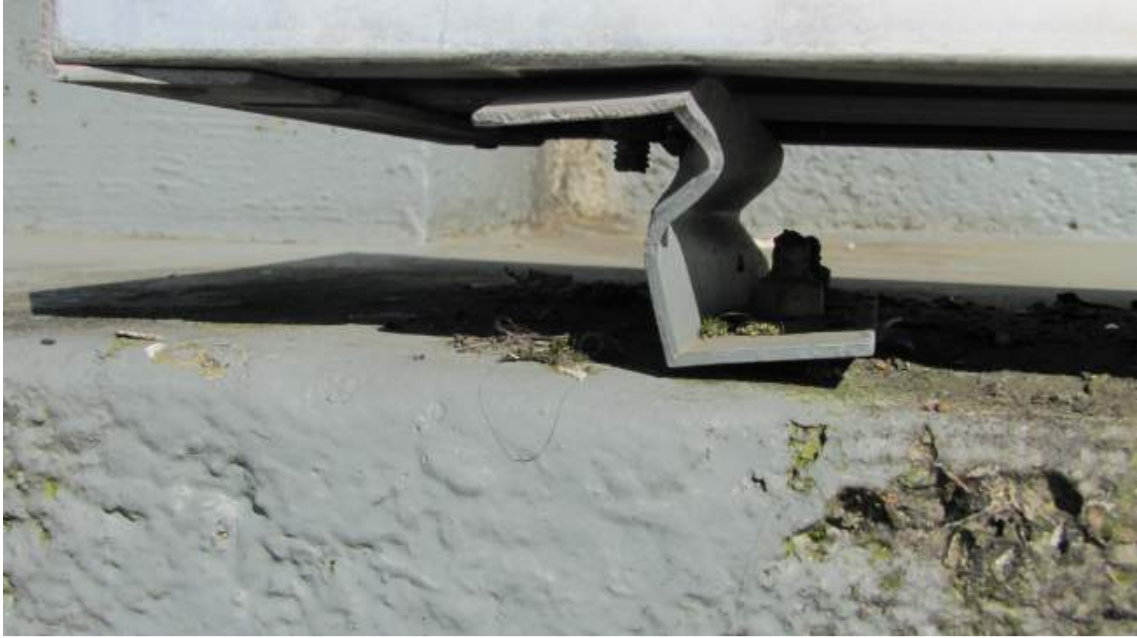
FIGURE B9: DAMAGED SEAT BRACKETS

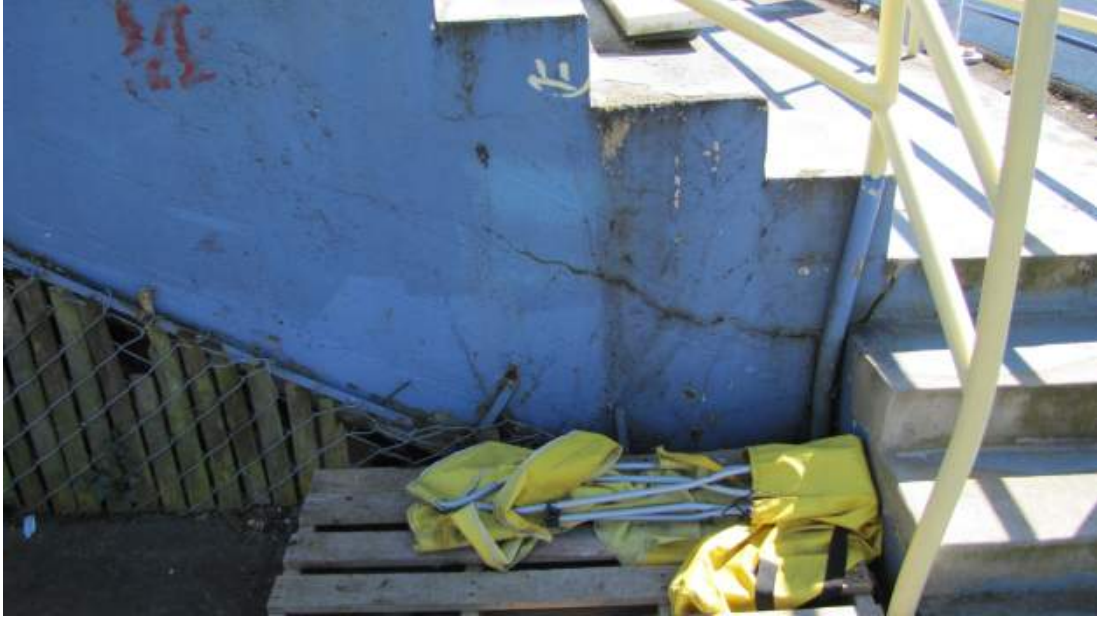
FIGURE C1A-1: CRACKING/SPALLING IN CONC. GIRDER

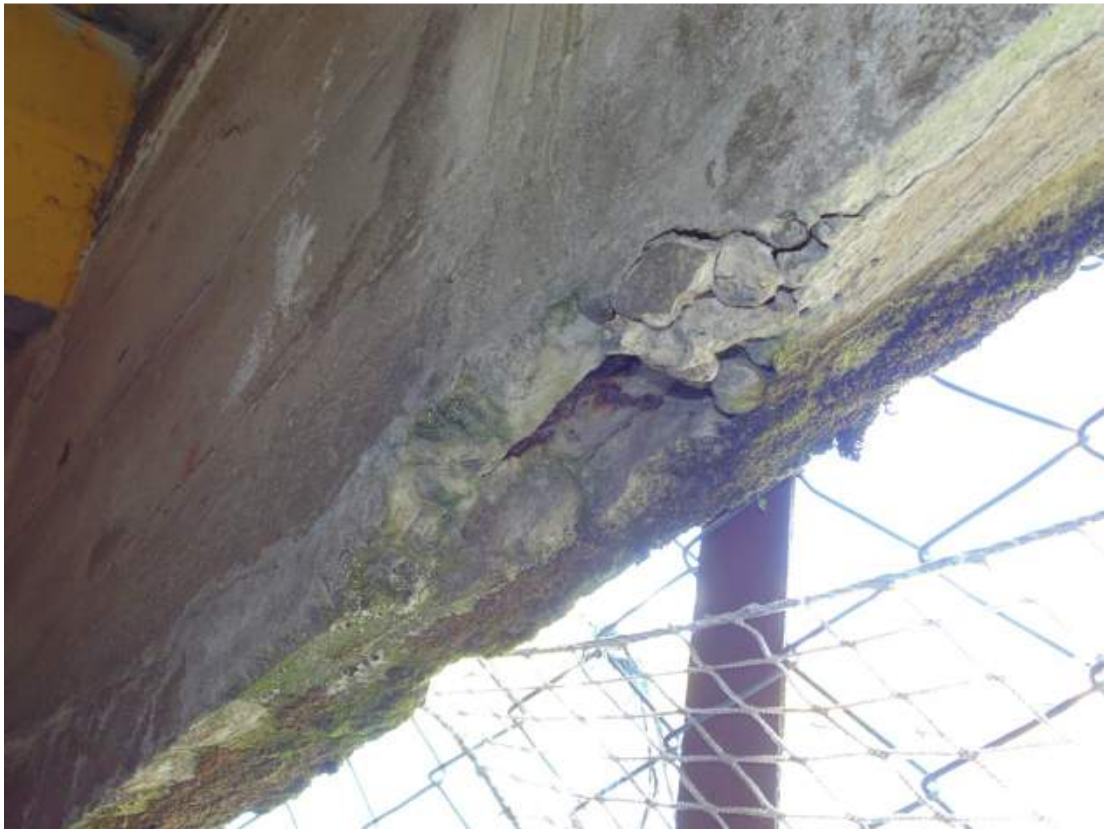
FIGURE C1A-2: CRACKING/SPALLING IN CONC. GIRDER

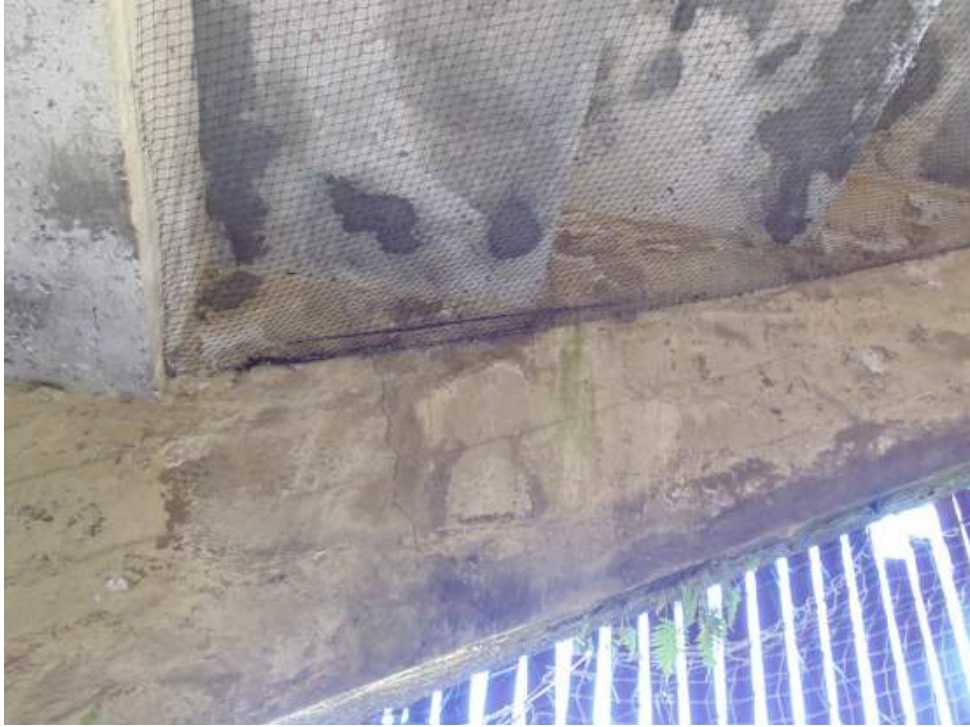
FIGURE C1A-3: CRACKING/SPALLING IN CONC. GIRDER

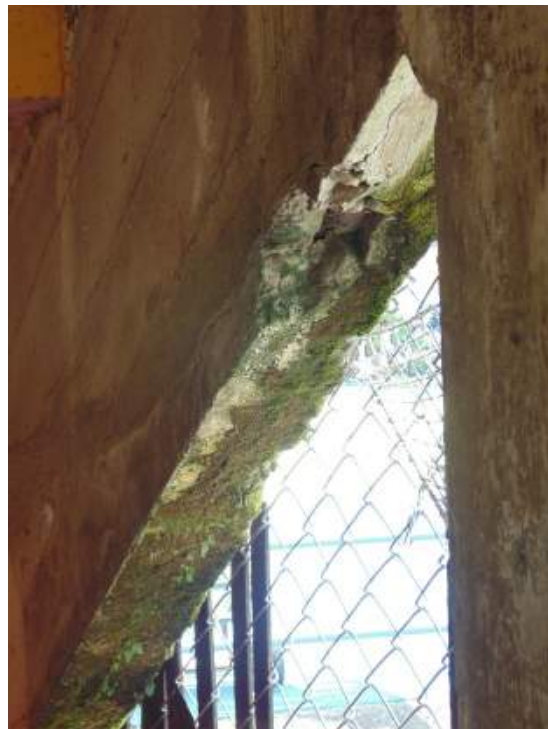
FIGURE C1A-4: CRACKING/SPALLING IN CONC. GIRDER

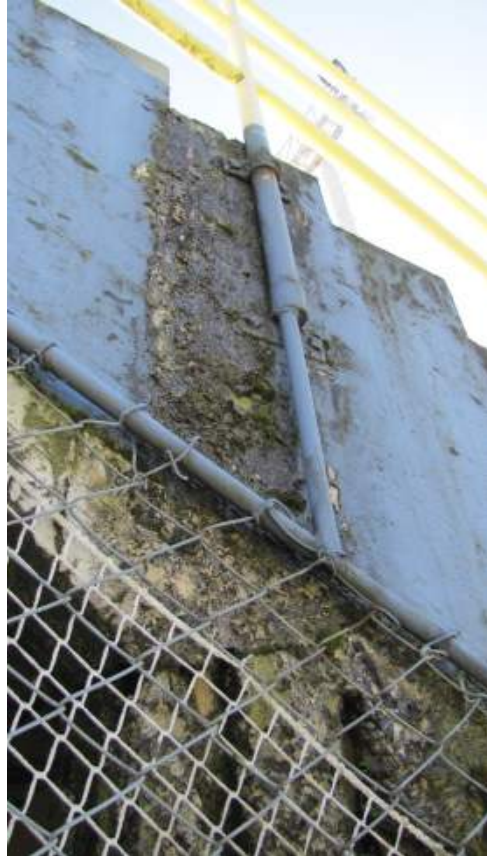
FIGURE C1A-5: CRACKING/SPALLING IN CONC. GIRDER

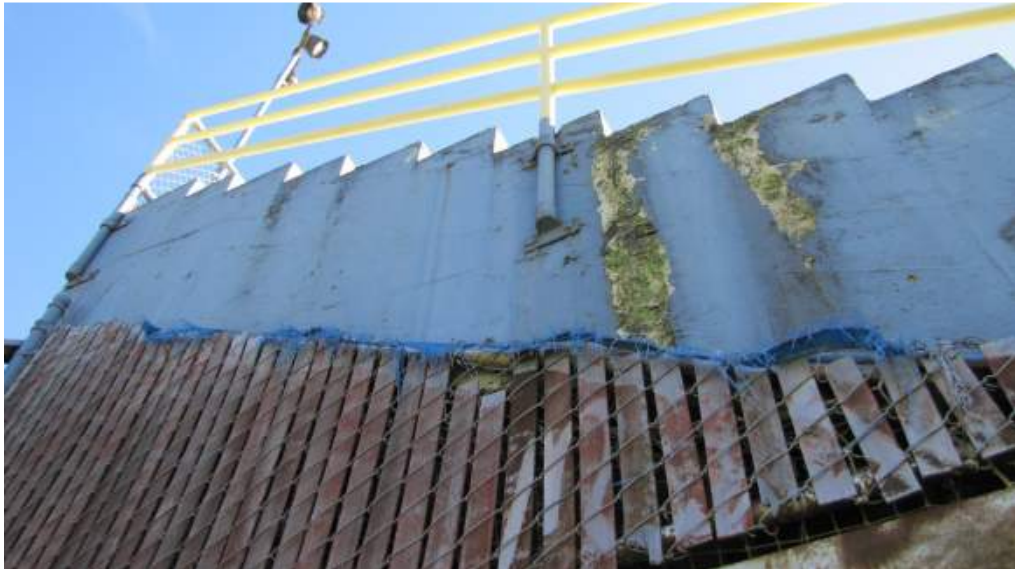
FIGURE C1A-6: CRACKING/SPALLING IN CONC. GIRDER

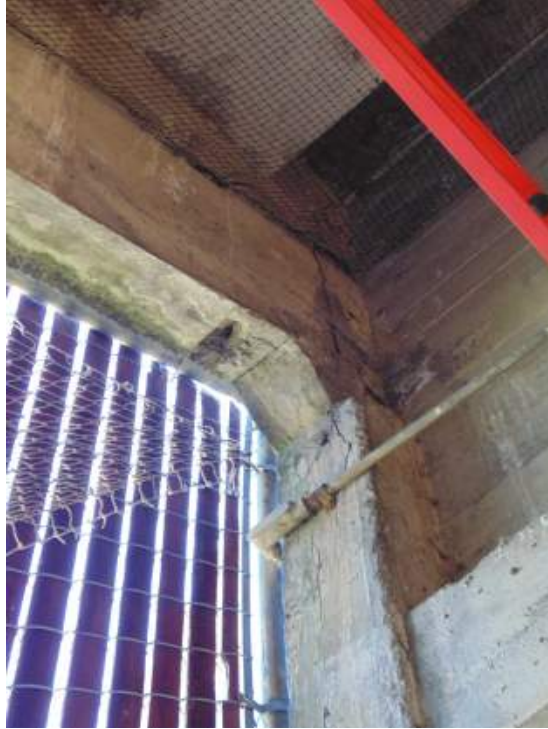
FIGURE C1A-7: CRACKING/SPALLING IN CONC. GIRDER

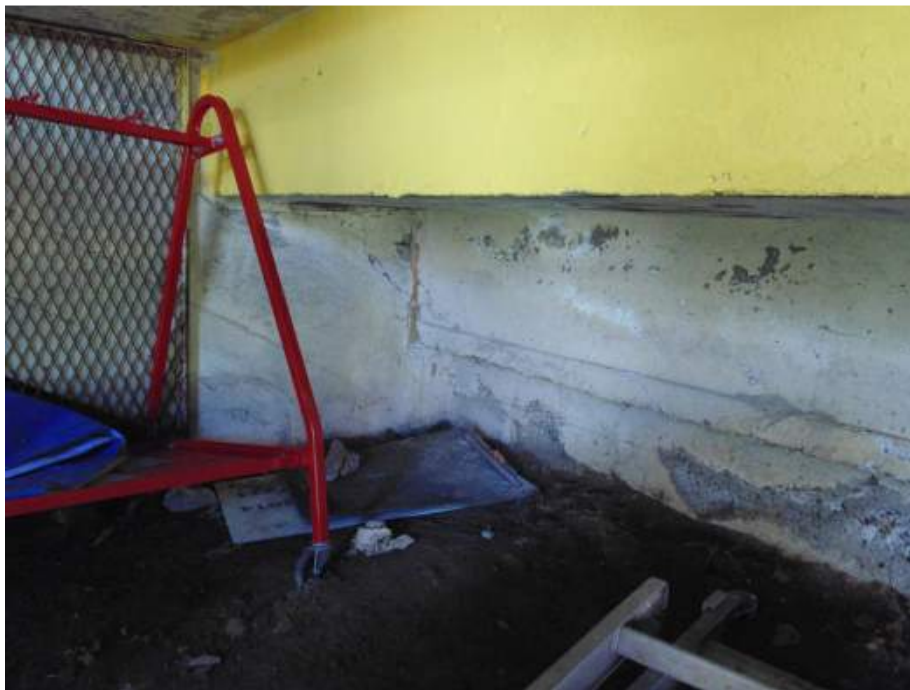
FIGURE C1B-1: CRACKING/SPALLING IN CONC. GIRDER

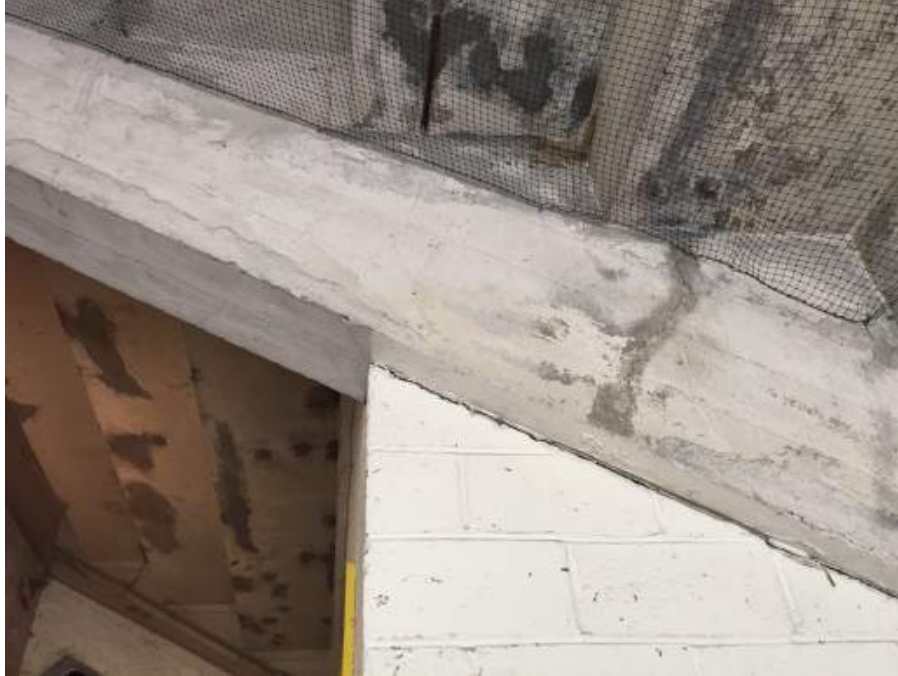
FIGURE C1B-2: CRACKING/SPALLING IN CONC. GIRDER

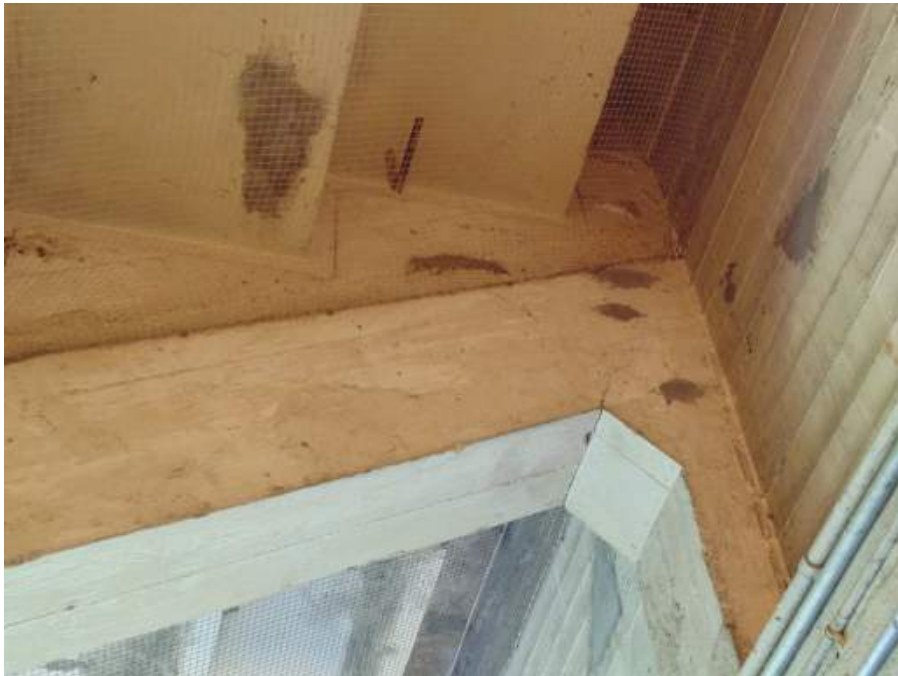
FIGURE C1B-3: CRACKING/SPALLING IN CONC. GIRDER

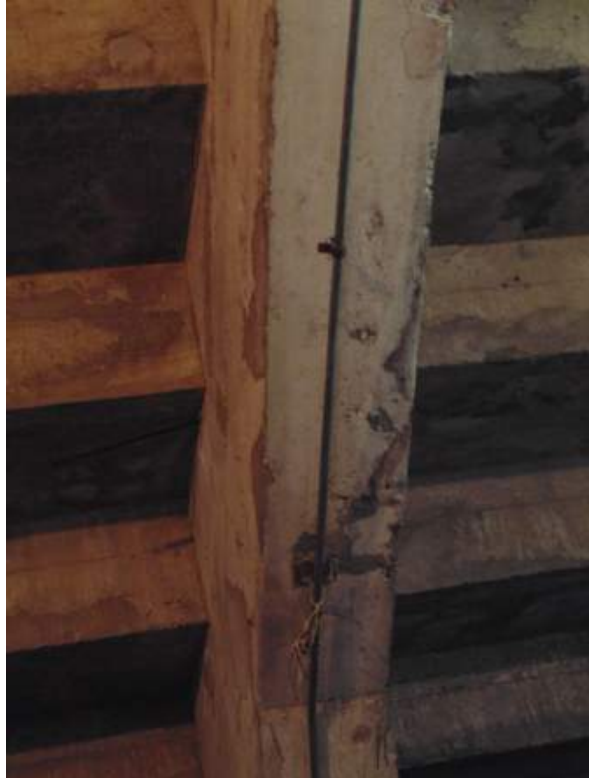
FIGURE C1C: CRACKING/SPALLING IN CONC. GIRDER

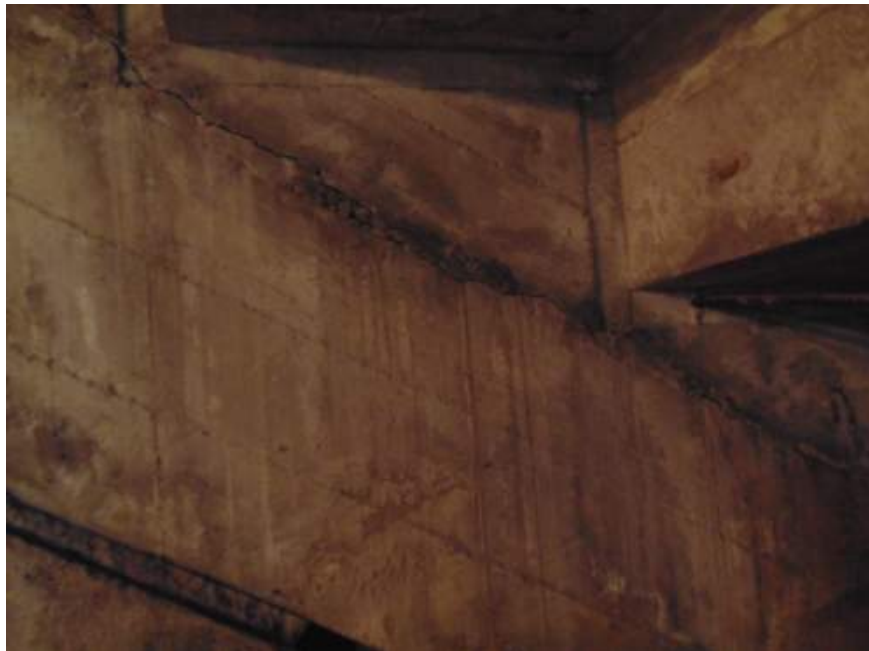
FIGURE C1D-1: CRACKING/SPALLING IN CONC. GIRDER

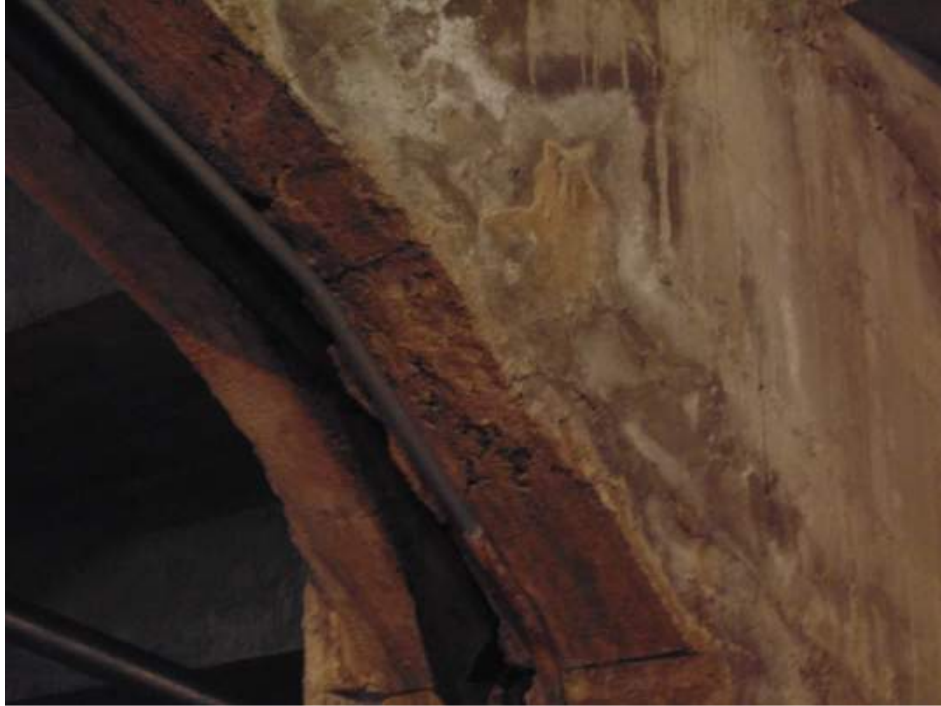
FIGURE C1D-2: CRACKING/SPALLING IN CONC. GIRDER

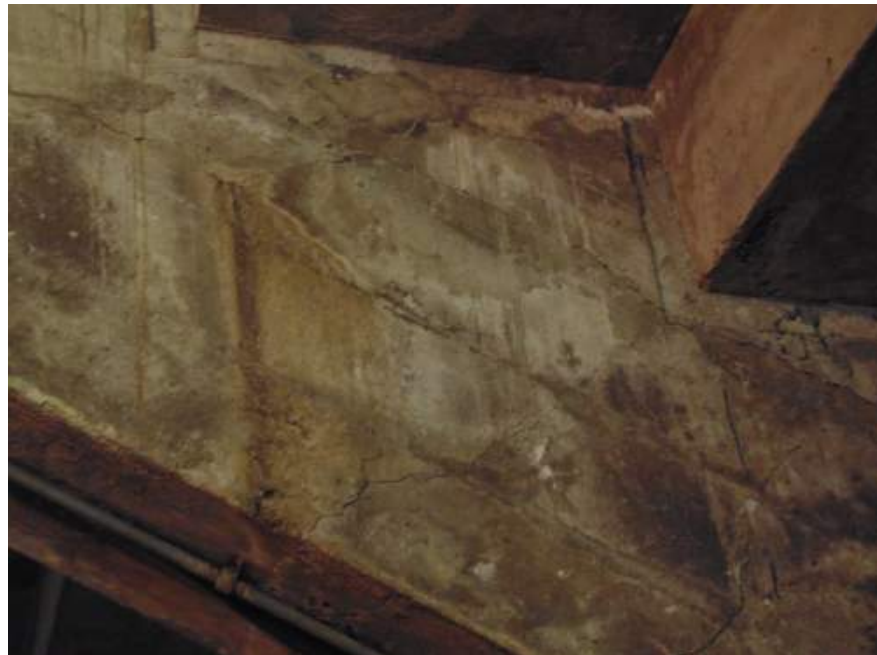
FIGURE C1D-3: CRACKING/SPALLING IN CONC. GIRDER

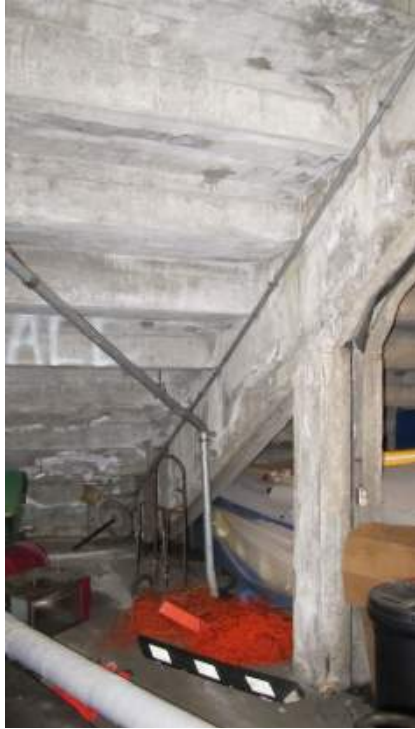
FIGURE C1D-4: CRACKING/SPALLING IN CONC. GIRDER

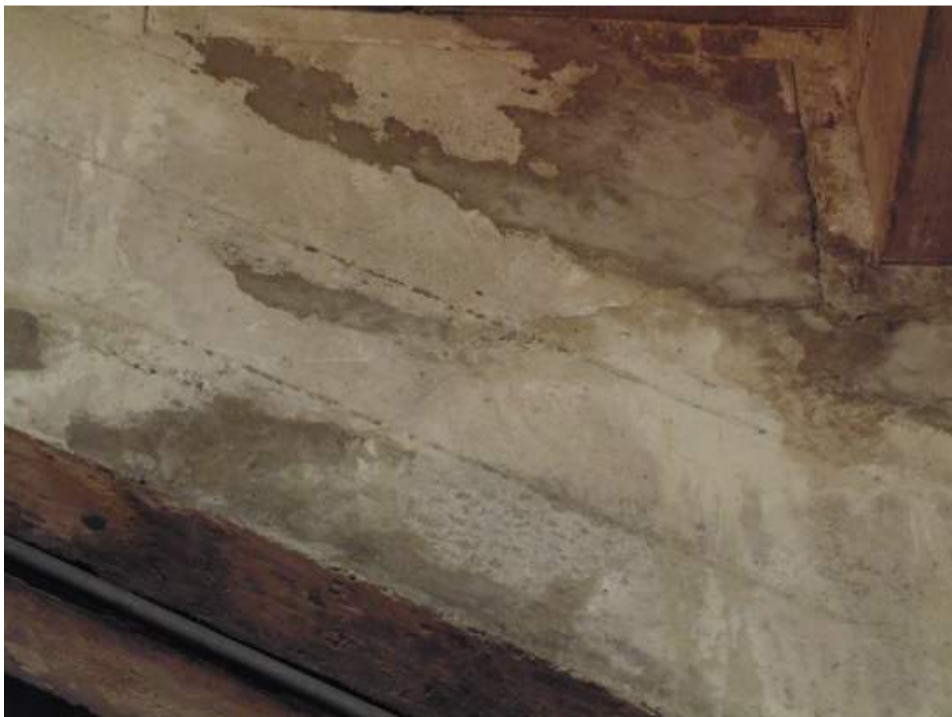
FIGURE C1D-6: CRACKING/SPALLING IN CONC. GIRDER

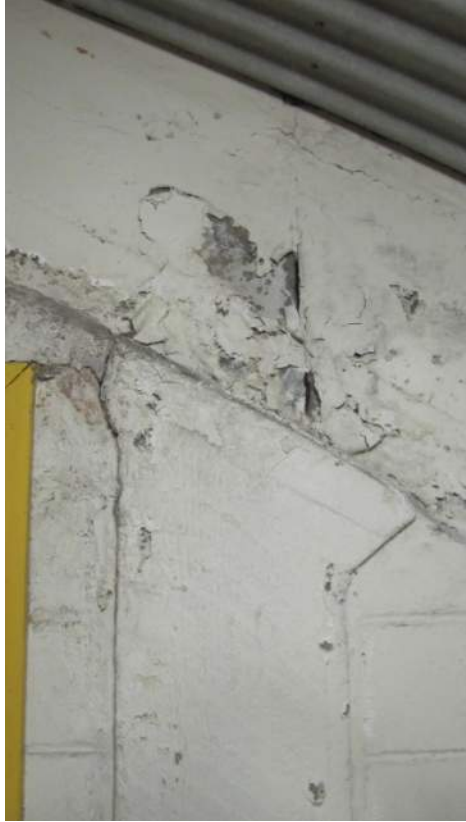
FIGURE C1E: CRACKING/SPALLING IN CONC. GIRDER

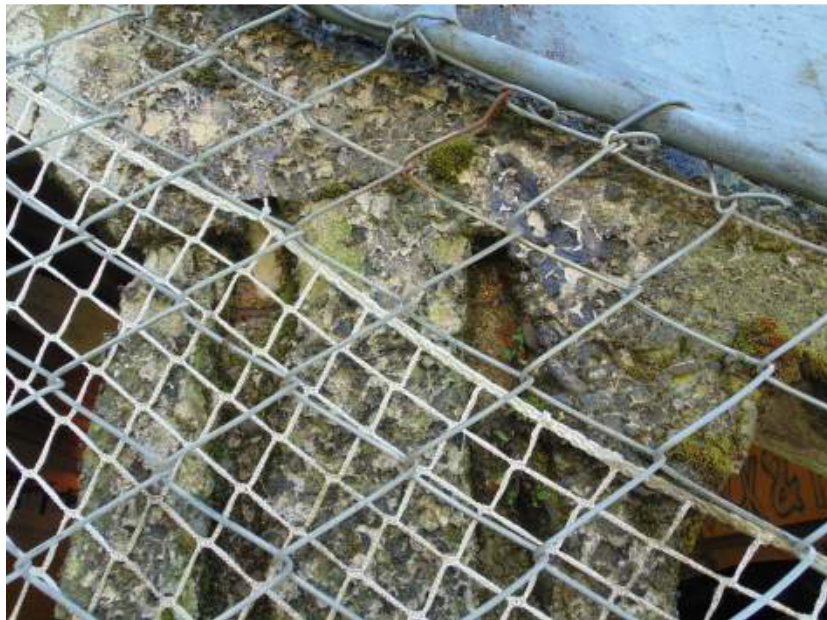
FIGURE C2A: CRACKING/SPALLING IN CONC. COLUMN

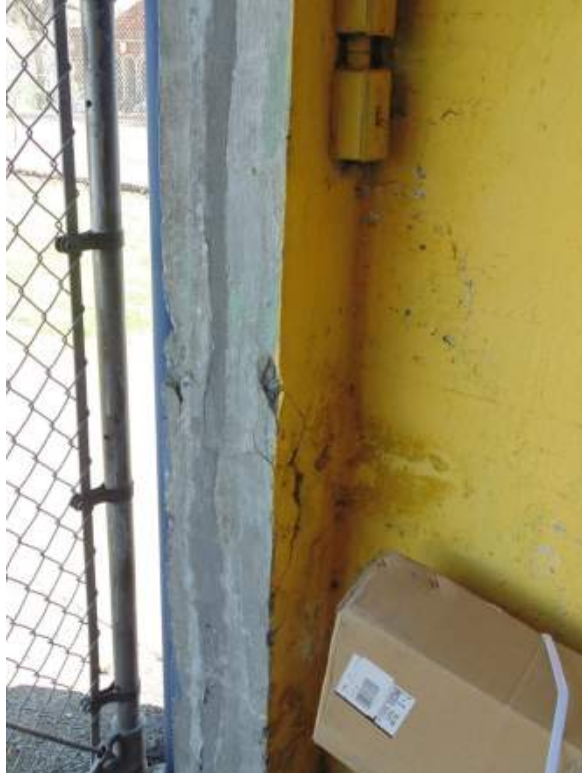
FIGURE C2B-1: CRACKING/SPALLING IN CONC. COLUMN

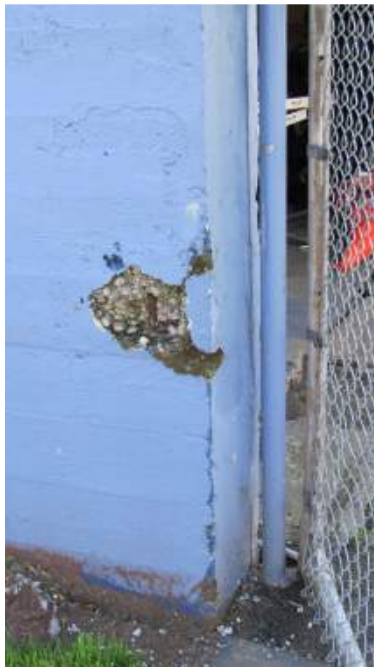
FIGURE C2B-2: CRACKING/SPALLING IN CONC. COLUMN

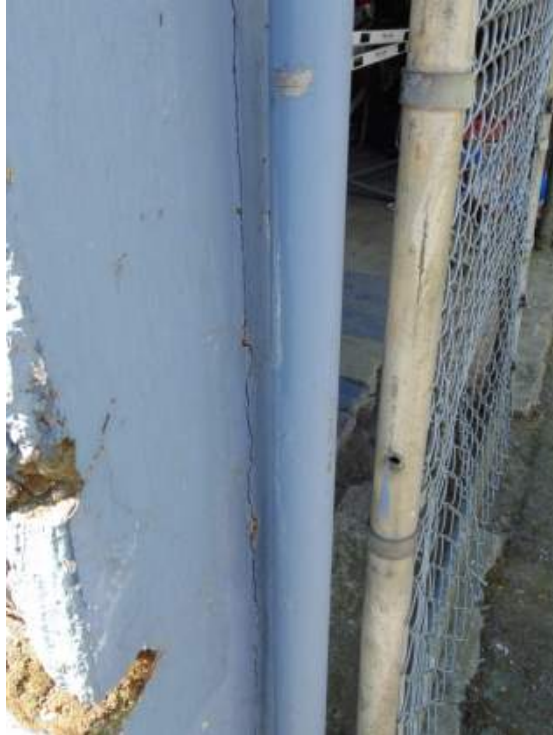
FIGURE C2B-3: CRACKING/SPALLING IN CONC. COLUMN

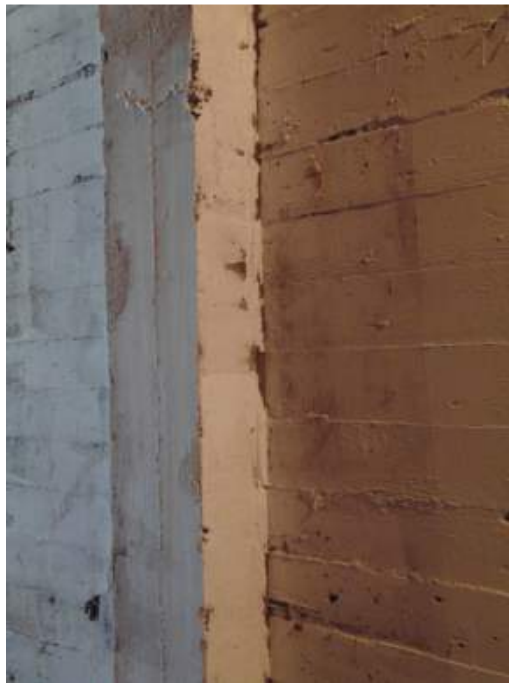
FIGURE C2C: CRACKING/SPALLING IN CONC. COLUMN

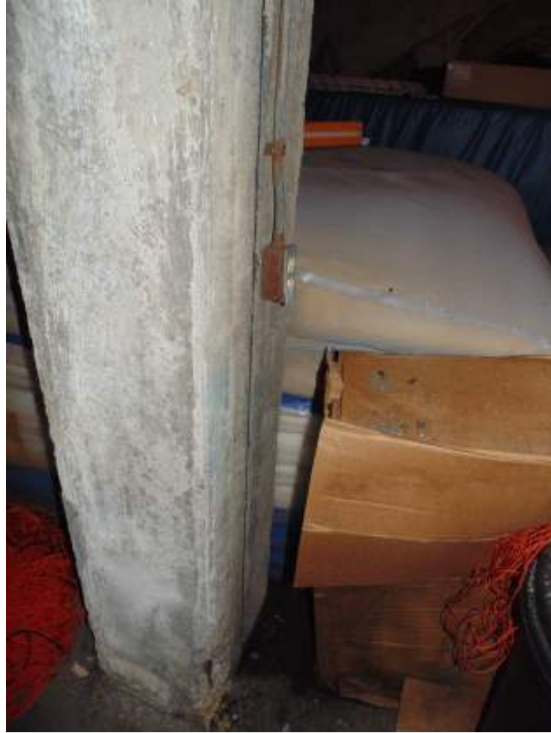
FIGURE C2D: CRACKING/SPALLING IN CONC. COLUMN

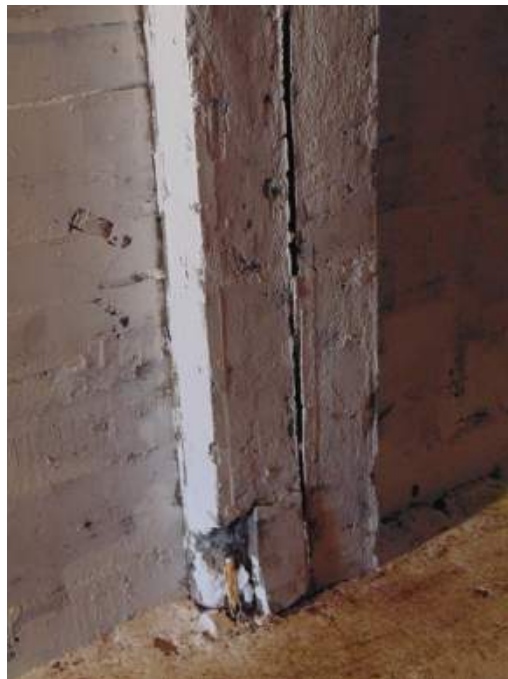
FIGURE C2E: CRACKING/SPALLING IN CONC. COLUMN

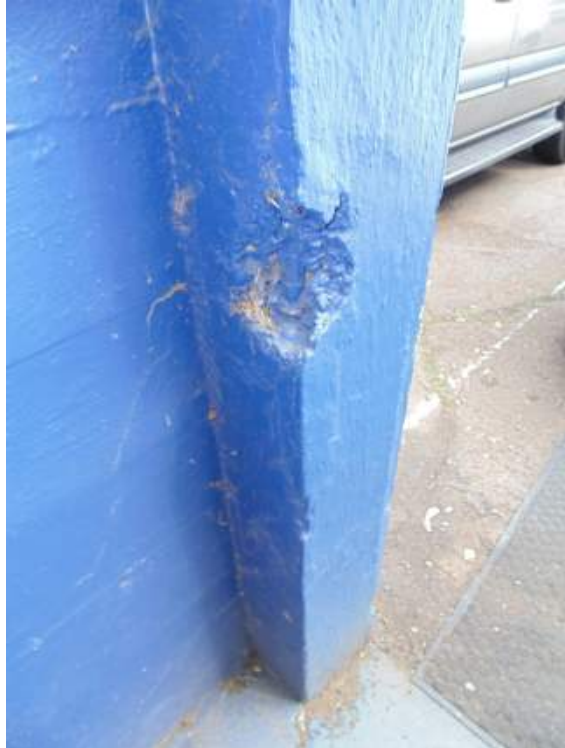
FIGURE C2F-1: CRACKING/SPALLING IN CONC. COLUMN

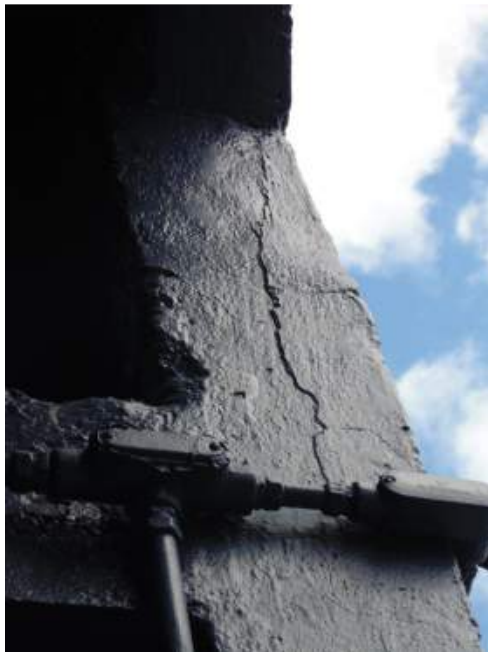
FIGURE C2F-2: CRACKING/SPALLING IN CONC. COLUMN

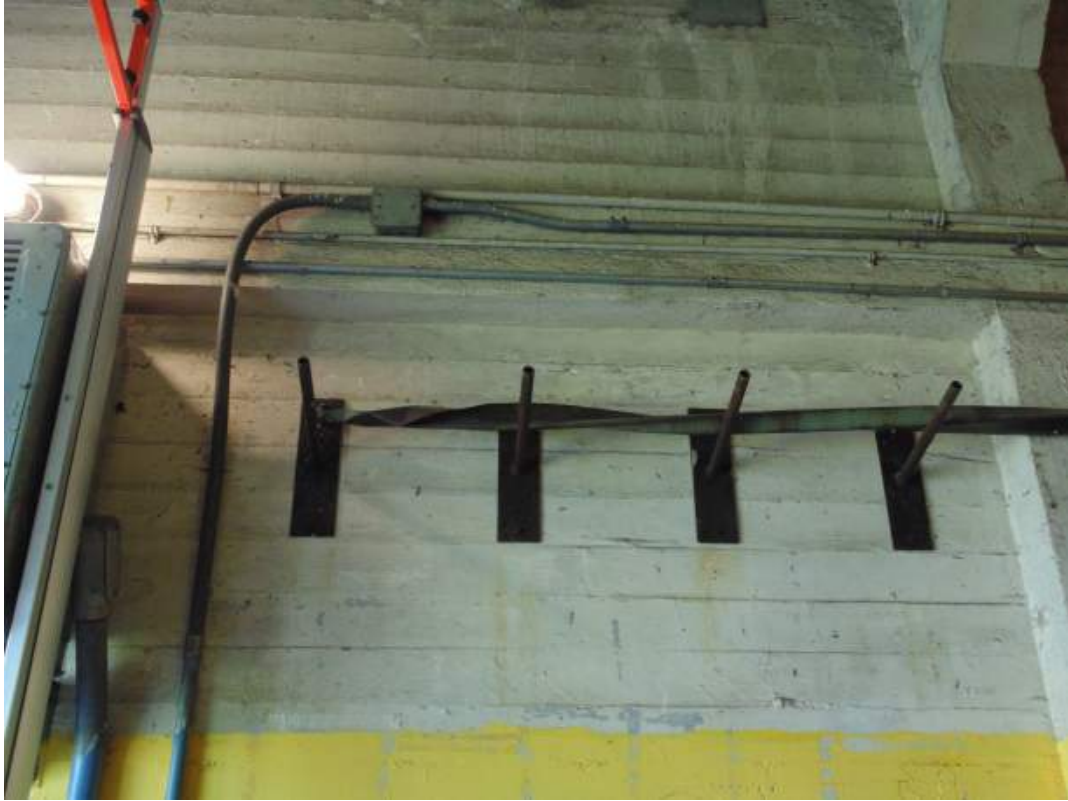
FIGURE C3A: CRACK IN CONC. WALL

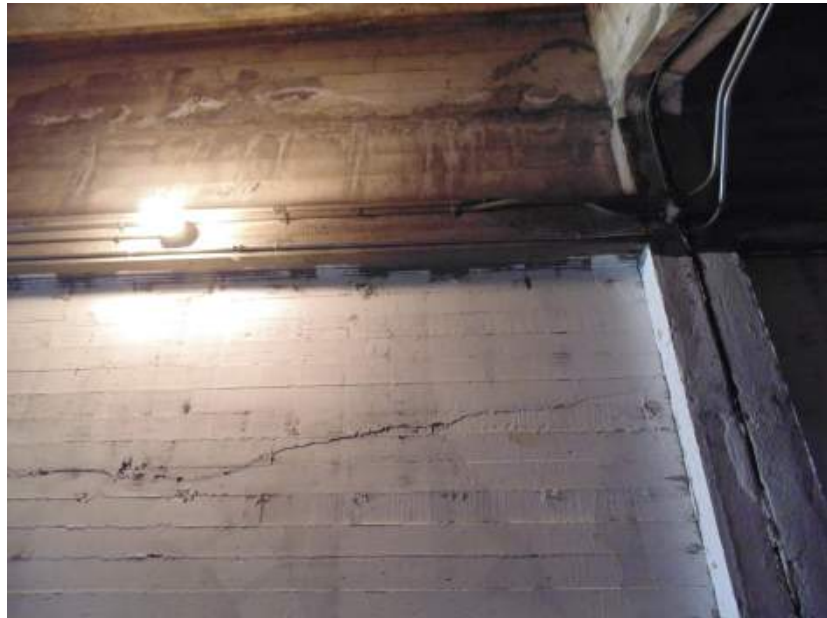
FIGURE C3B: CRACK IN CONC. WALL

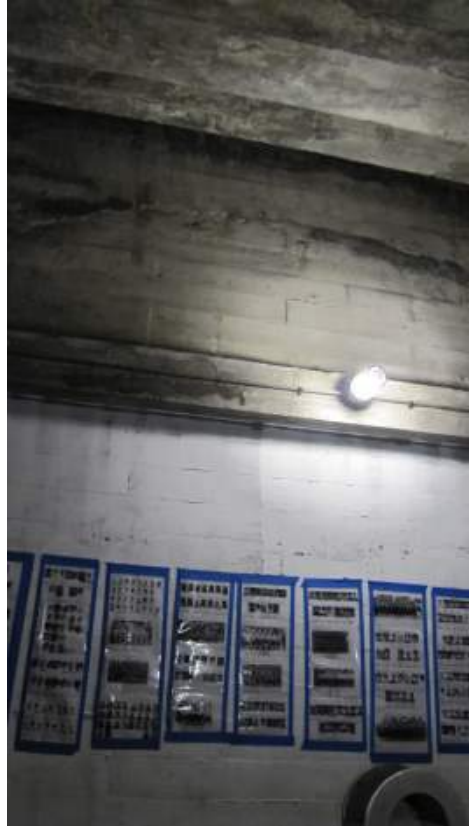
FIGURE C3C: CRACK IN CONC. WALL

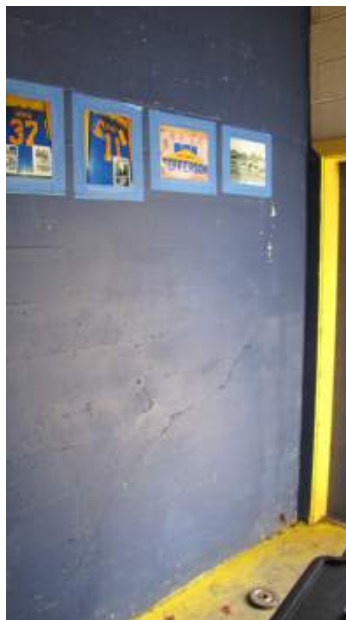
FIGURE C3D-1: CRACK IN CONC. WALL

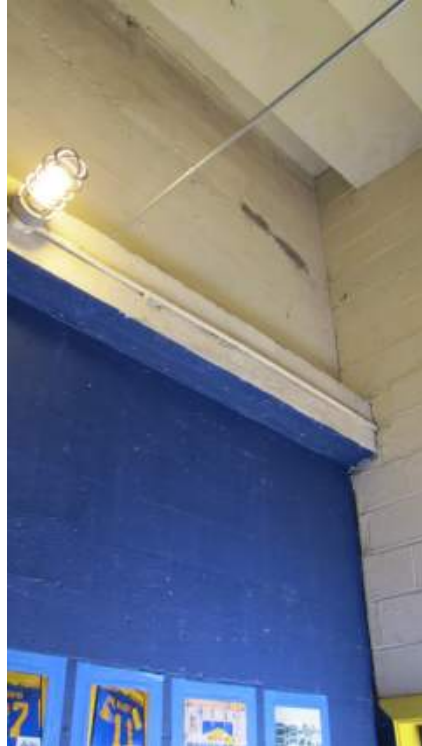
FIGURE C3D-2: CRACK IN CONC. WALL

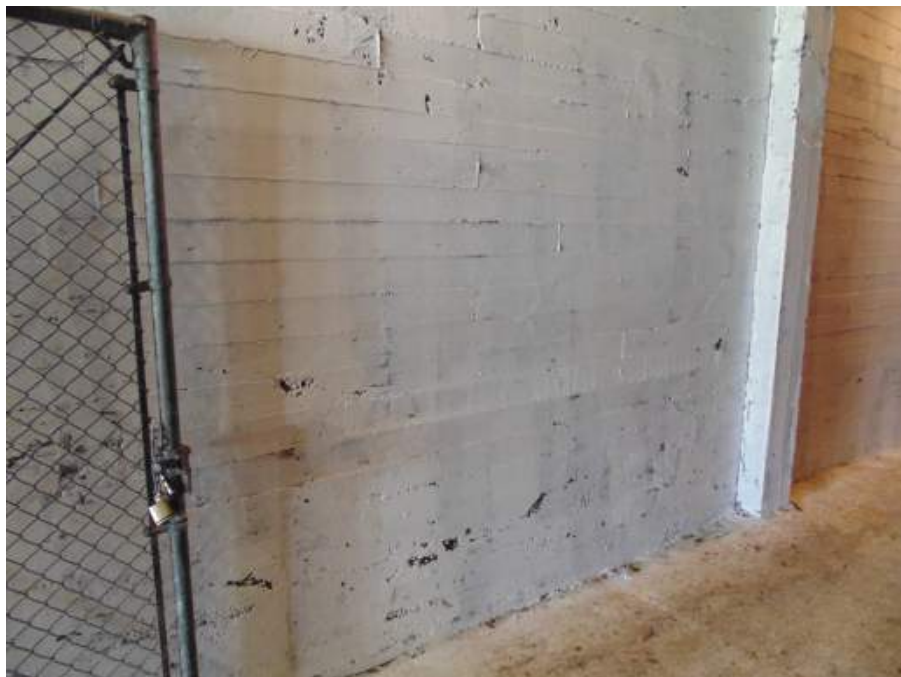
FIGURE C4A: SPALL IN CONC. WALL

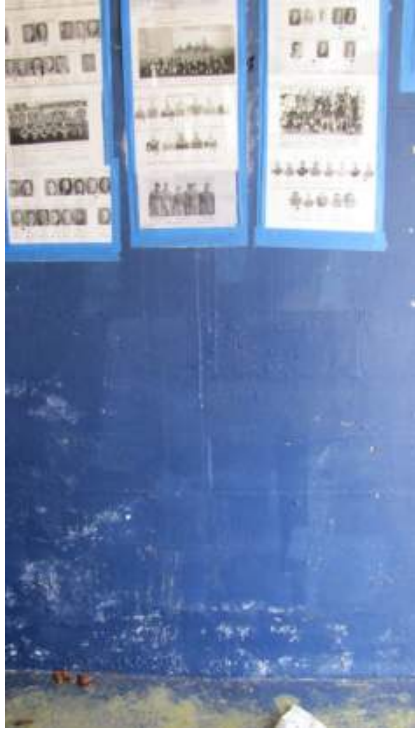
FIGURE C4B: SPALL IN CONC. WALL

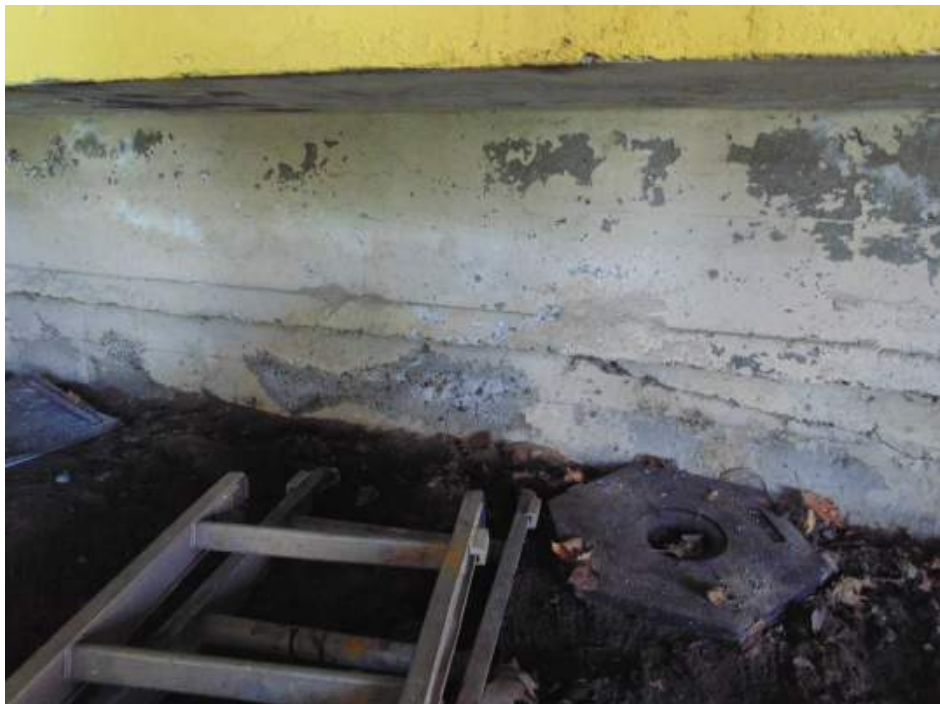
FIGURE C5: SPALLING/CRACKING IN STEM WALL
