PPS - Jefferson High School - Grandstand Assessment

ABHT Project #11516

June 29, 2016

EXECUTIVE SUMMARY

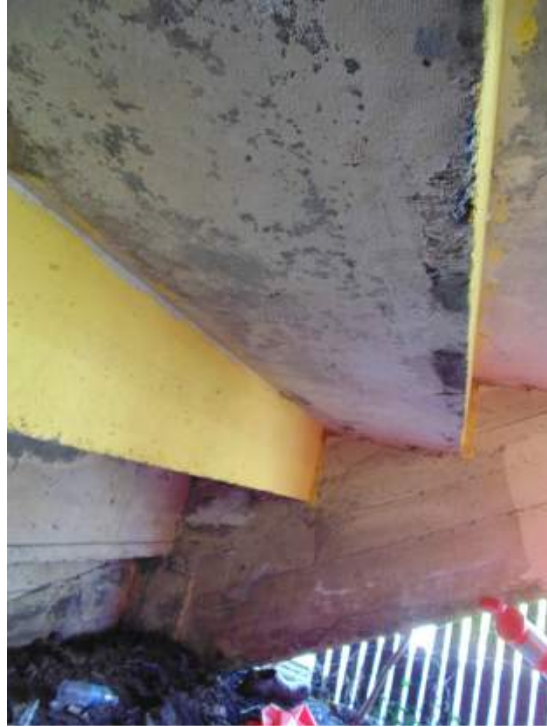
FIGURE C6A: SPALLING/CRACKING/EXPOSED STEEL ON UNDERSIDE OF BEAMS

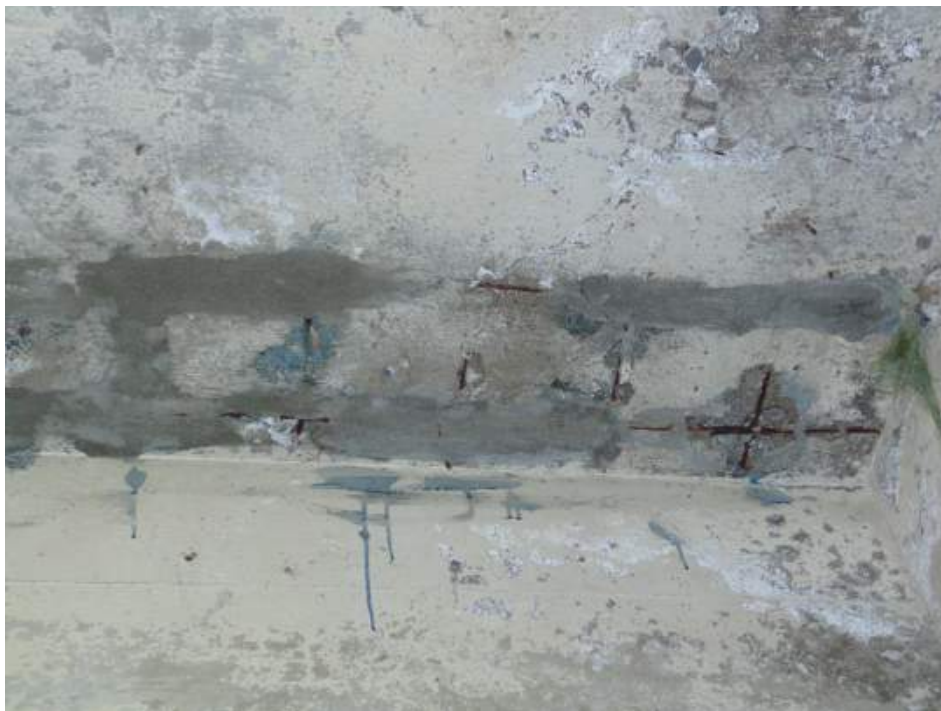
FIGURE C6B: SPALLING/CRACKING/EXPOSED STEEL ON UNDERSIDE OF BEAMS

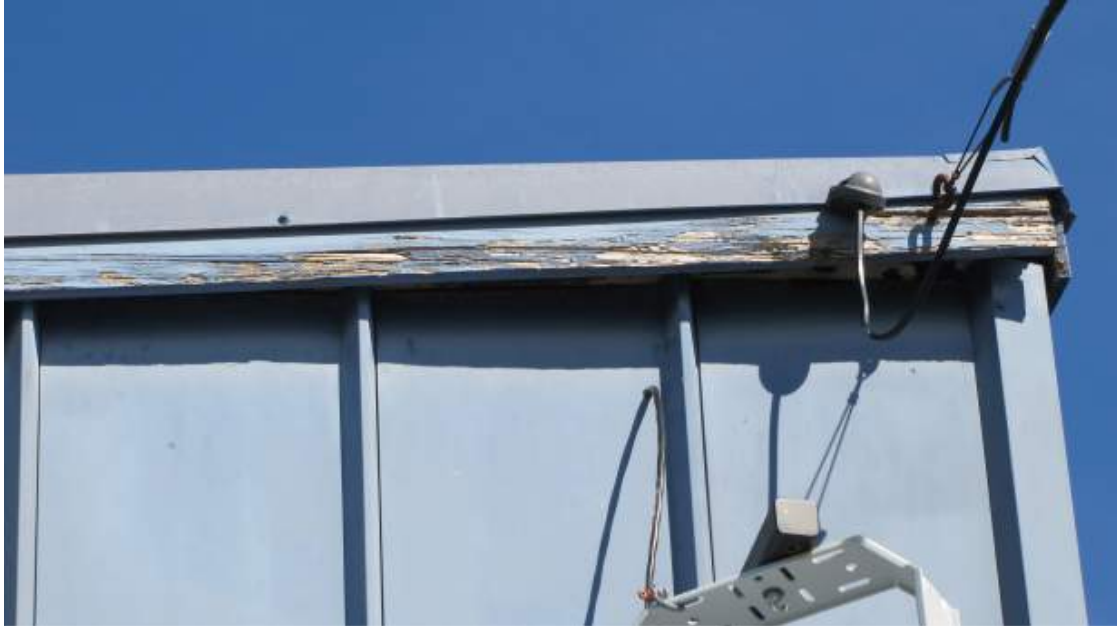
FIGURE W1: WOOD DETERIORATING AT PRESS BOX

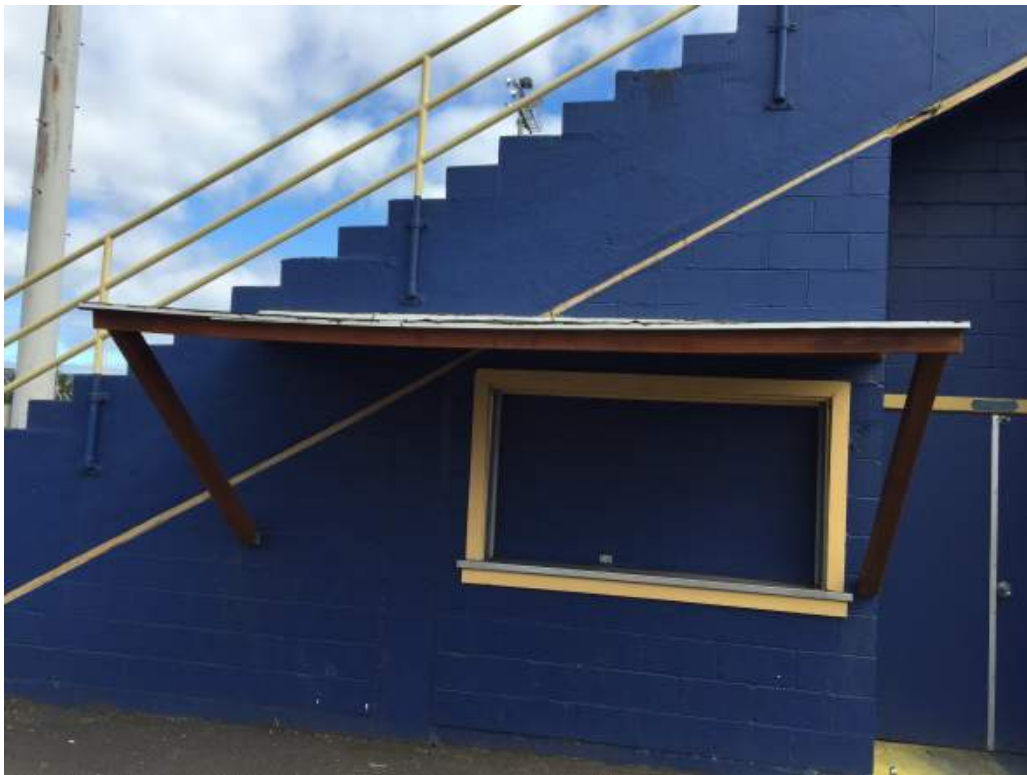
FIGURE W2: WOOD CANOPY ISSUES
