PPS - Lincoln High School - Grandstand Assessment

View From Underside of Grandstand

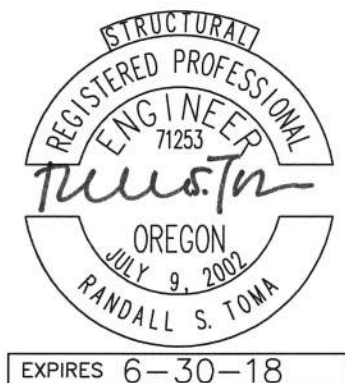
Randall S. Toma, P.E., S.E.
Principal
ABHT STRUCTURAL ENGINEERS
1640 NW Johnson St.
Portland, OR 97209

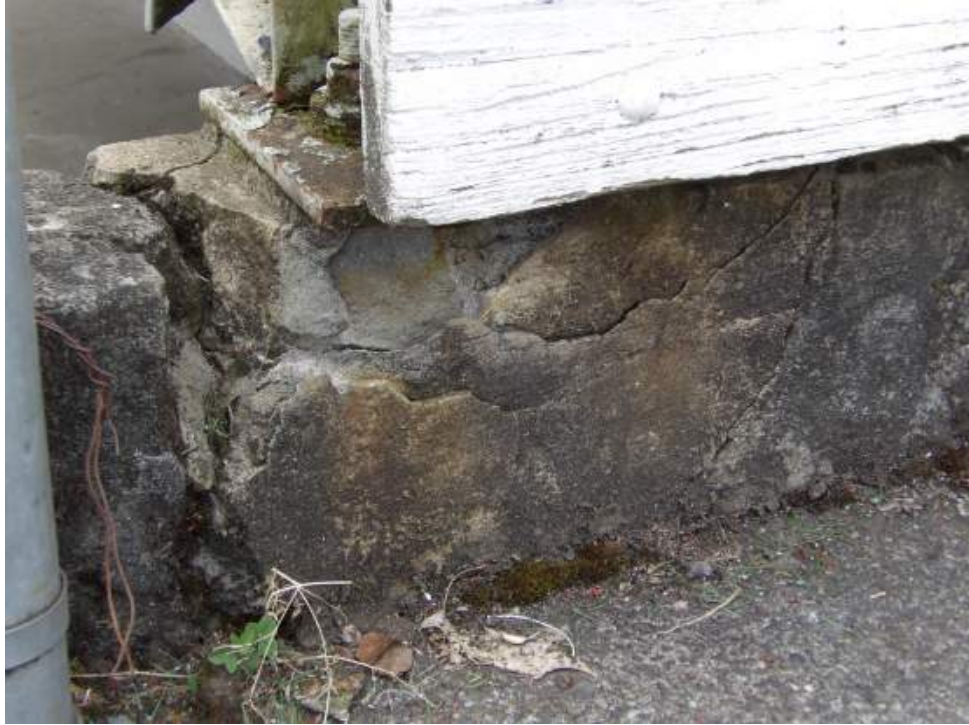
FIGURE F1A: CRACKING AND SPALLING IN FRONT BEARING CONCRETE WALL

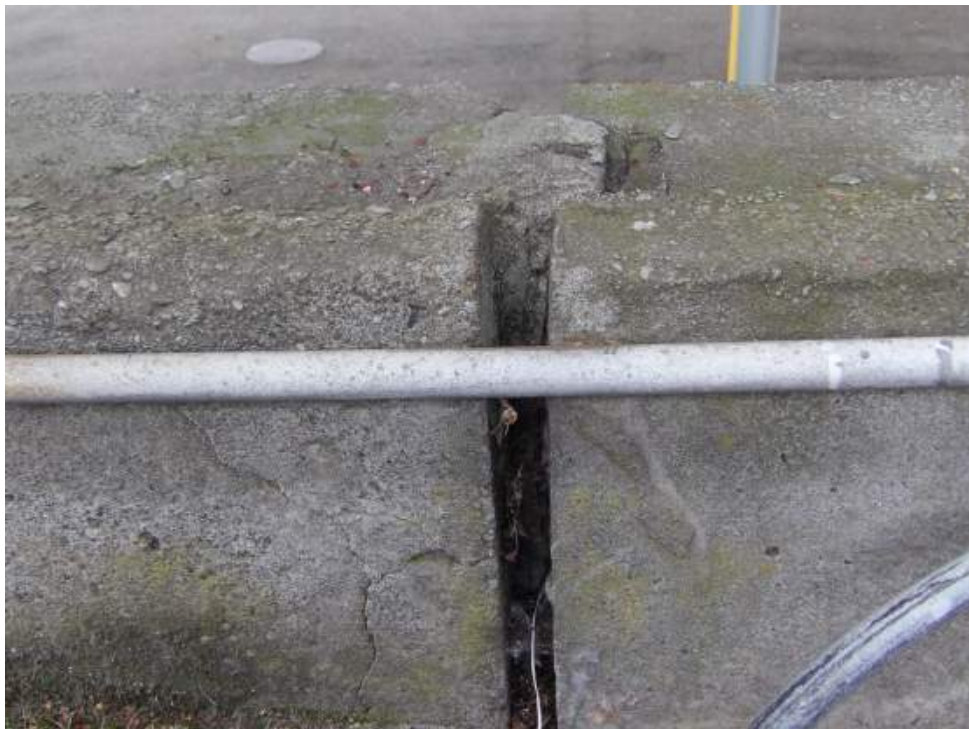
FIGURE F1B: CRACKING AND SPALLING IN FRONT BEARING CONCRETE WALL

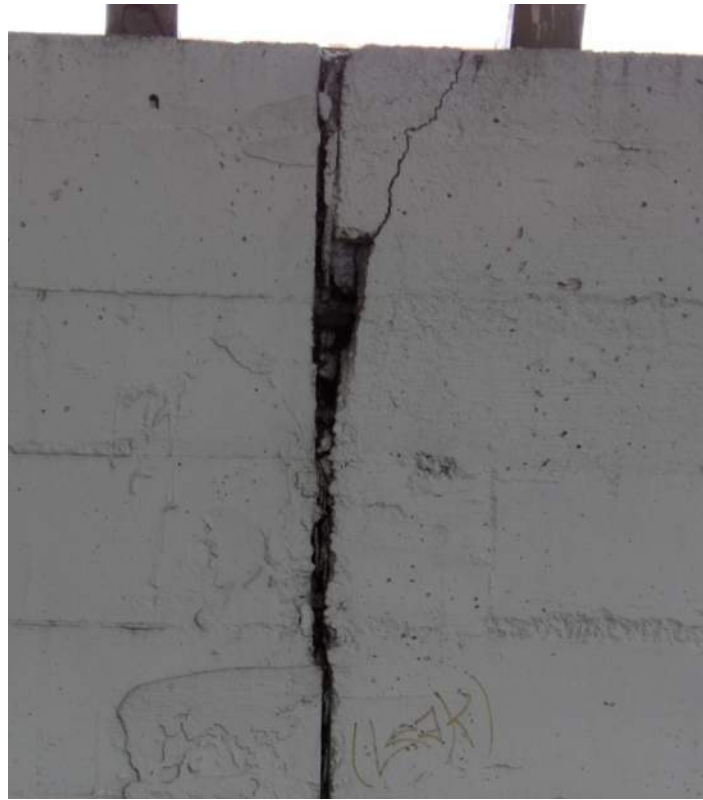
FIGURE F1C: CRACKING AND SPALLING IN FRONT BEARING CONCRETE WALL

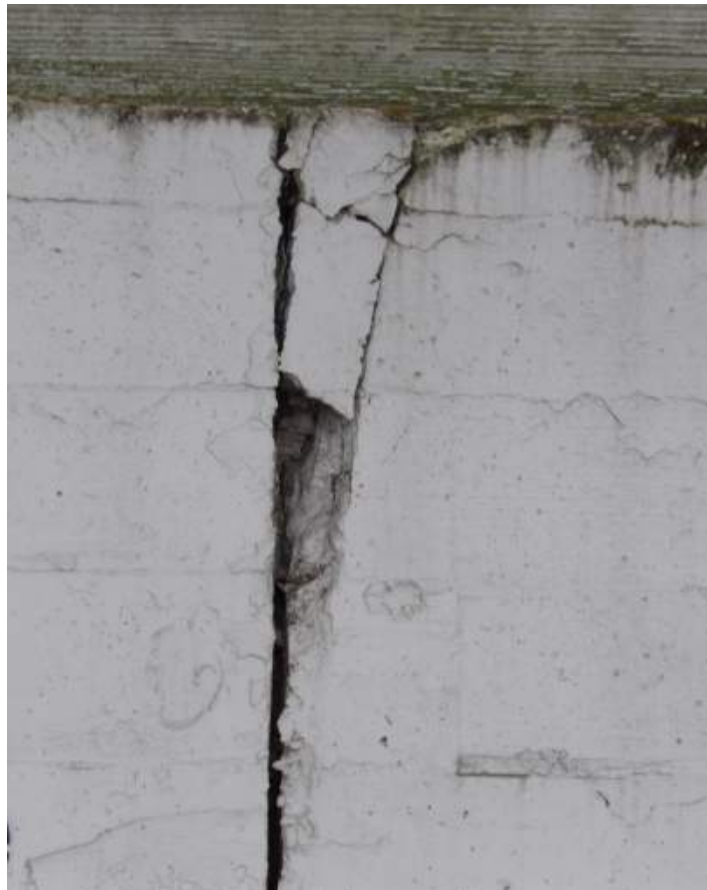
FIGURE F1D: SPALLING AT TOP OF WALL JOINT

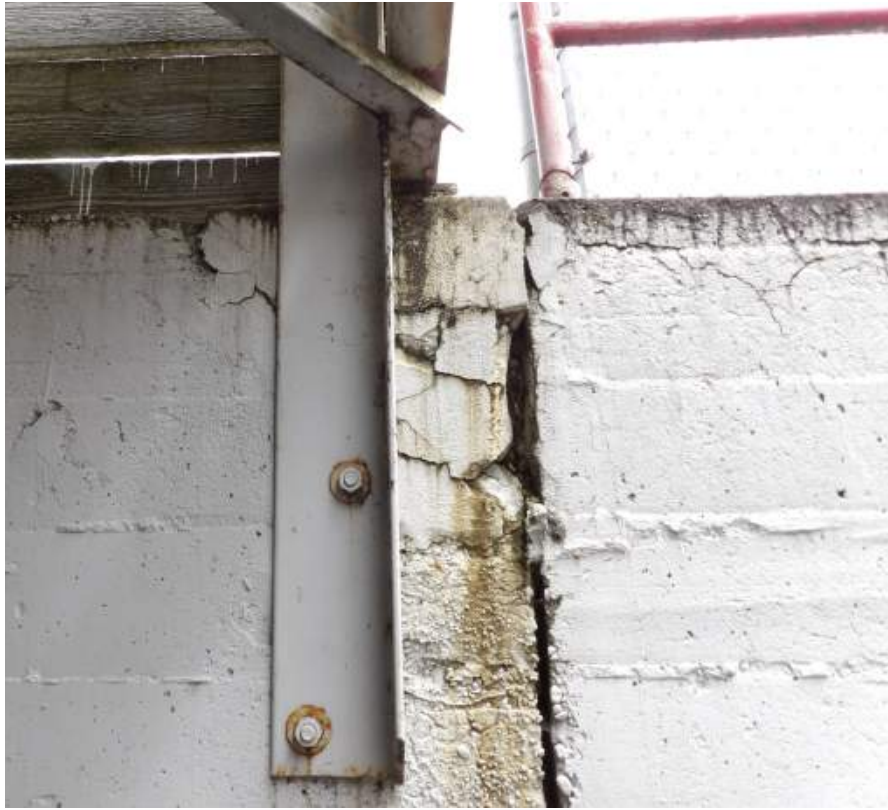
FIGURE F1E: CRACKING AND SPALLING AT TOP OF CONCRETE WALL

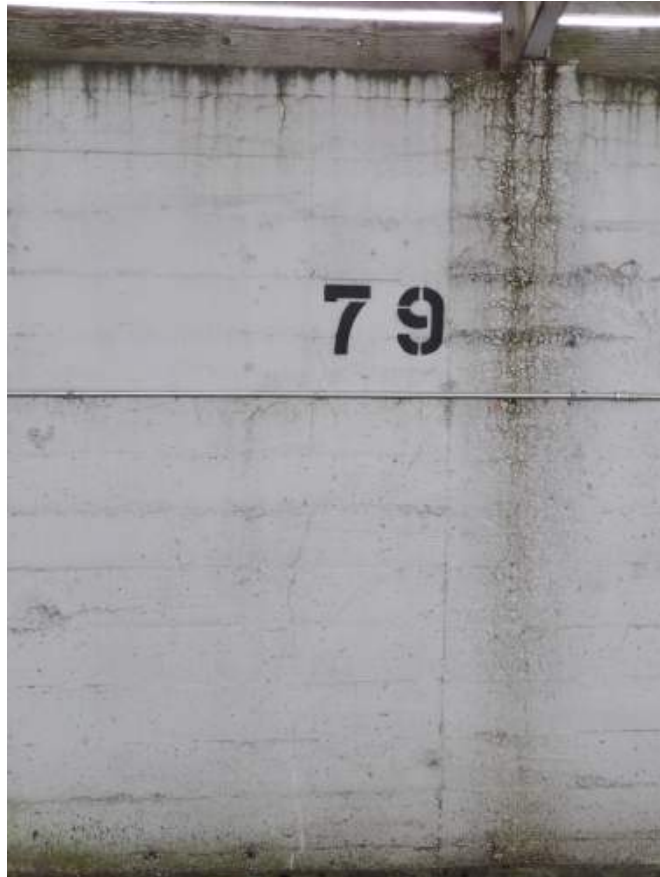
FIGURE F2A: MINOR CRACKING IN FRONT BEARING CONCRETE WALL (TYPICAL OF ENTIRE WALL)

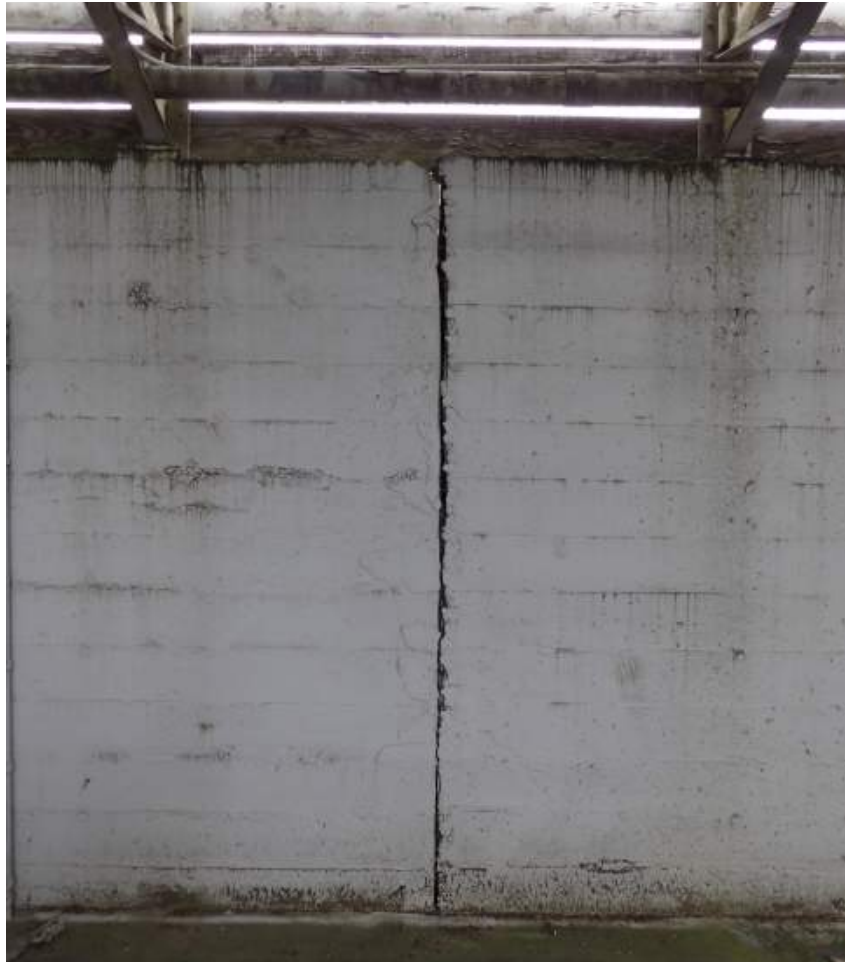
FIGURE F2B: MINOR SPALLING AT TOP OF WALL JOINT

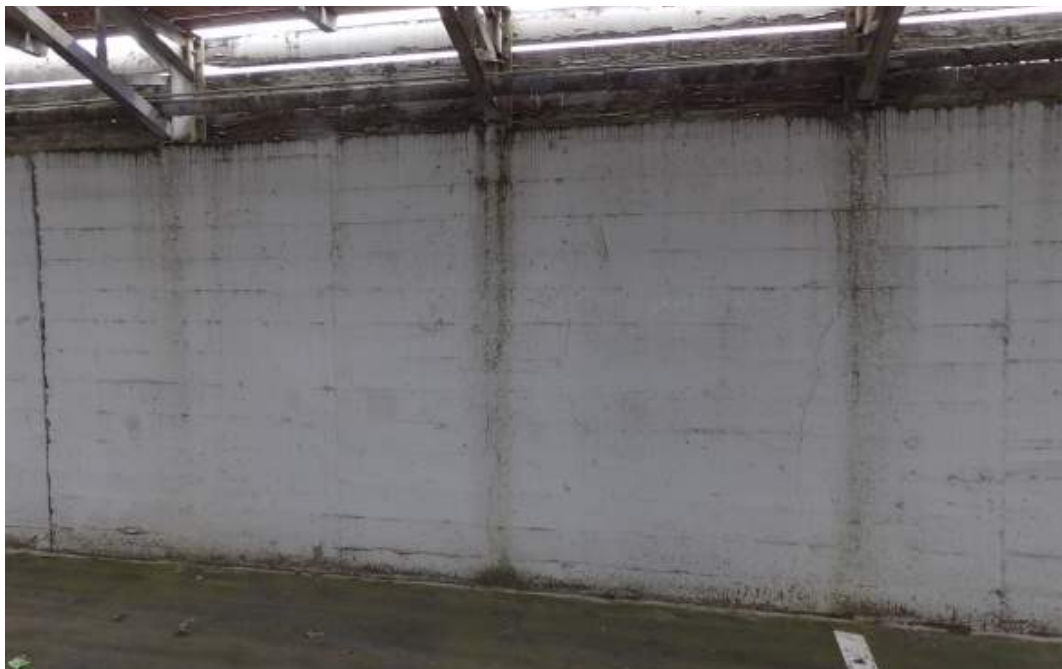
FIGURE F2C: MINOR VERTICAL CRACKING IN WALL (TYPICAL OF ENTIRE WALL)

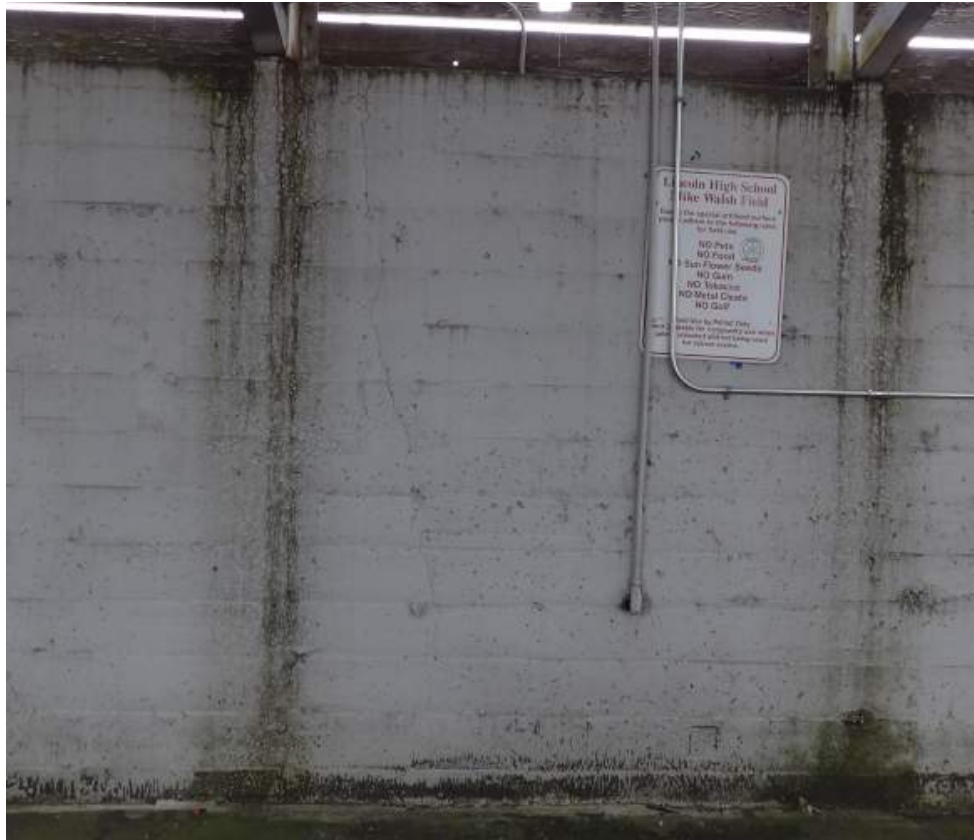
FIGURE F2D: MINOR VERTICAL CRACKING IN WALL (TYPICAL OF ENTIRE WALL)

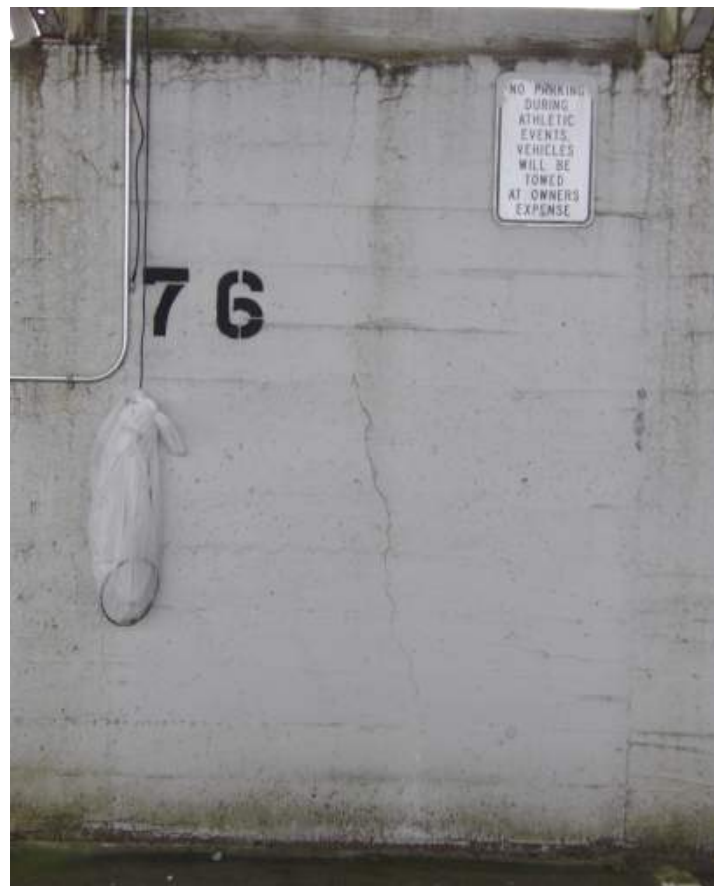
FIGURE F2E: MINOR VERTICAL CRACKING IN WALL (TYPICAL OF ENTIRE WALL)

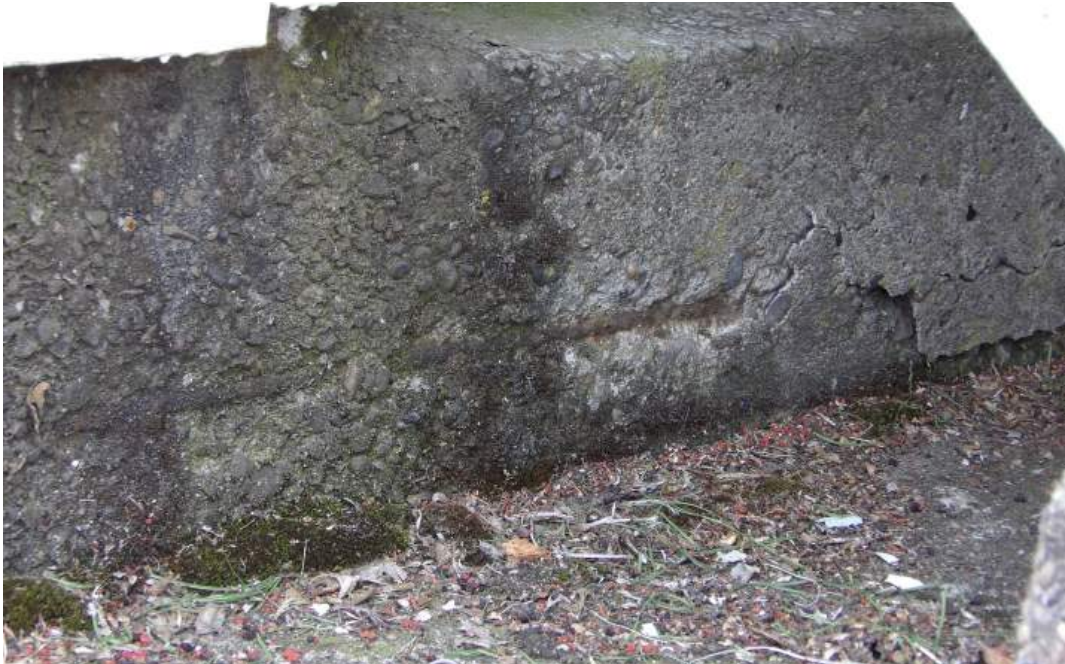
FIGURE F3A: EXPOSED REBAR WITH MINOR CRACKING AND SPALLING

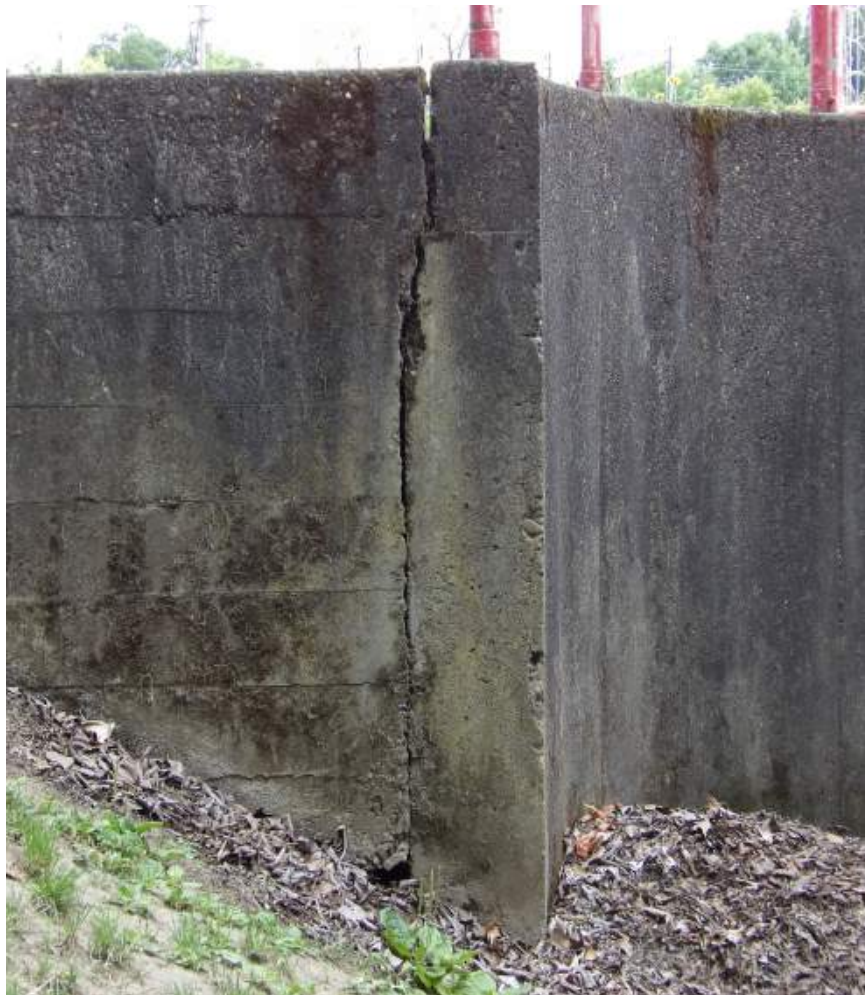
FIGURE F4A: CONCRETE WALL SEPARATION AT CORNER

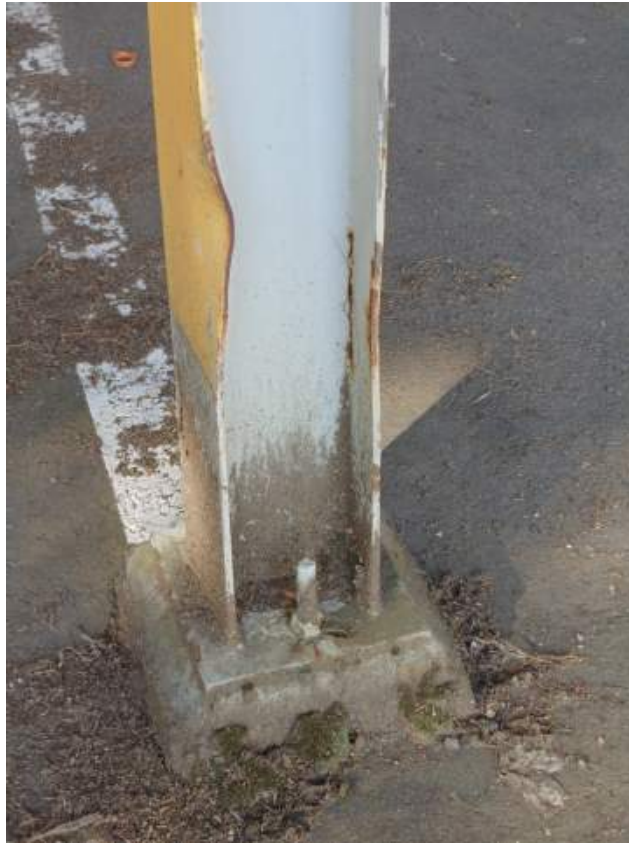
FIGURE S1A: STEEL COLUMN DAMAGE

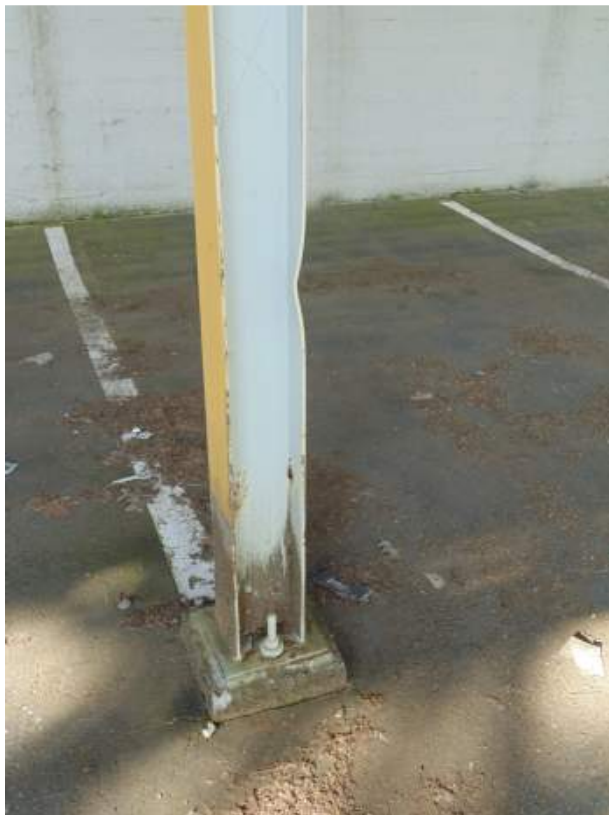
FIGURE S1B: STEEL COLUMN DAMAGE

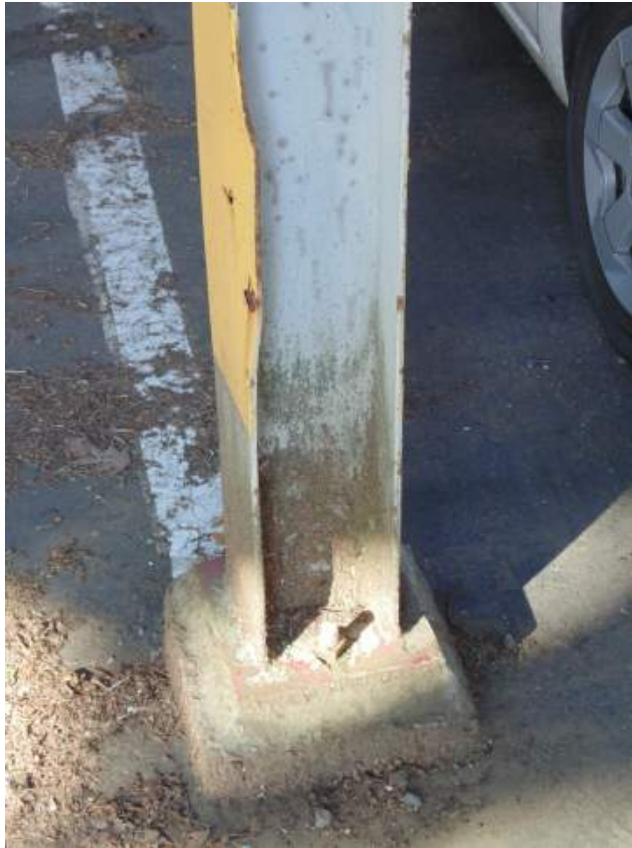
FIGURE S1C: STEEL COLUMN DAMAGE

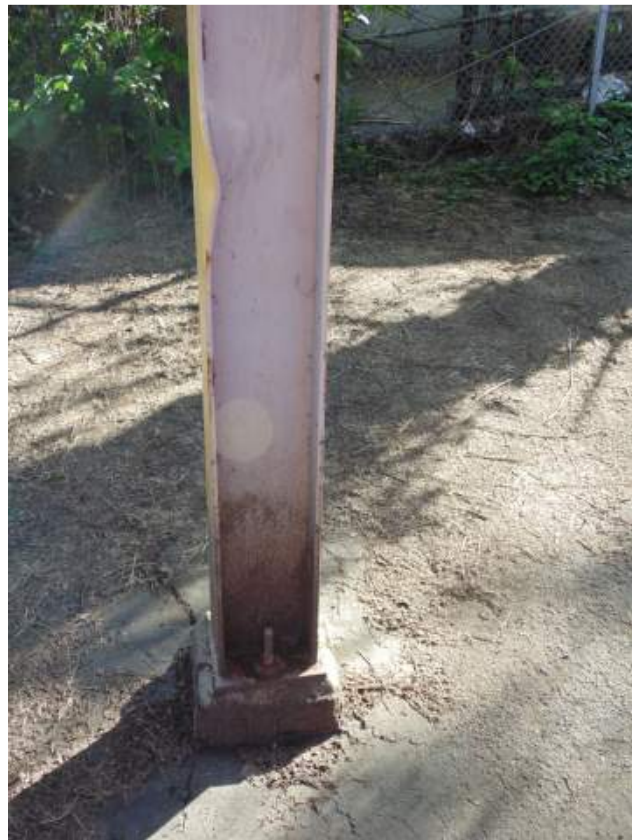
FIGURE S1D: STEEL COLUMN DAMAGE

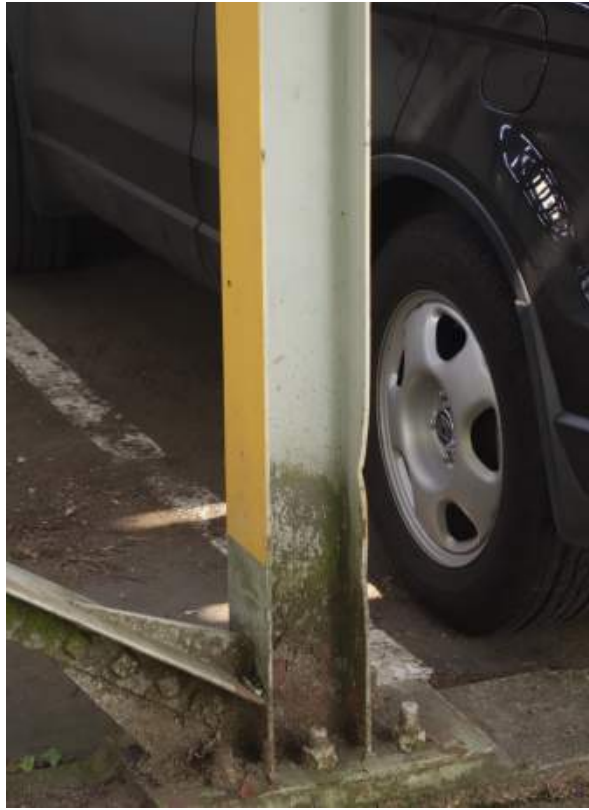
FIGURE S1E: STEEL COLUMN DAMAGE

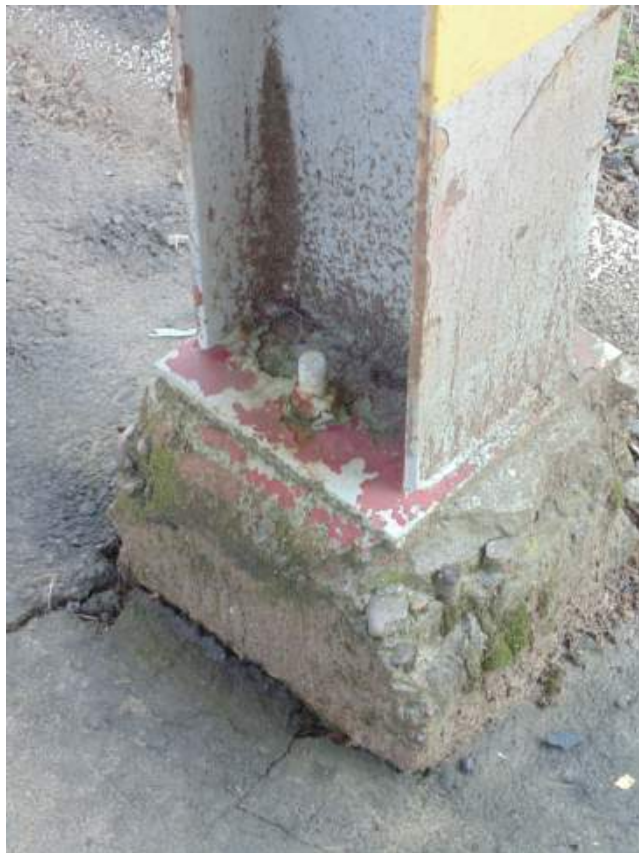
FIGURE S2A: TYPICAL SLIGHT CORROSION

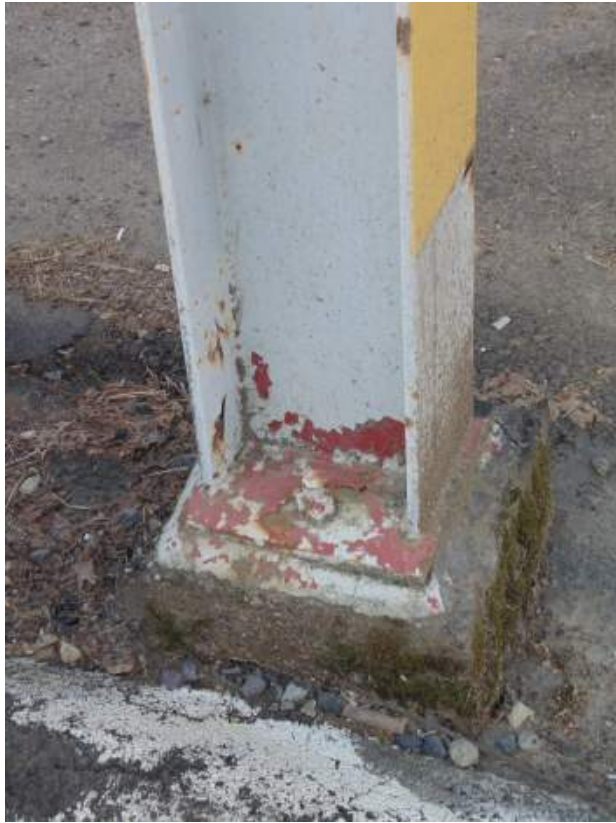
FIGURE S2B: TYPICAL SLIGHT CORROSION

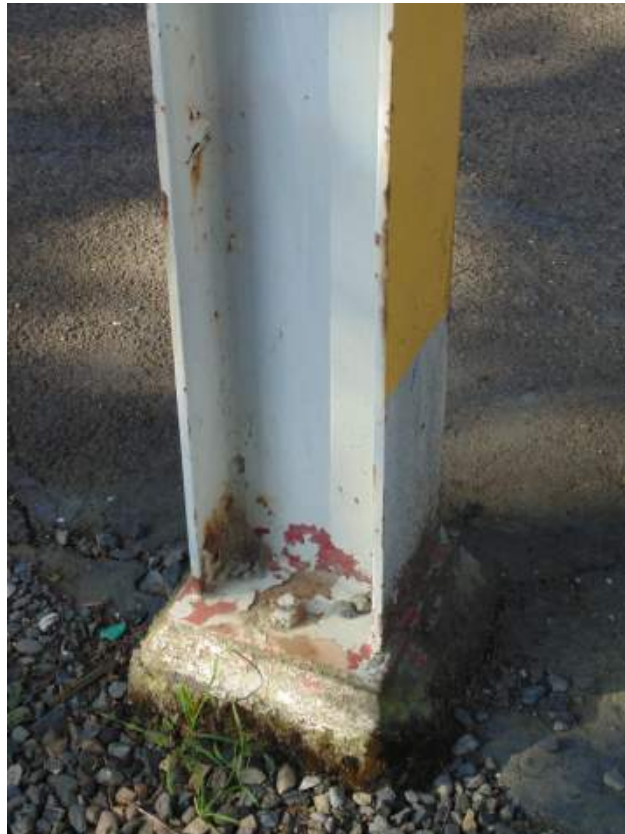
FIGURE S2C: TYPICAL SLIGHT CORROSION

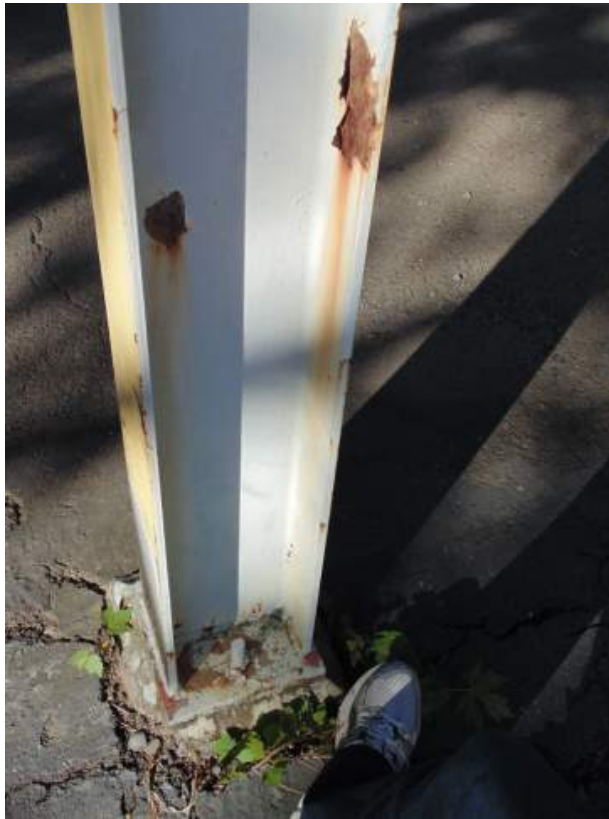
FIGURE S2D: TYPICAL SLIGHT CORROSION

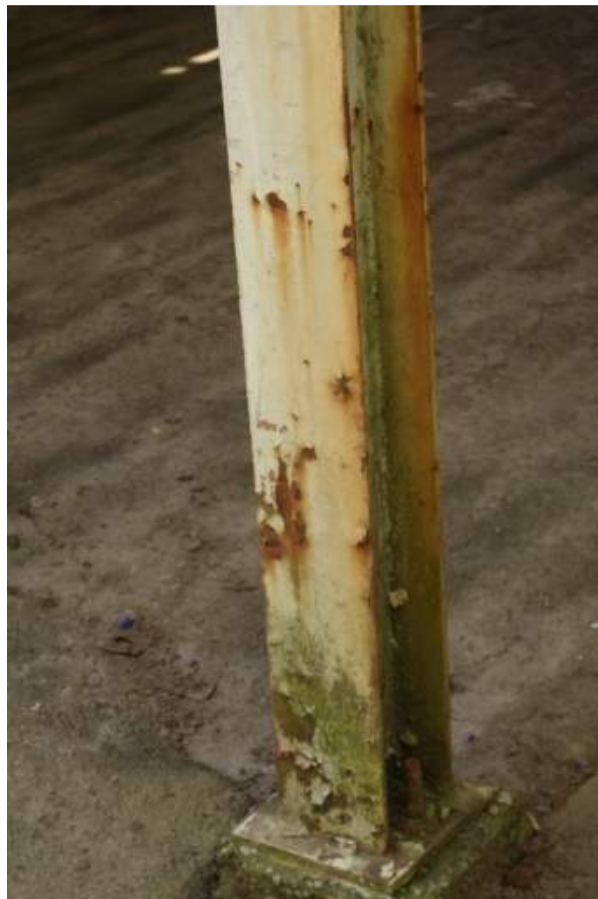
FIGURE S2E: TYPICAL SLIGHT CORROSION

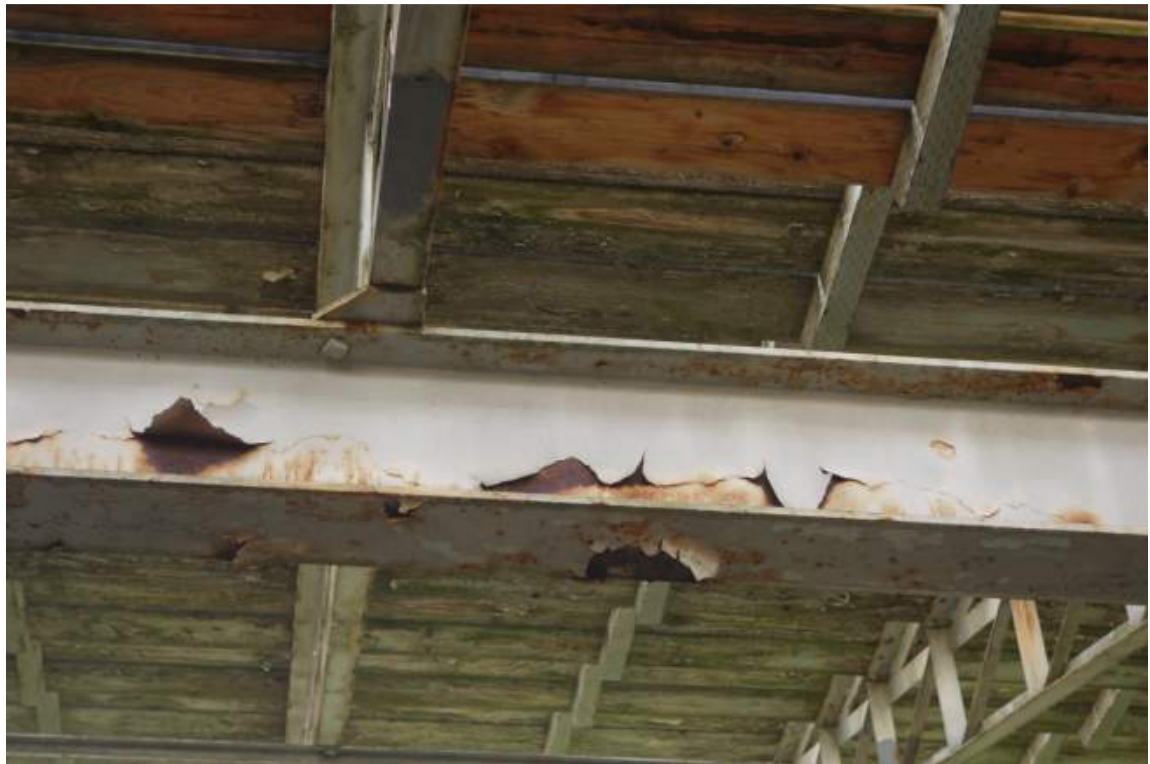
FIGURE S2F: TYPICAL SLIGHT CORROSION

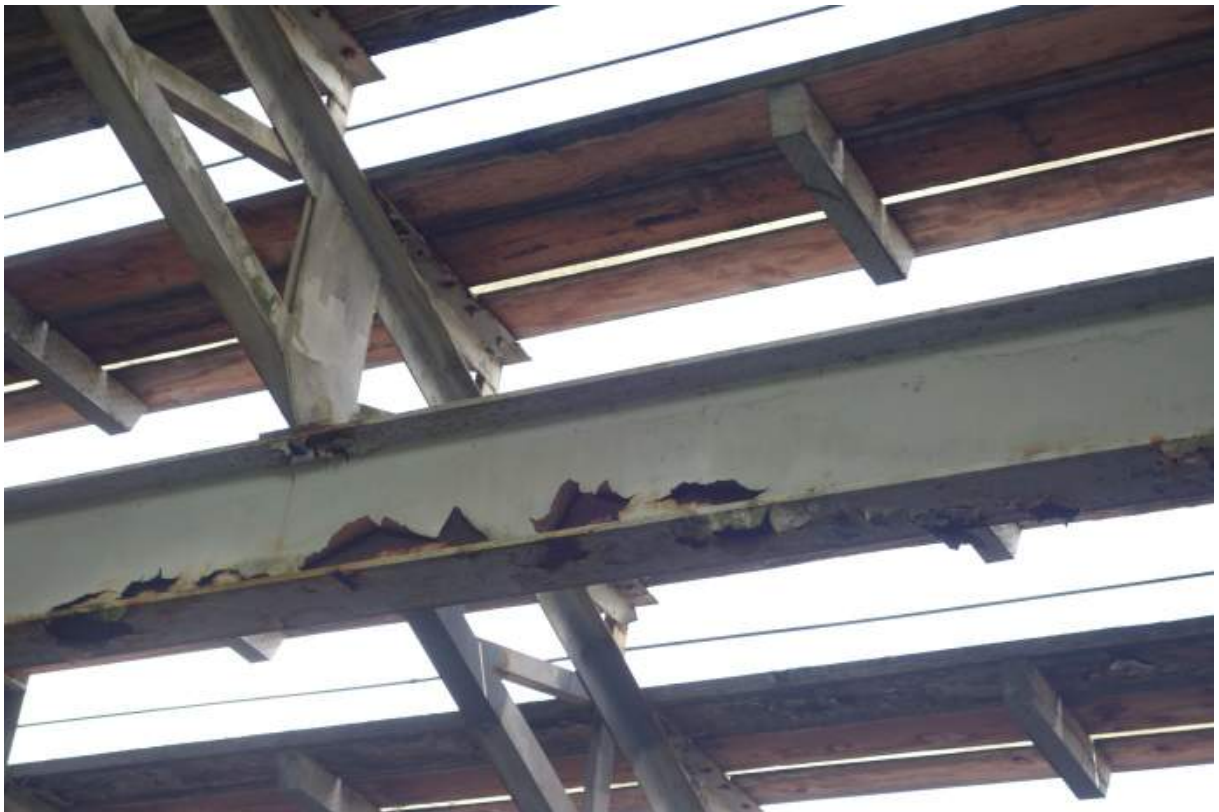
FIGURE S2G: TYPICAL SLIGHT CORROSION

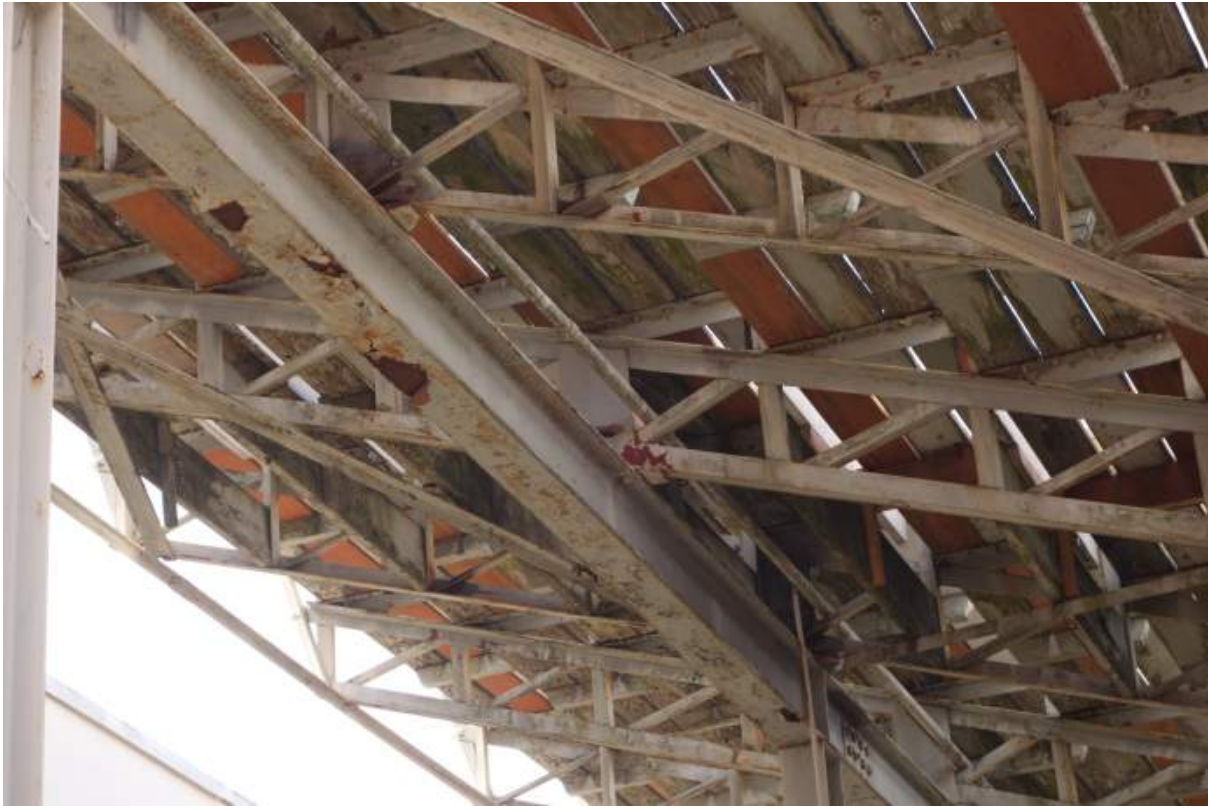
FIGURE S2H: TYPICAL SLIGHT CORROSION

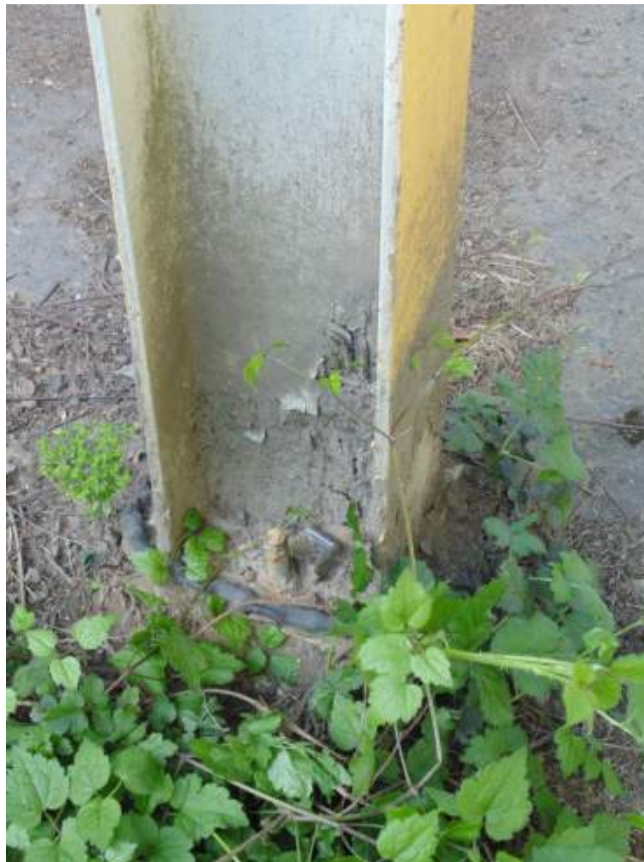
FIGURE S3A: SLIGHT CORROSION ON COLUMN ALONG WITH EMBEDDED DEBRIS

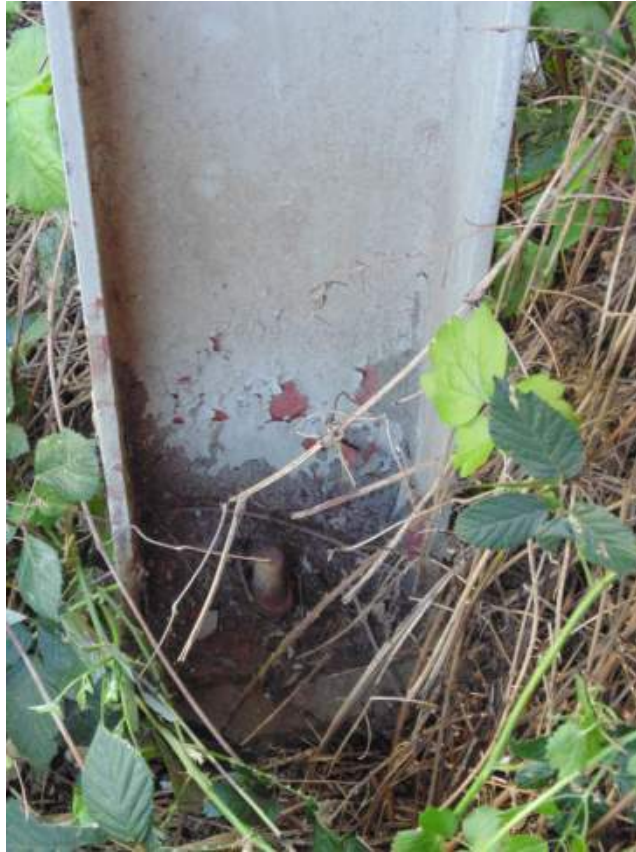
FIGURE S3B: SLIGHT CORROSION ON COLUMN ALONG WITH EMBEDDED DEBRIS

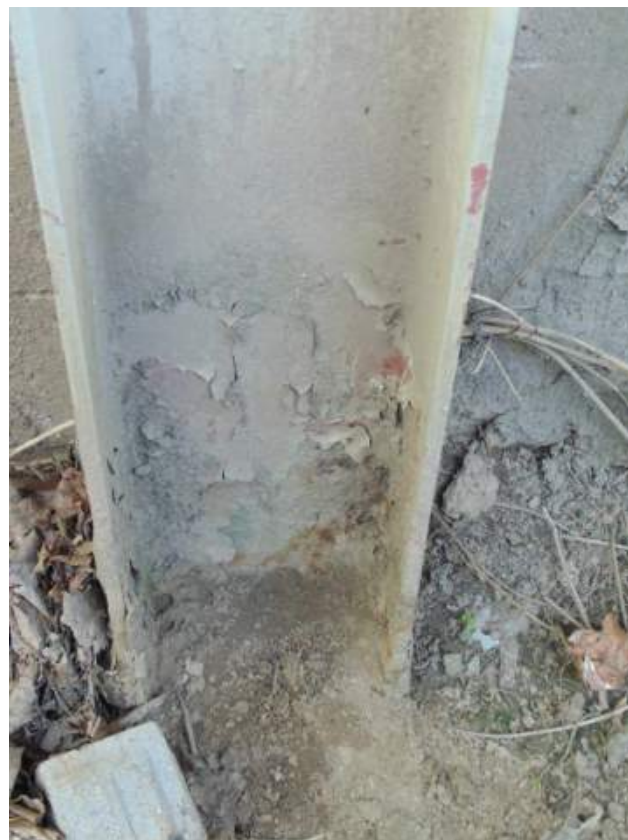
FIGURE S3C: SLIGHT CORROSION ON COLUMN ALONG WITH EMBEDDED DEBRIS

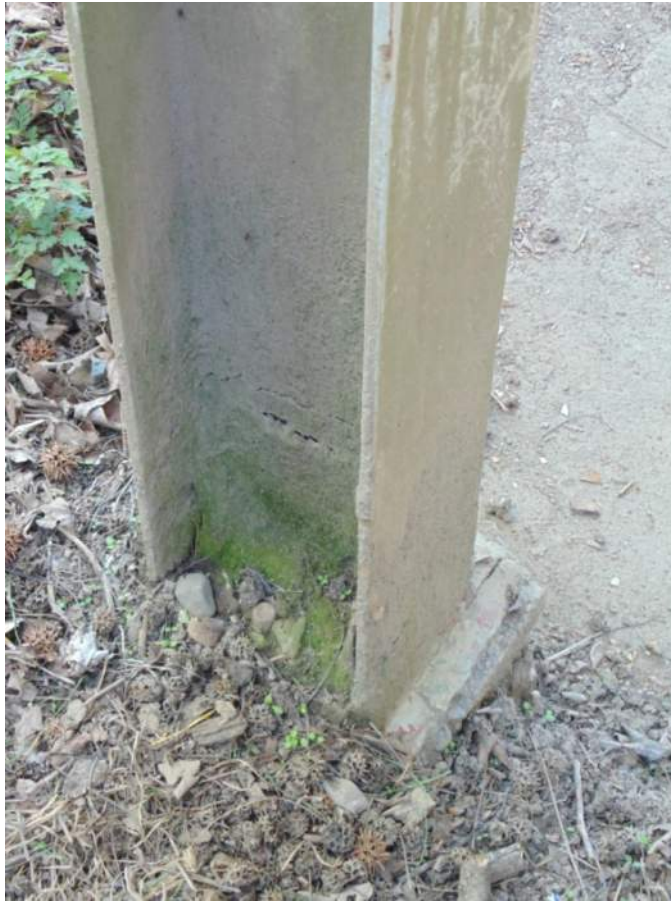
FIGURE S3D: SLIGHT CORROSION ON COLUMN ALONG WITH EMBEDDED DEBRIS

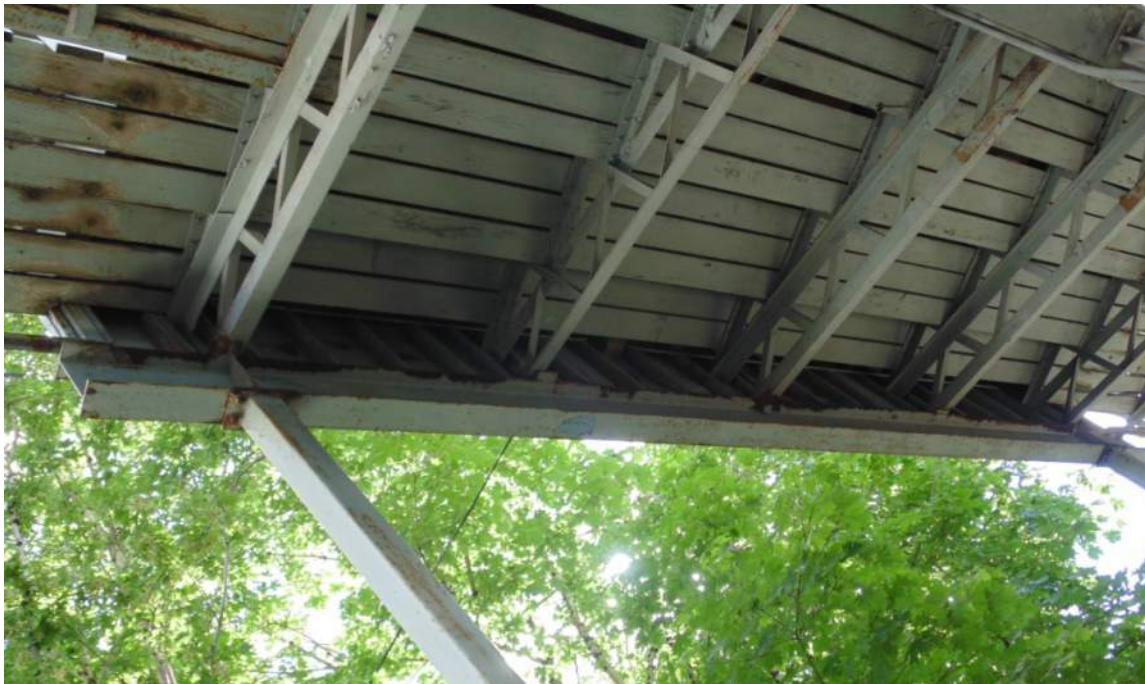
FIGURE S4A: SIGNIFICANT CORROSION ON STEEL BEAM ADDED FOR PRESSBOX

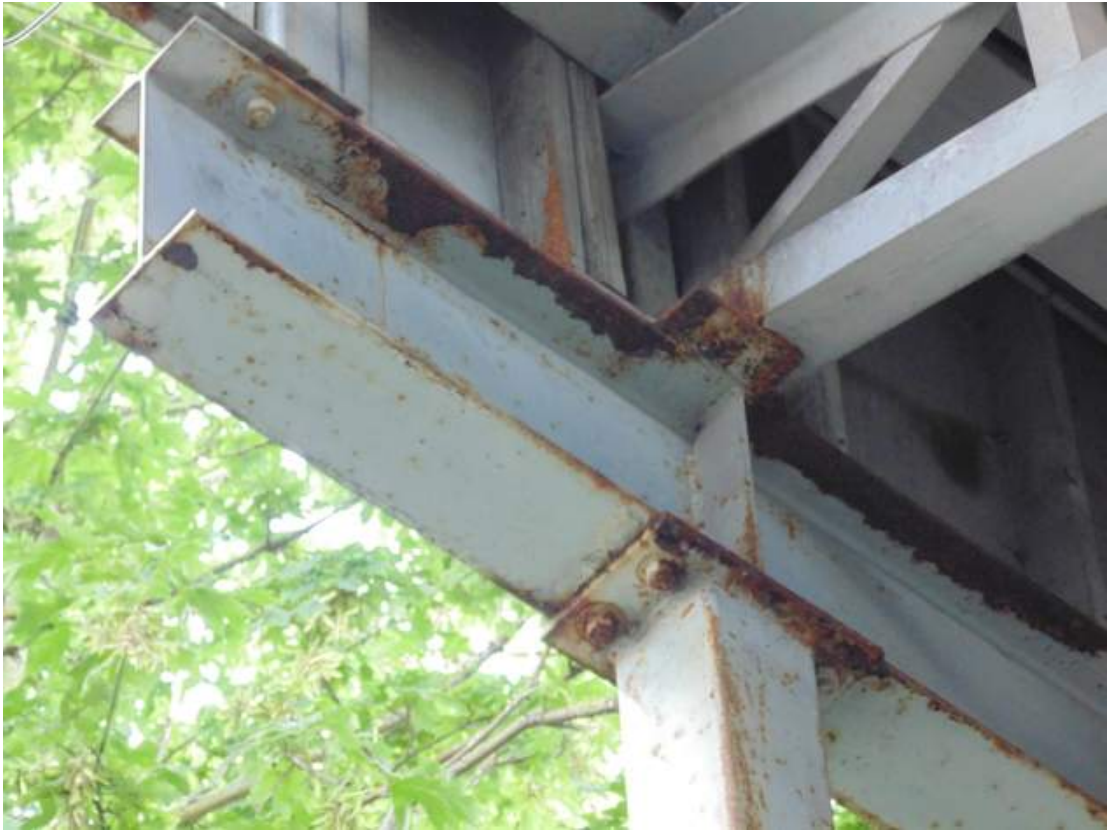
FIGURE S4B: SIGNIFICANT CORROSION ON STEEL BEAM ADDED FOR PRESSBOX

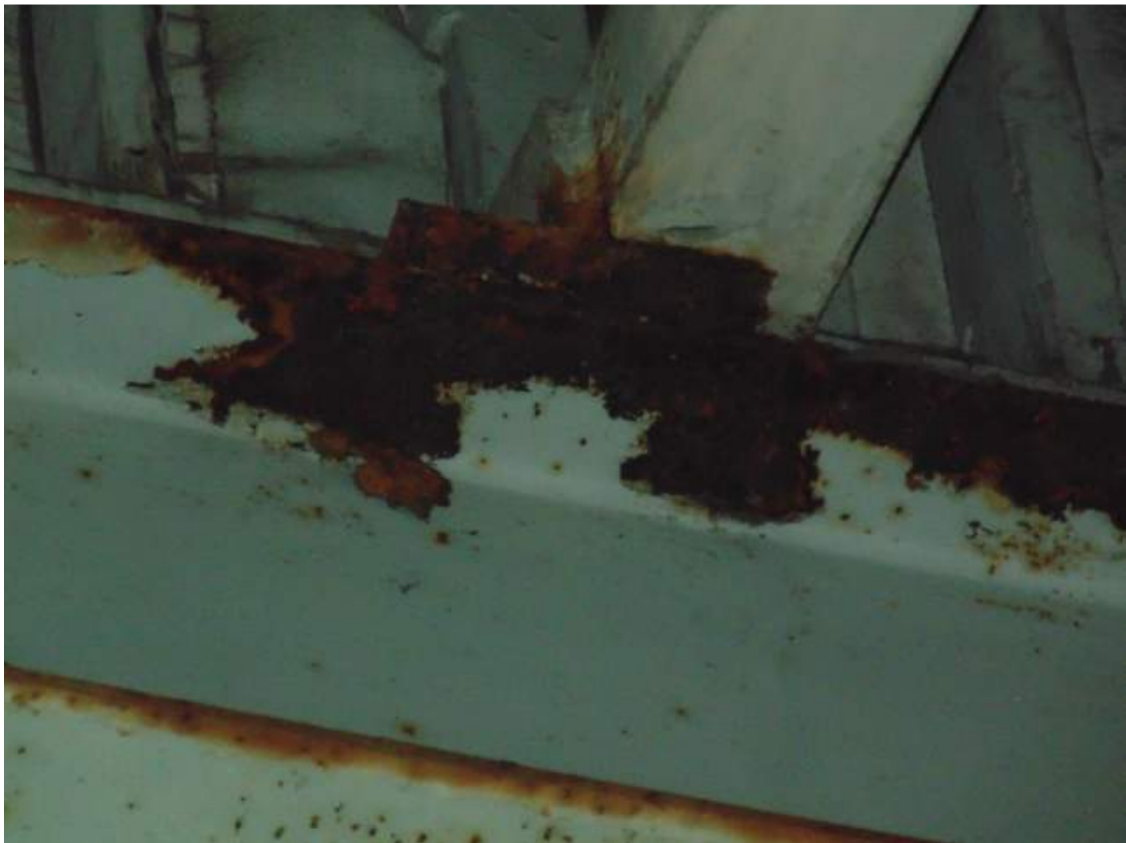
FIGURE S4C: SIGNIFICANT CORROSION ON STEEL BEAM ADDED FOR PRESSBOX

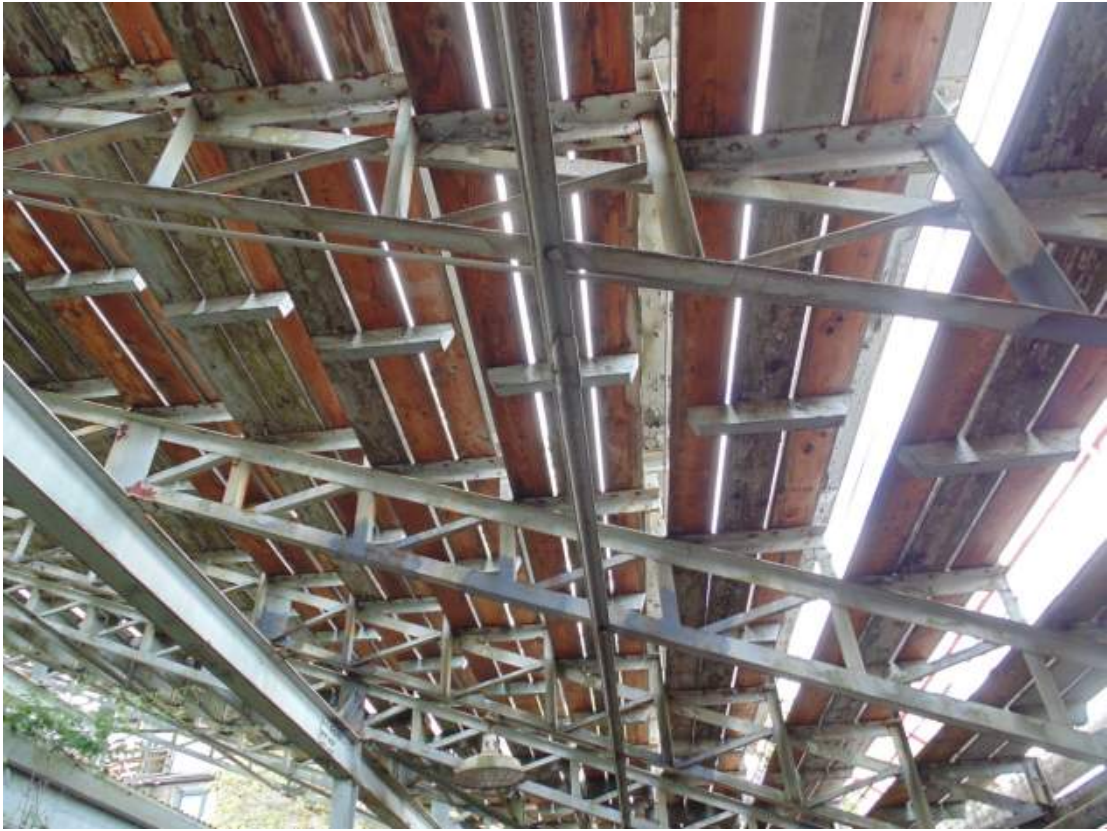
FIGURE S5A: BLEACHER BOARD STEEL SUPPORT RUSTING FROM TOP
