PPS - Lincoln High School - Grandstand Assessment

View From Underside of Grandstand

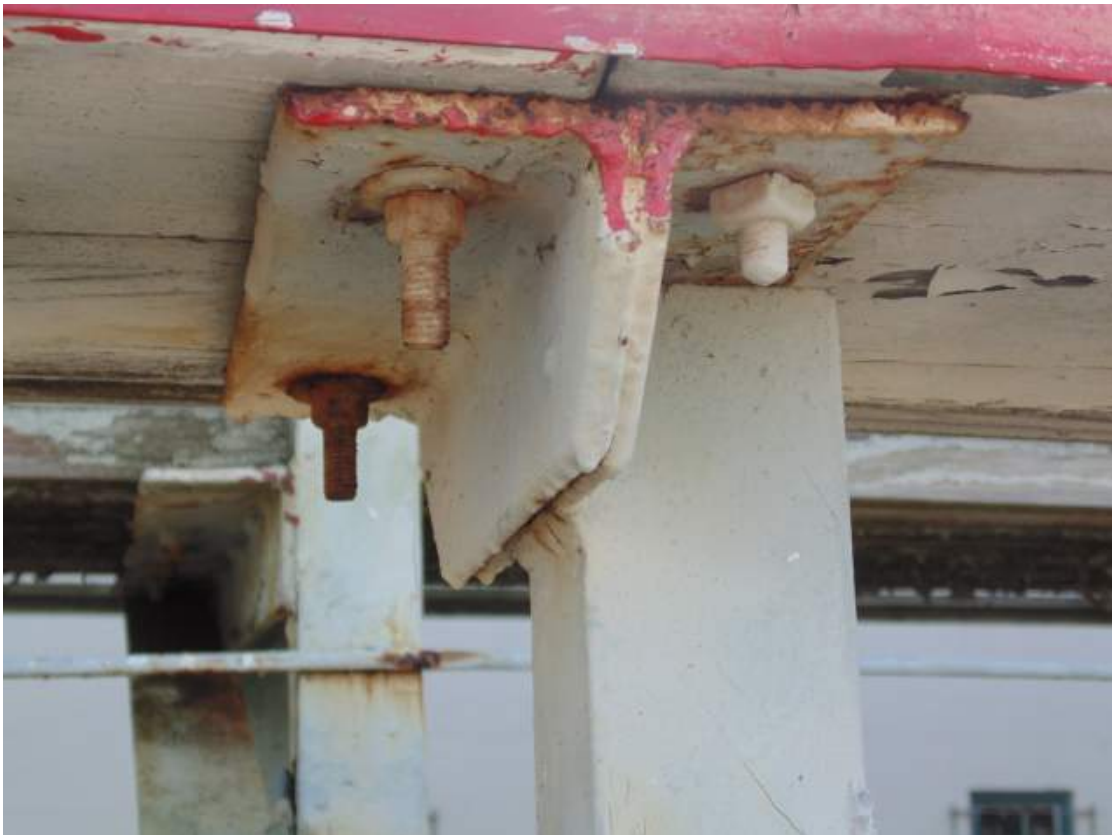
FIGURE S5B: BLEACHER BOARD STEEL SUPPORT RUSTING FROM TOP

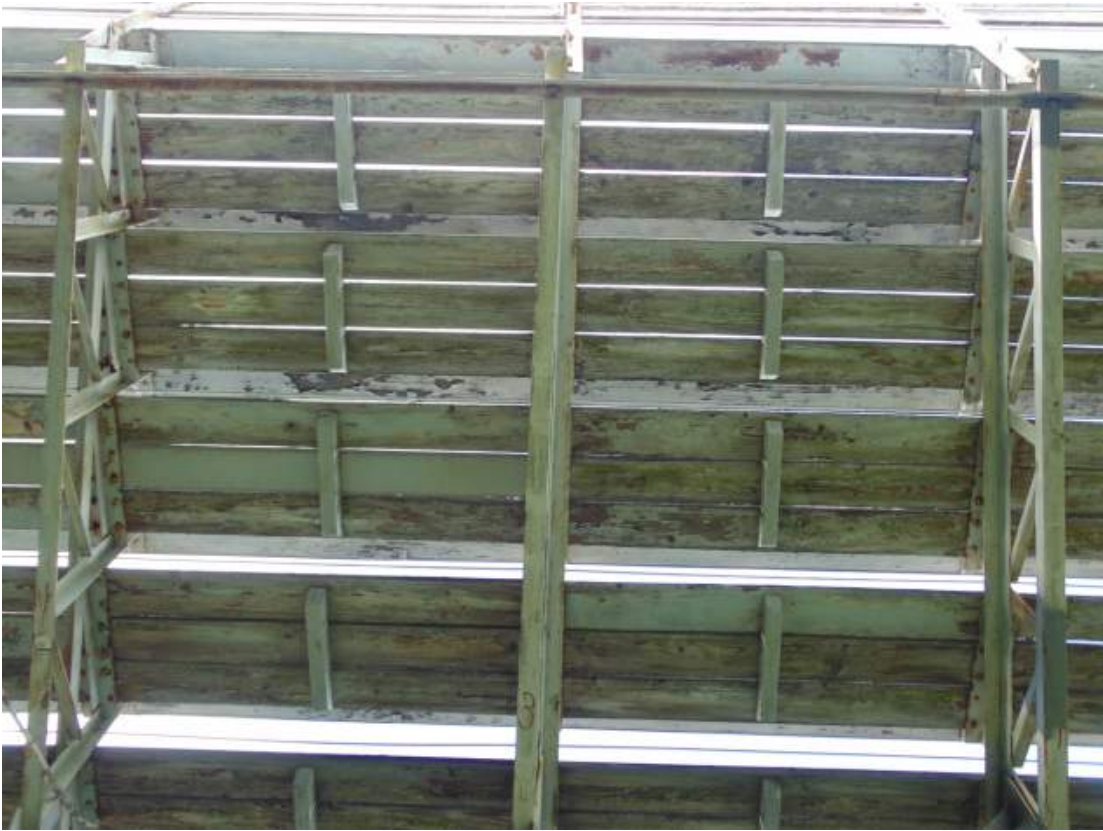
FIGURE S5C: BLEACHER BOARD STEEL SUPPORT RUSTING FROM TOP
