PPS - Madison High School - Grandstand Assessment

West View of Grandstand

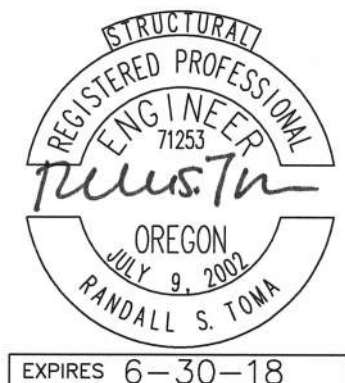
Randall S. Toma, P.E., S.E.
Principal
ABHT STRUCTURAL ENGINEERS
1640 NW Johnson St.
Portland, OR 97209

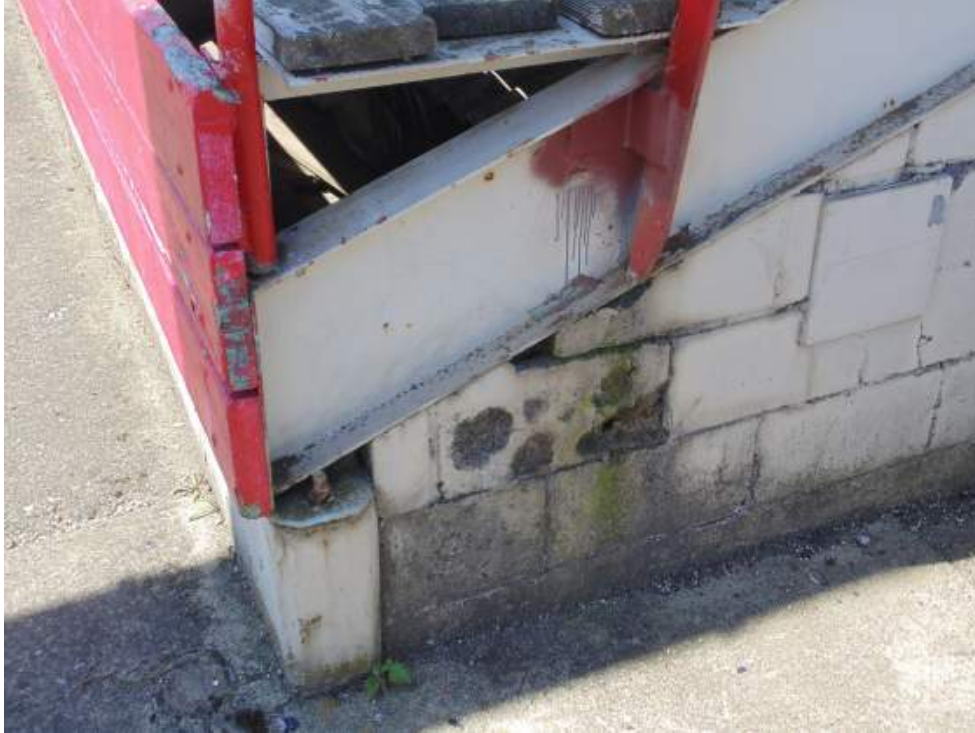
**FIGURE F1A:
DETERIORATION OF CMU**

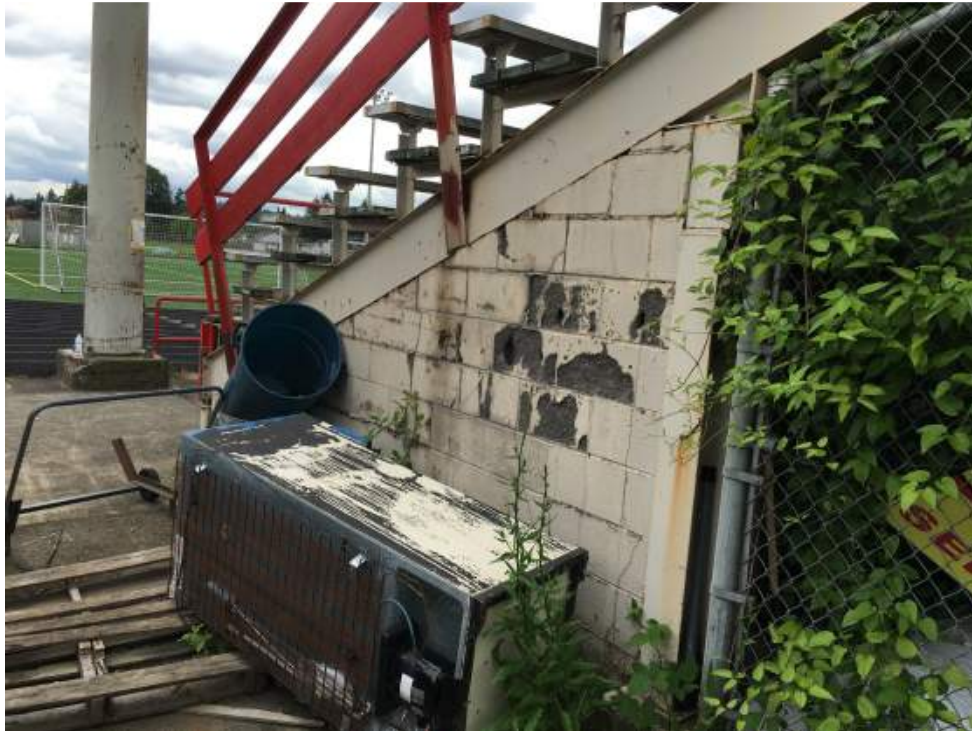
**FIGURE F1B:
DETERIORATION OF CMU**

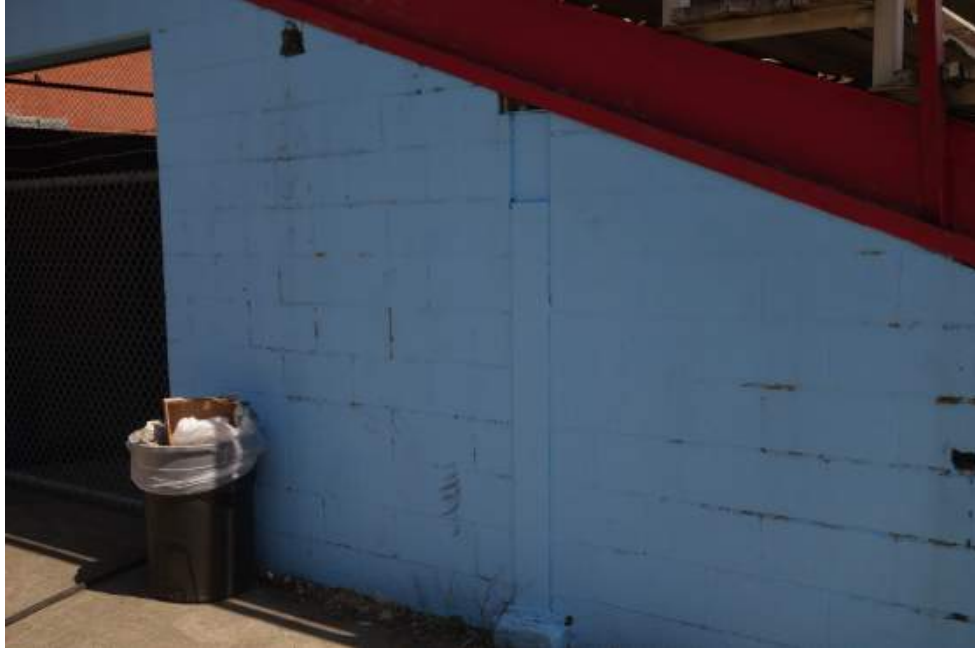
**FIGURE F1C:
DETERIORATION OF CMU**

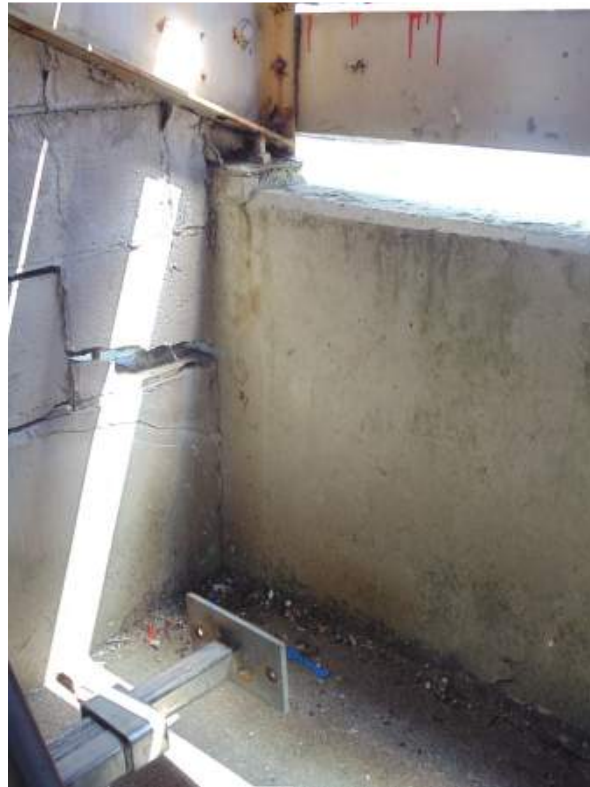
**FIGURE F1D:
DETERIORATION OF CMU**

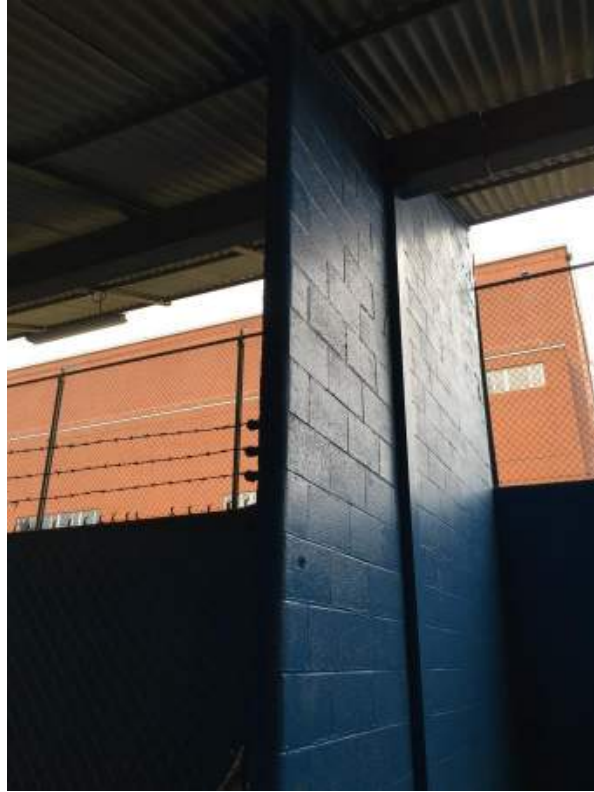
**FIGURE F2A:
4" CMU NON-BEARING PARTITION**

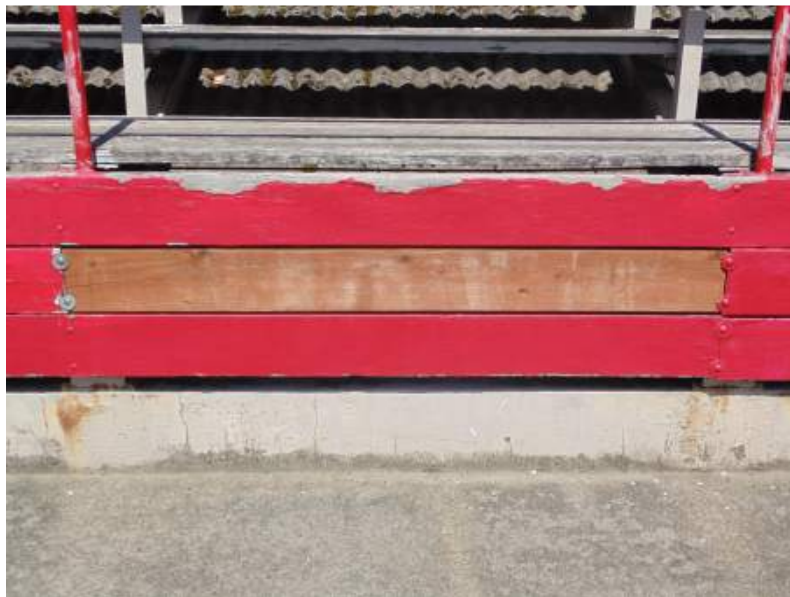
**FIGURE F3A:
MINOR CRACKING IN FRONT BEARING CONCRETE STEMWALL
TYPICAL OF ENTIRE STEMWALL**

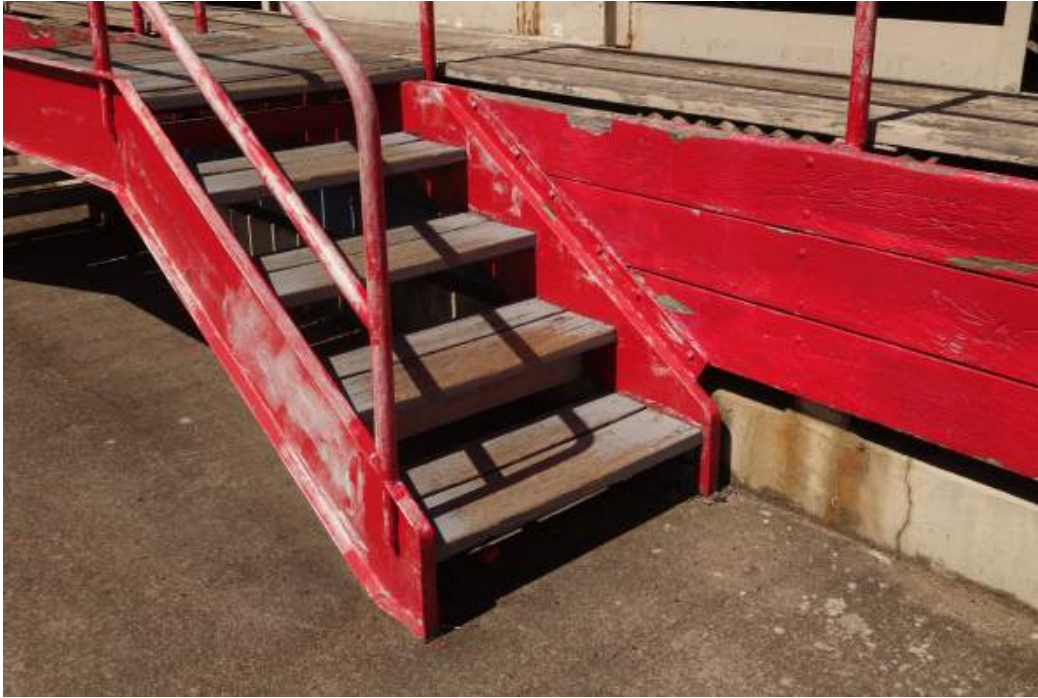
**FIGURE F3B:
MINOR CRACKING IN FRONT BEARING CONCRETE STEMWALL
TYPICAL OF ENTIRE STEMWALL**

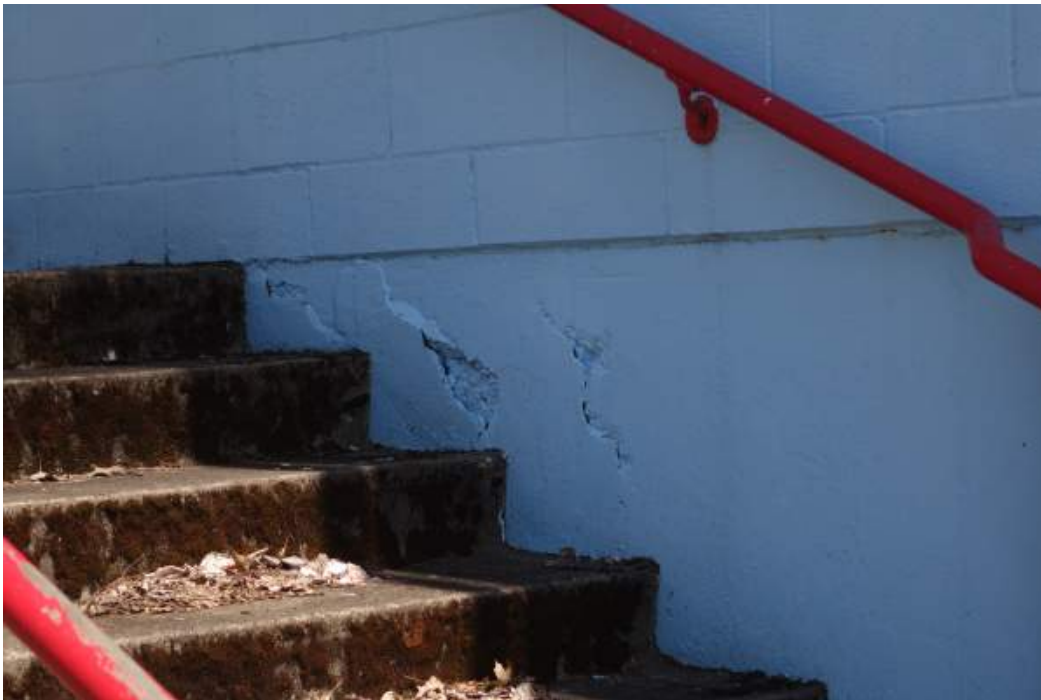
**FIGURE F3C:
MINOR CRACKING AND SPALLING IN CONCRETE WALL**

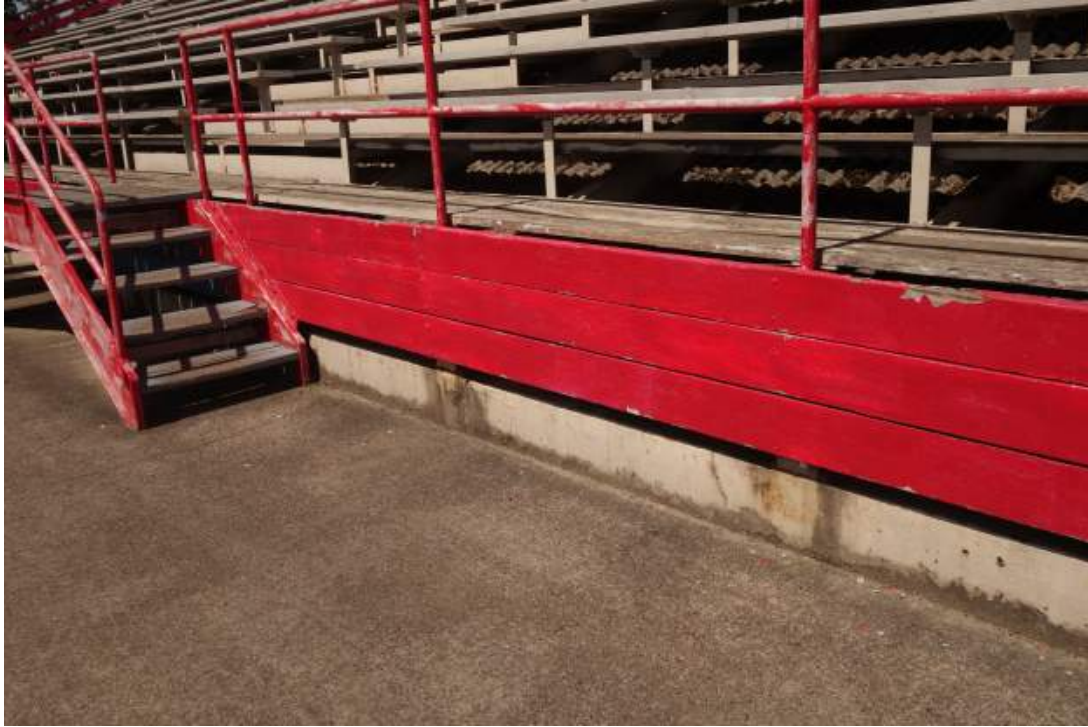
**FIGURE F4A:
CRACKING AND SPALLING IN FRONT BEARING CONCRETE STEMWALL**

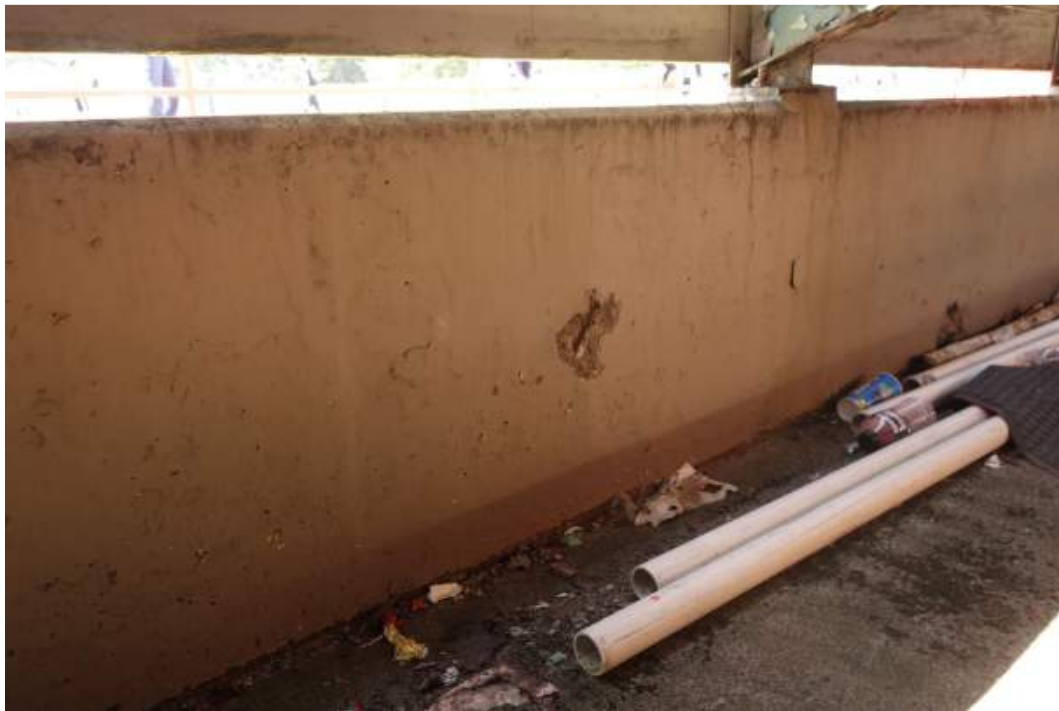
**FIGURE F4B:
SPALLING IN STEMWALL WITH REBAR EXPOSED**

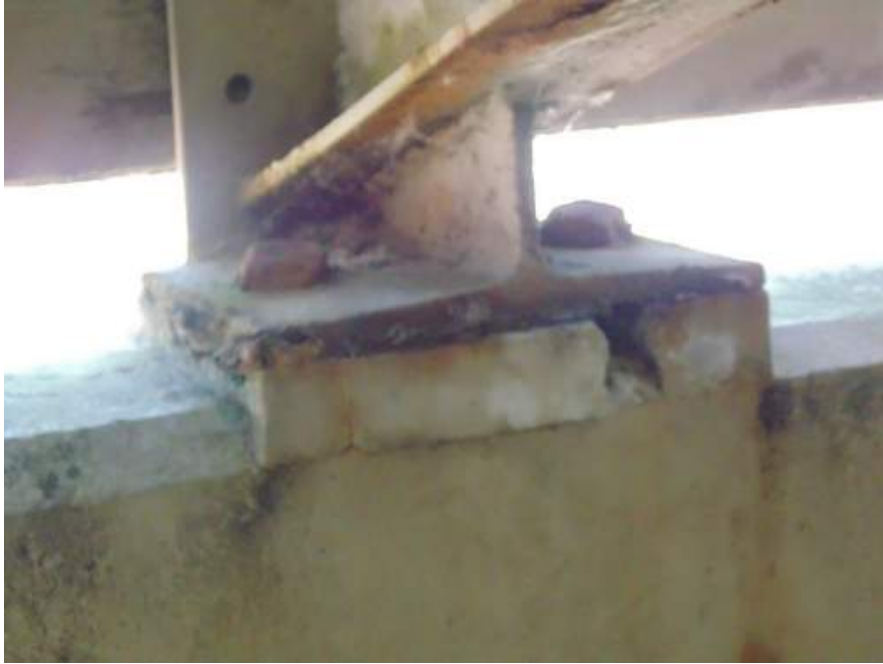
**FIGURE F5A:
PORTION ON NON-SHRINK GROUT BENEATH BASE PLATE IS DETERIORATING**

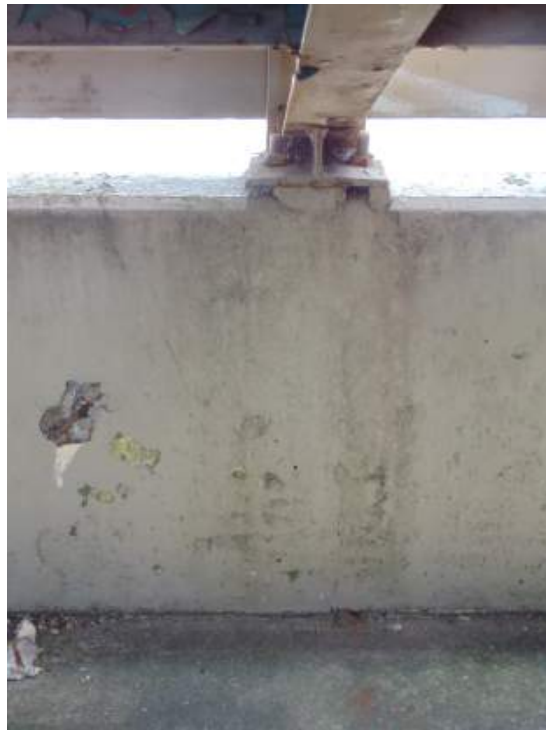
**FIGURE F5B:
PORTION ON NON-SHRINK GROUT BENEATH BASE PLATE IS DETERIORATING**

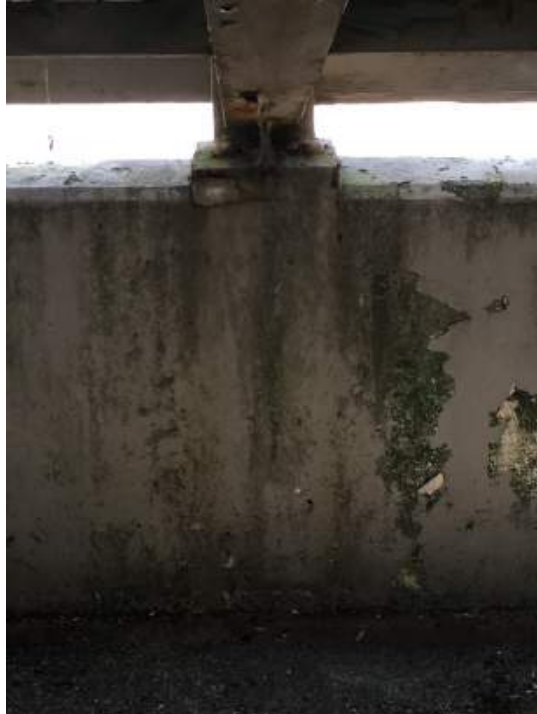
**FIGURE F5C:
PORTION OF NON-SHRINK GROUT BENEATH BASE PLATE IS DETERIORATING**

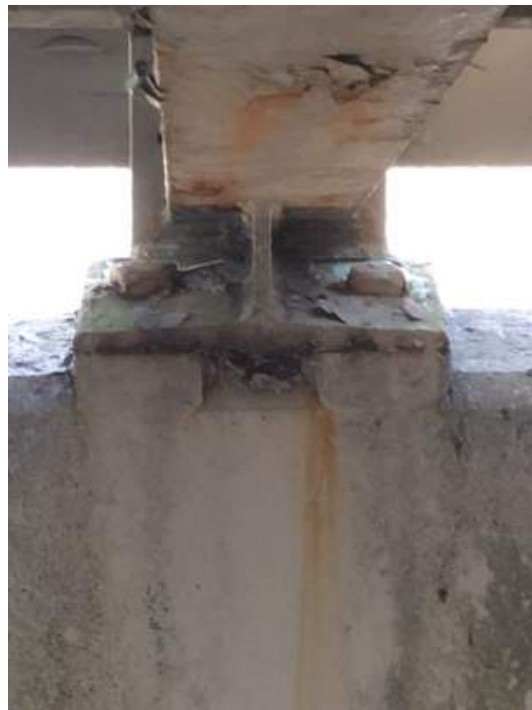
**FIGURE F5D:
PORTION OF NON-SHRINK GROUT BENEATH BASE PLATE IS DETERIORATING**

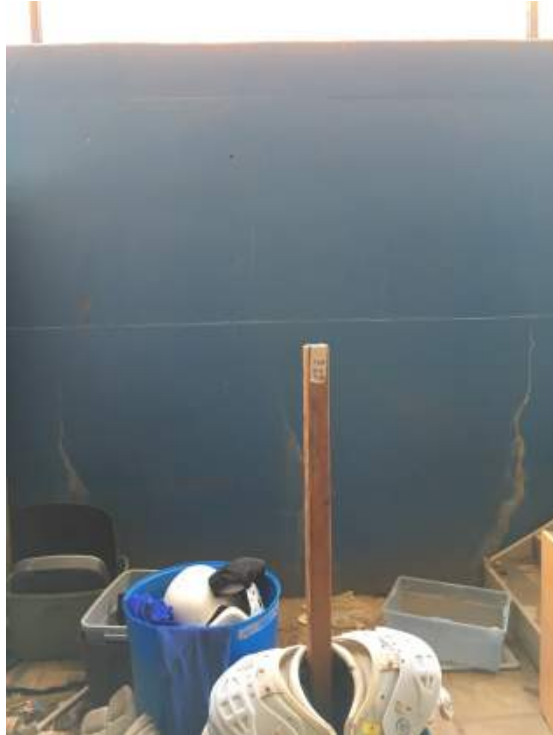
**FIGURE F6A:
VERTICAL CRACKS IN BACK RETAINING WALL (TYPICAL OF WALL)**

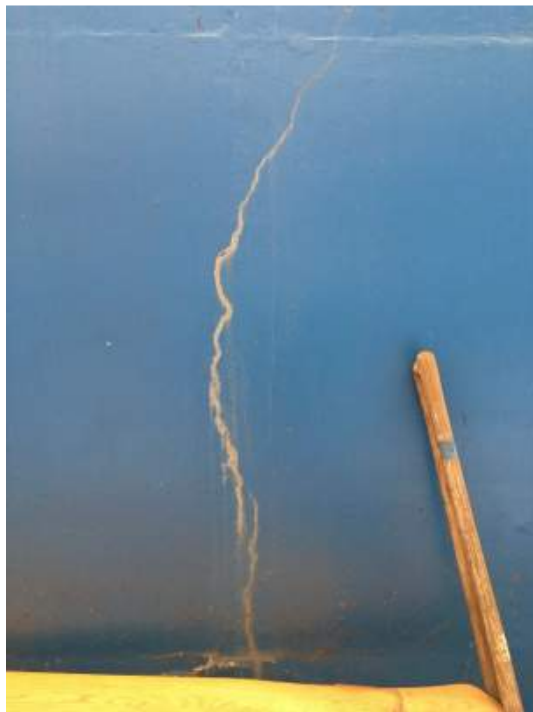
**FIGURE F6B:
VERTICAL CRACKS IN BACK RETAINING WALL (TYPICAL OF WALL)**

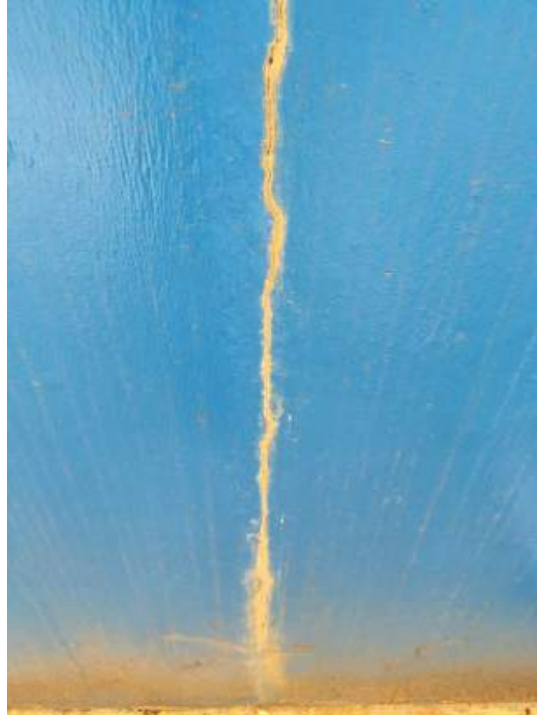
**FIGURE F6C:
VERTICAL CRACKS IN BACK RETAINING WALL (TYPICAL OF WALL)**

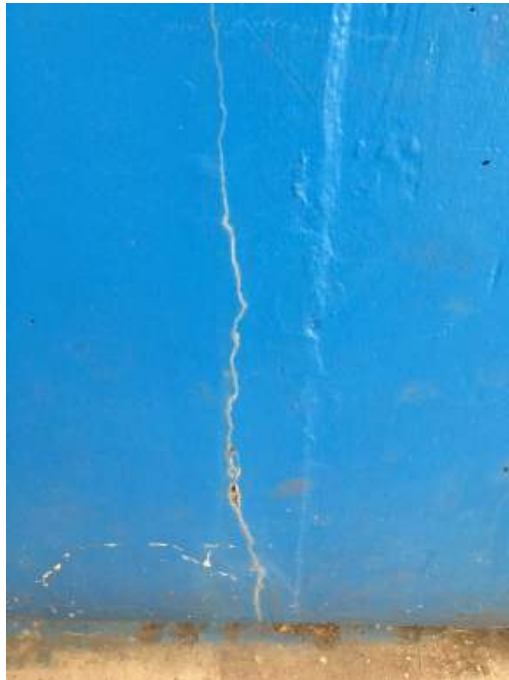
**FIGURE F7A:
SPALLING ALONG WITH CRACK**

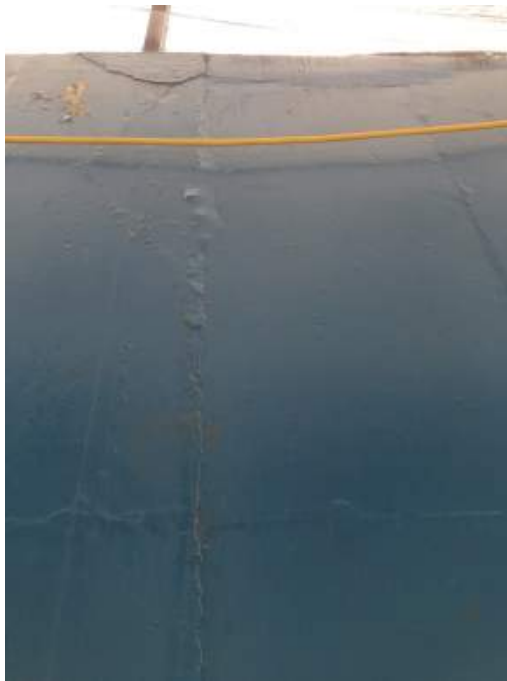
**FIGURE F7B:
SPALLING AND CRACKING AT TOP OF WALL PERHAPS DUE TO CORROSION
OF FENCE POST**

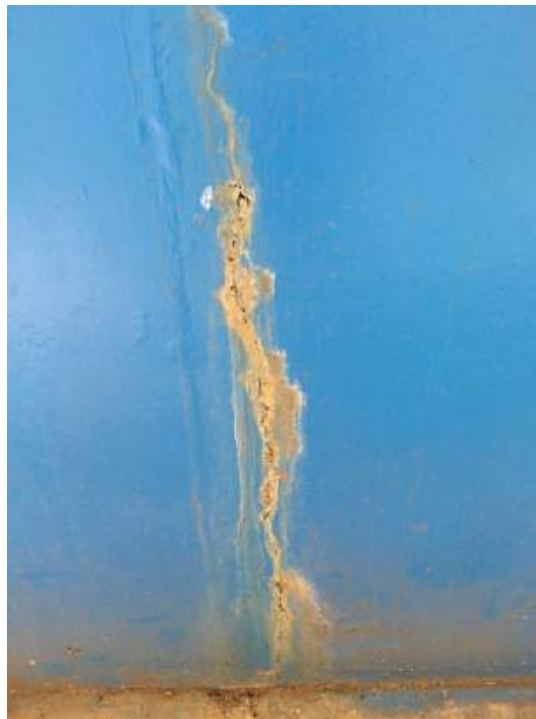
**FIGURE F7C:
SPALLING AND CRACKING**

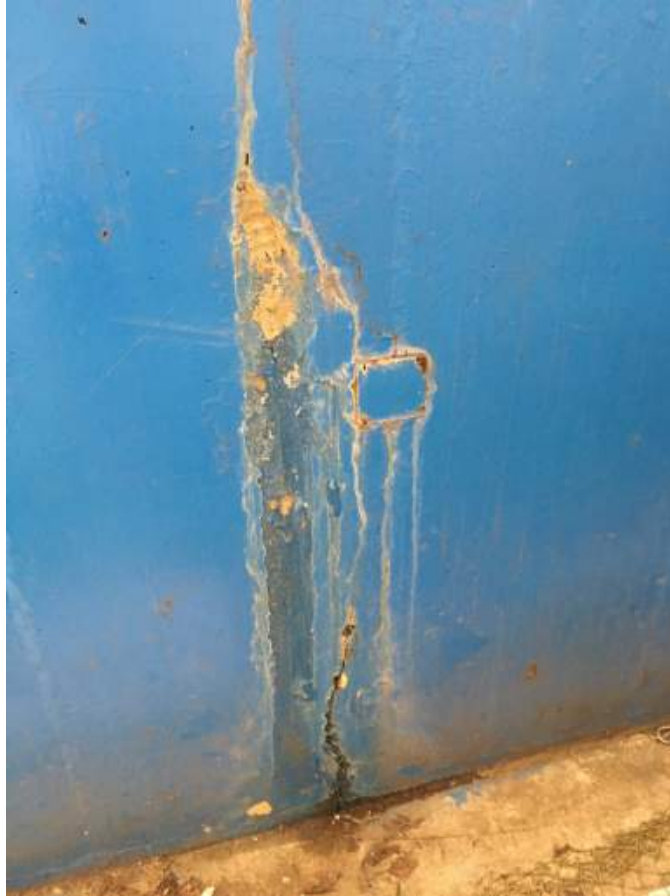
**FIGURE F7D:
SPALLING AND CRACKING**

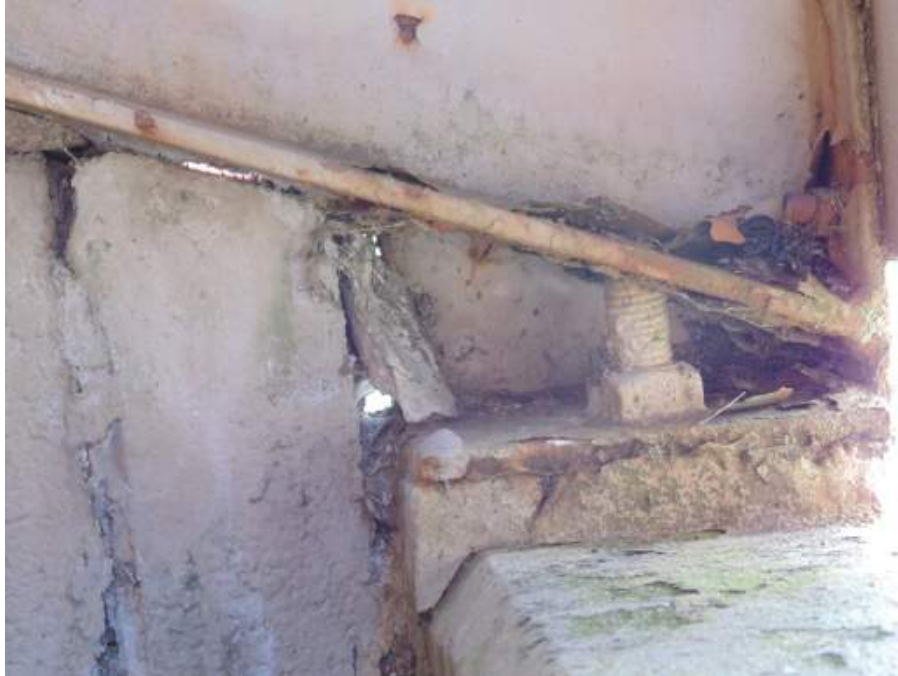
**FIGURE S1A:
GENERAL RUSTING OF THE STEEL STRUCTURE ABOVE
AND BEYOND SURFACE RUSTING**

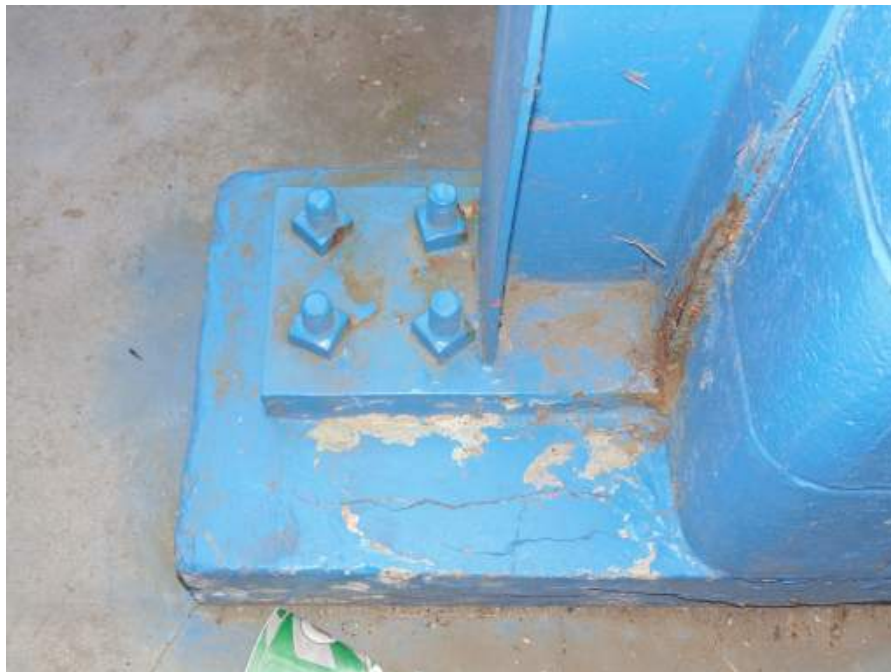
**FIGURE S1B:
GENERAL RUSTING OF STEEL STRUCTURE ABOVE
AND BEYOND SURFACE RUSTING**

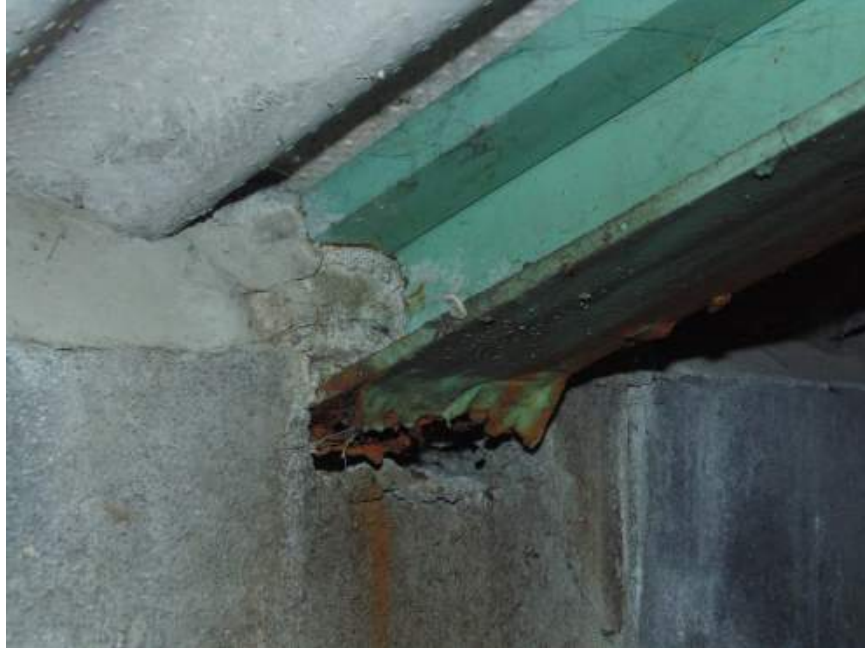
**FIGURE S1C:
GENERAL RUSTING OF STEEL STRUCTURE ABOVE
AND BEYOND SURFACE RUSTING**

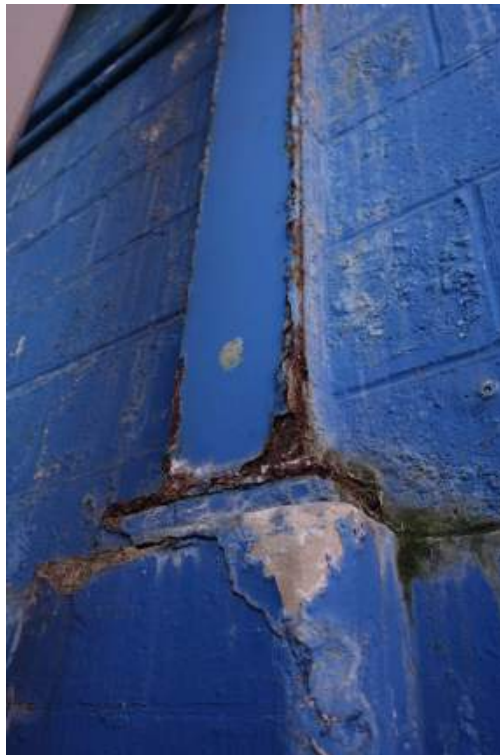
**FIGURE S2A:
SIGNIFICANT STEEL CORROSION AT STEEL COLUMN WITHIN CMU WALL**

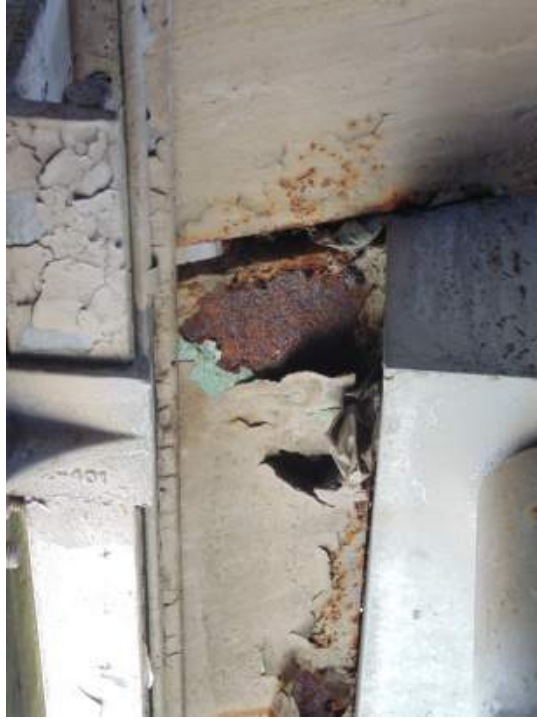
**FIGURE S3A:
SIGNIFICANT STEEL CORROSION AT CENTER GRANDSTAND BEAM**

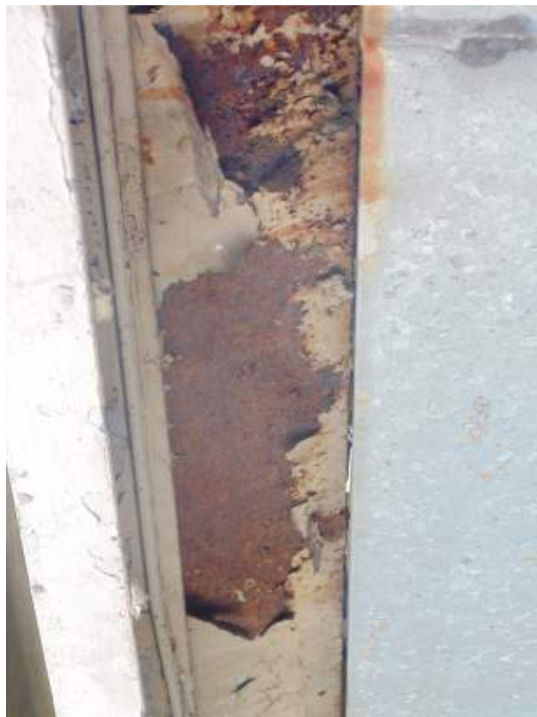
**FIGURE S3B:
SIGNIFICANT STEEL CORROSION AT CENTER GRANDSTAND BEAM**

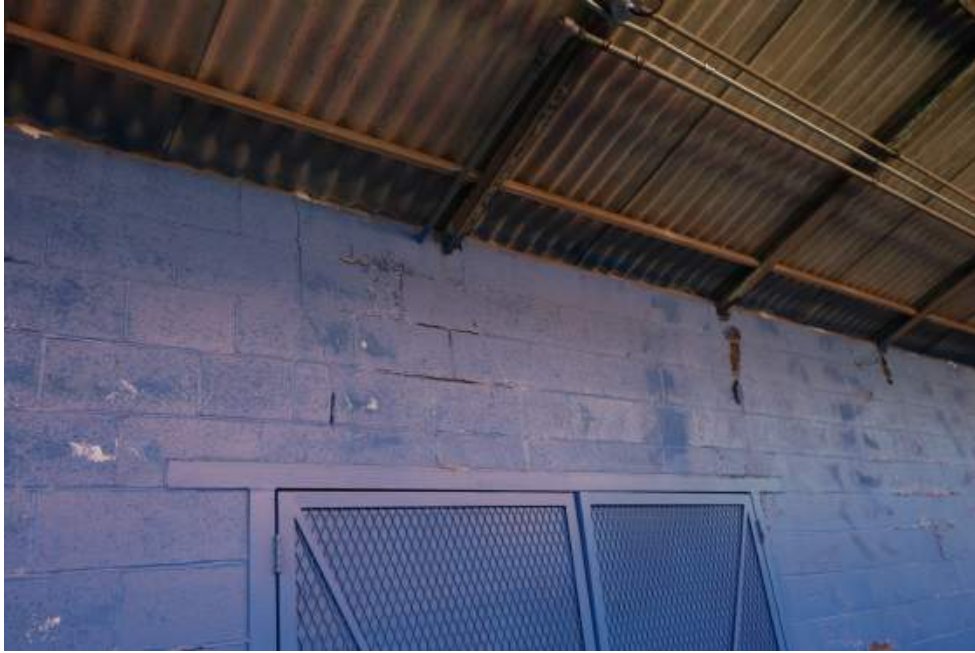
**FIGURE S4A:
SIGNIFICANT STEEL CORROSION AROUND AND IN MECHANICAL ROOM**

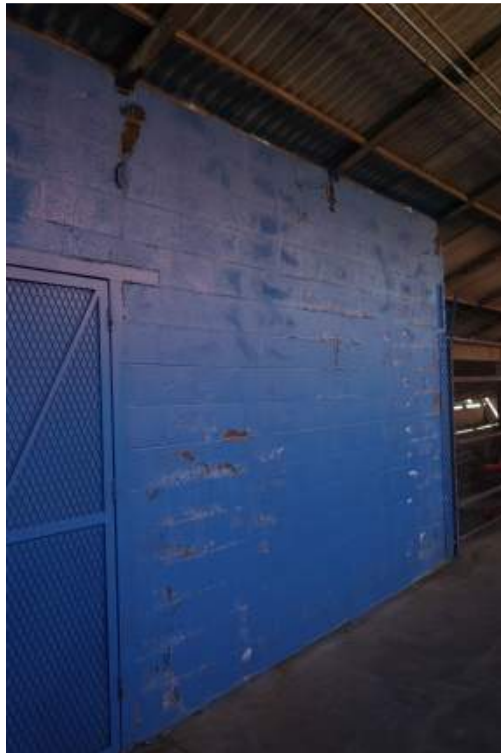
**FIGURE S4B:
SIGNIFICANT STEEL CORROSION AROUND AND IN MECHANICAL ROOM**

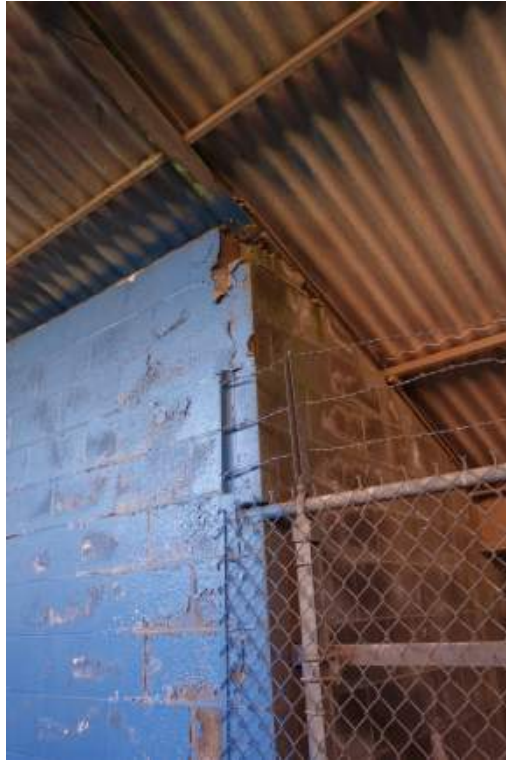
**FIGURE S4C:
SIGNIFICANT STEEL CORROSION AROUND AND IN MECHANICAL ROOM**

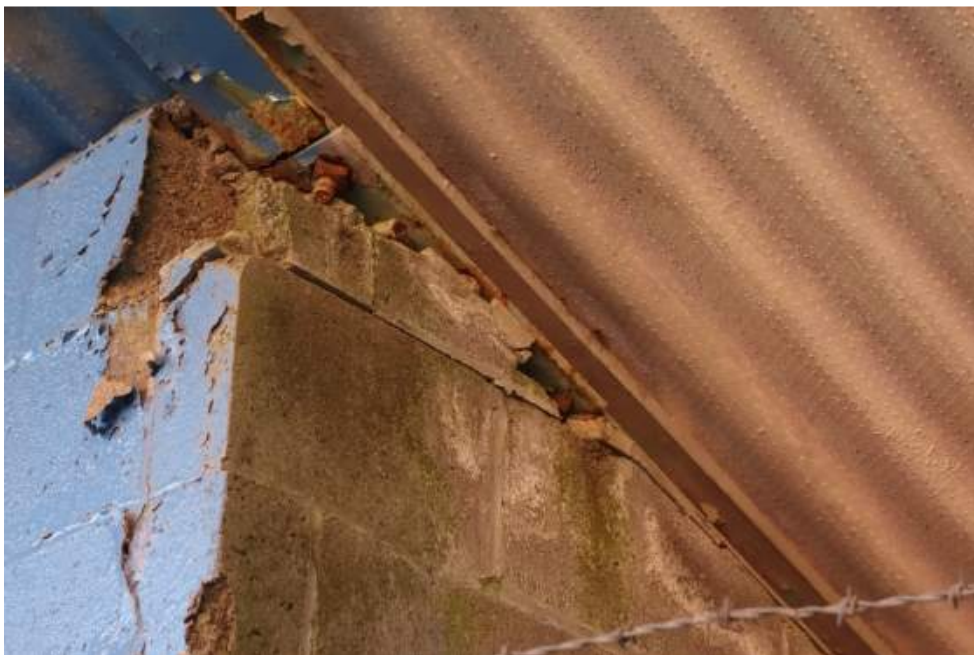
**FIGURE S4D:
SIGNIFICANT STEEL CORROSION AROUND AND IN MECHANICAL ROOM**

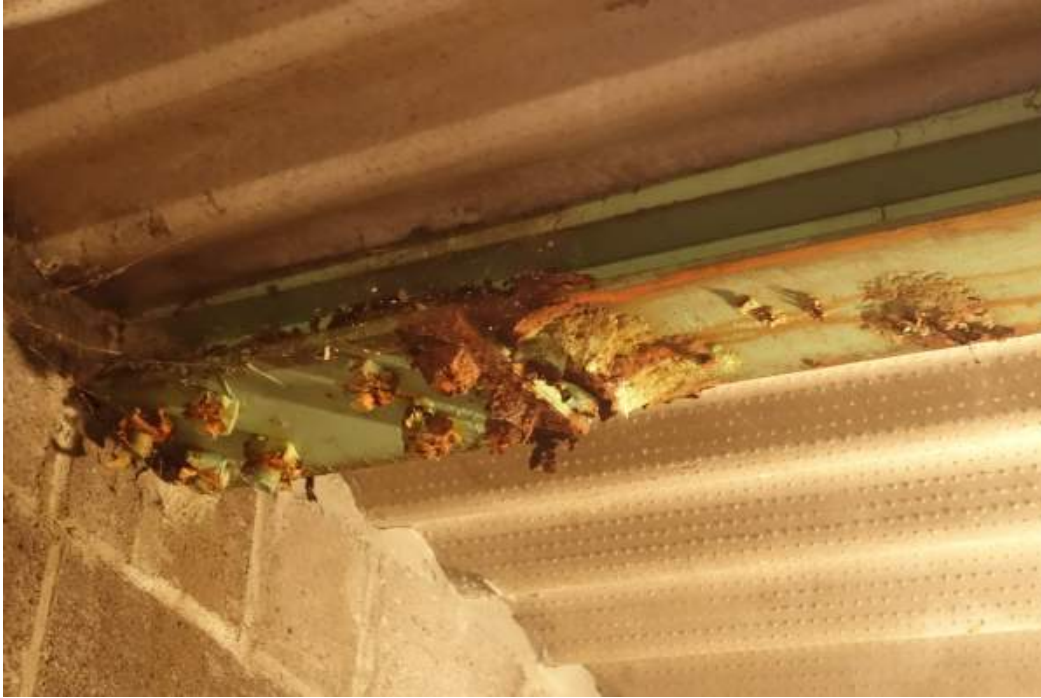
**FIGURE S4E:
SIGNIFICANT STEEL CORROSION AROUND AND IN MECHANICAL ROOM**

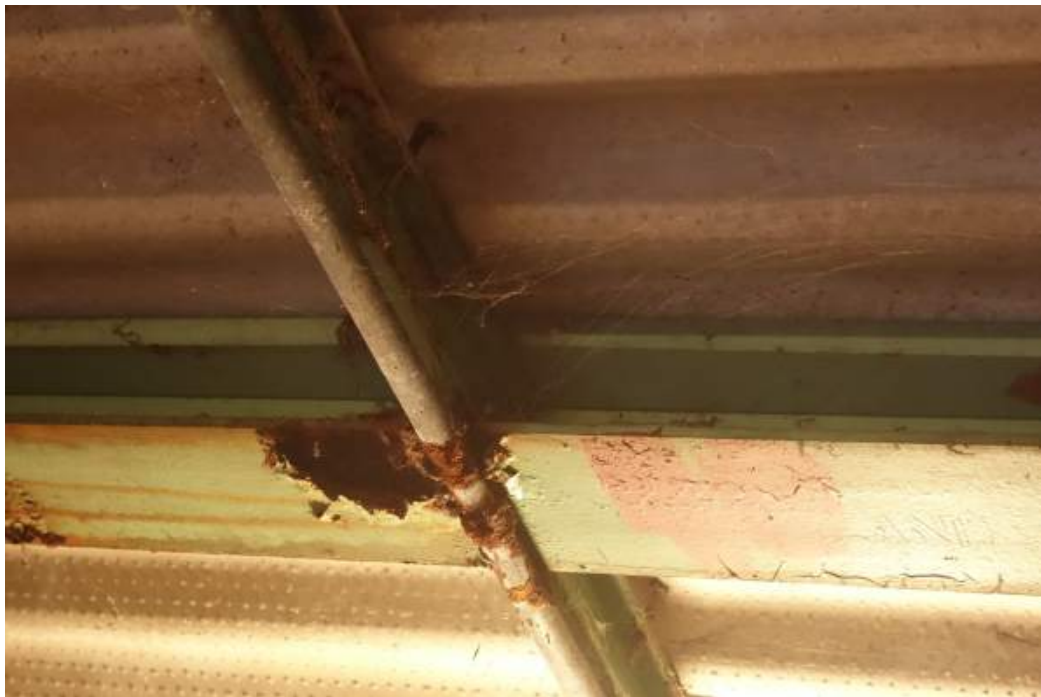
**FIGURE S4F:
SIGNIFICANT STEEL CORROSION AROUND AND IN MECHANICAL ROOM**

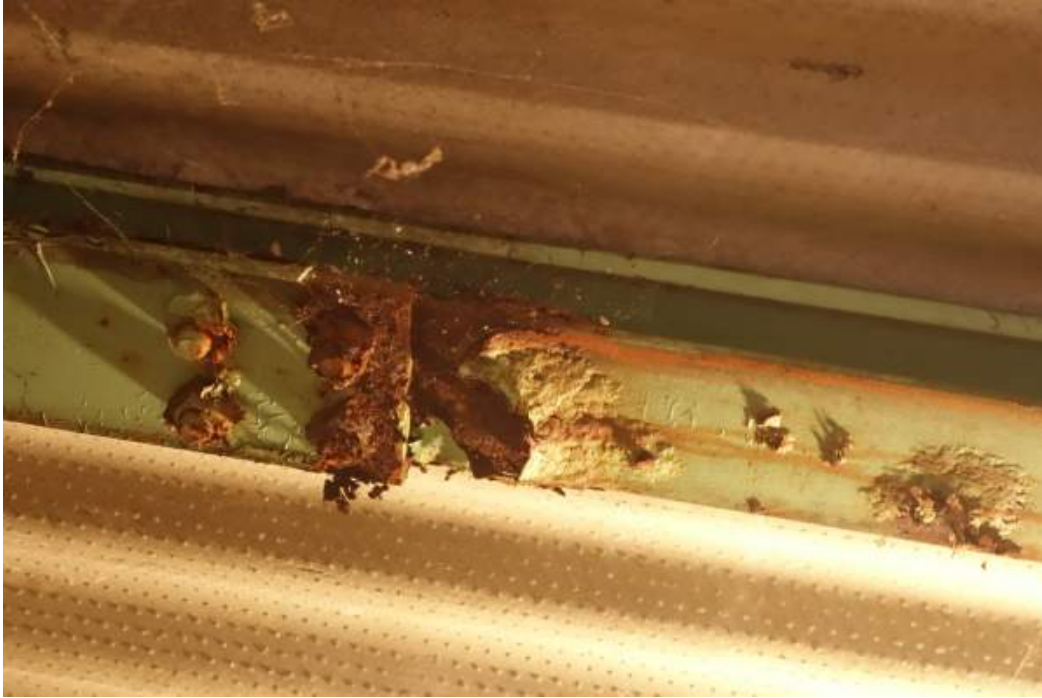
**FIGURE S4G:
SIGNIFICANT STEEL CORROSION AROUND AND IN MECHANICAL ROOM**

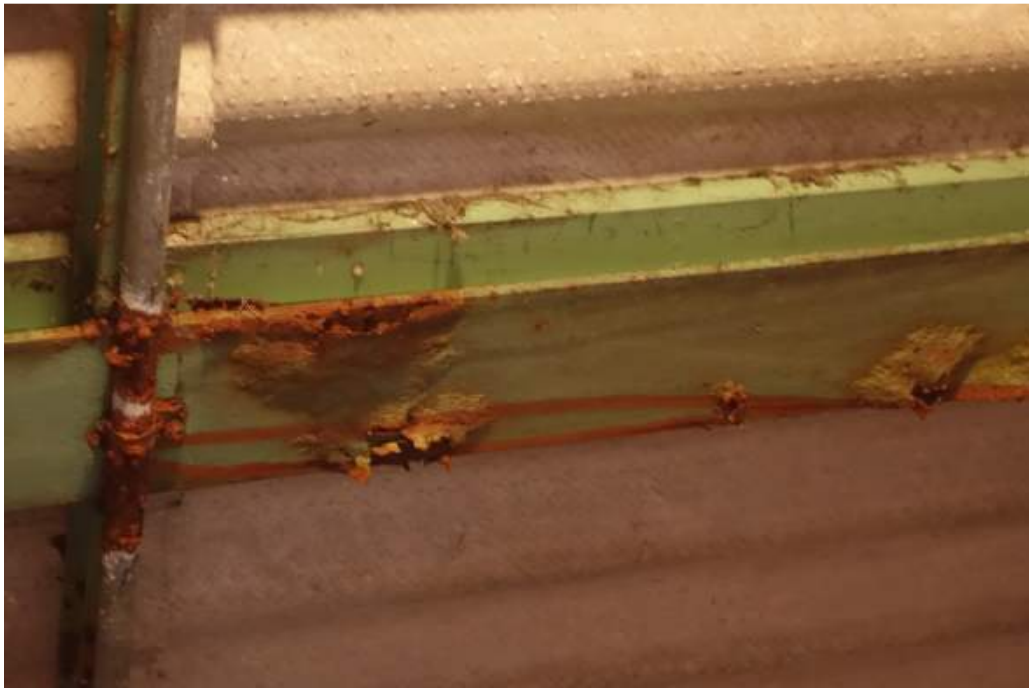
**FIGURE S4H:
SIGNIFICANT STEEL CORROSION AROUND AND IN MECHANICAL ROOM**

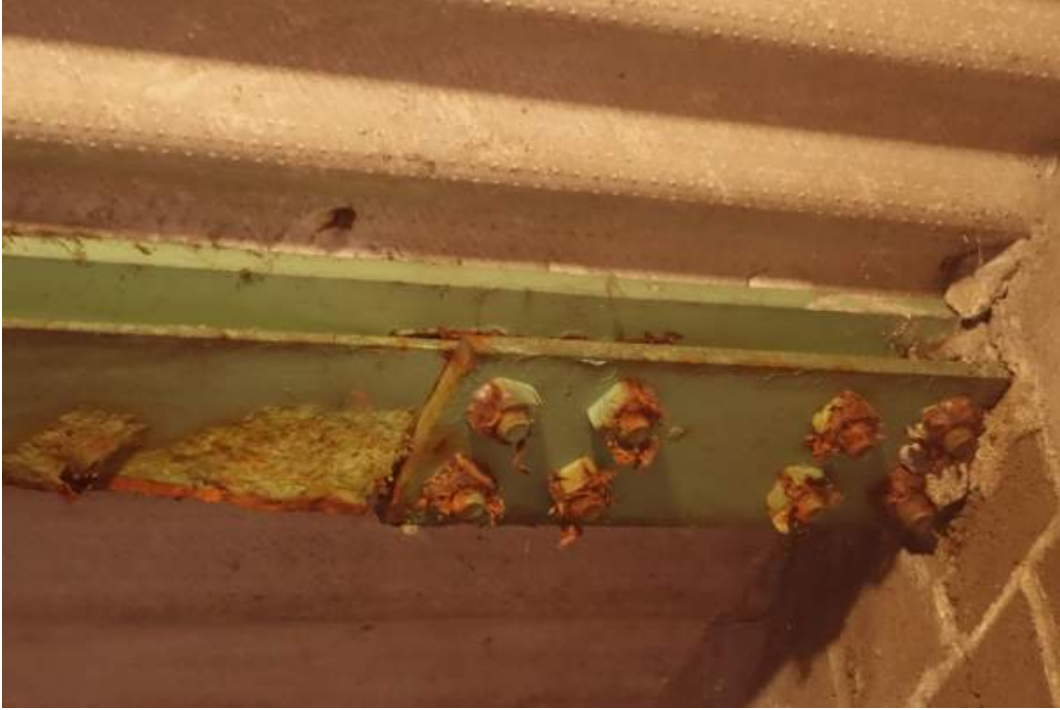
**FIGURE S4I:
SIGNIFICANT STEEL CORROSION AROUND AND IN MECHANICAL ROOM**

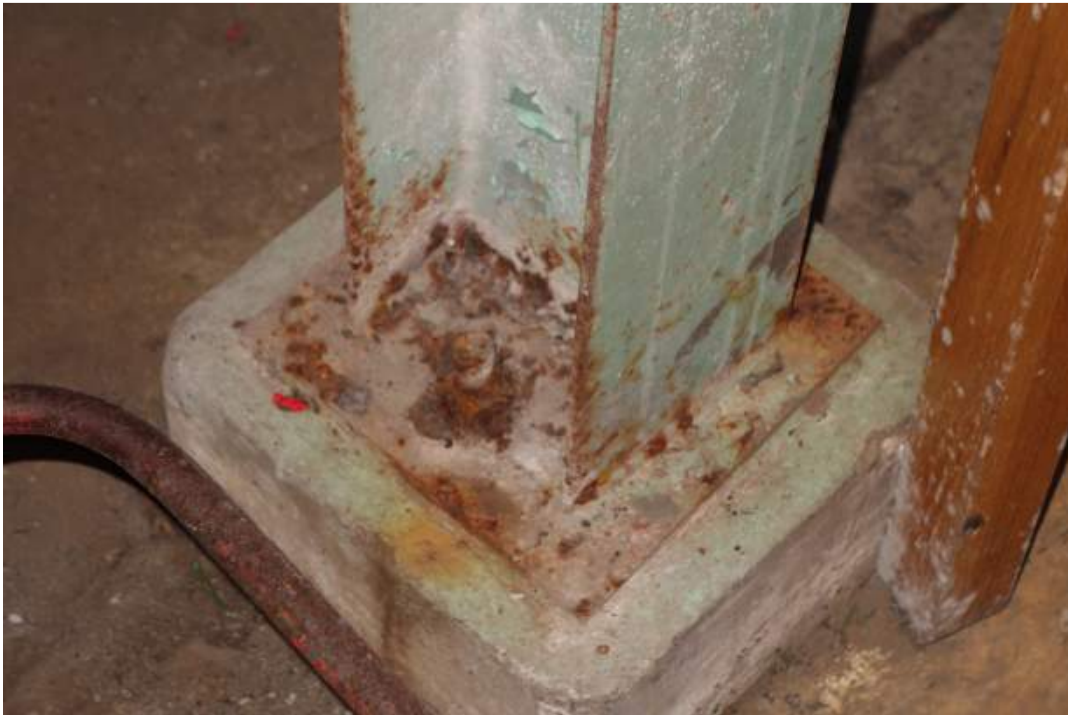
**FIGURE S4J:
SIGNIFICANT STEEL CORROSION AROUND AND IN MECHANICAL ROOM**

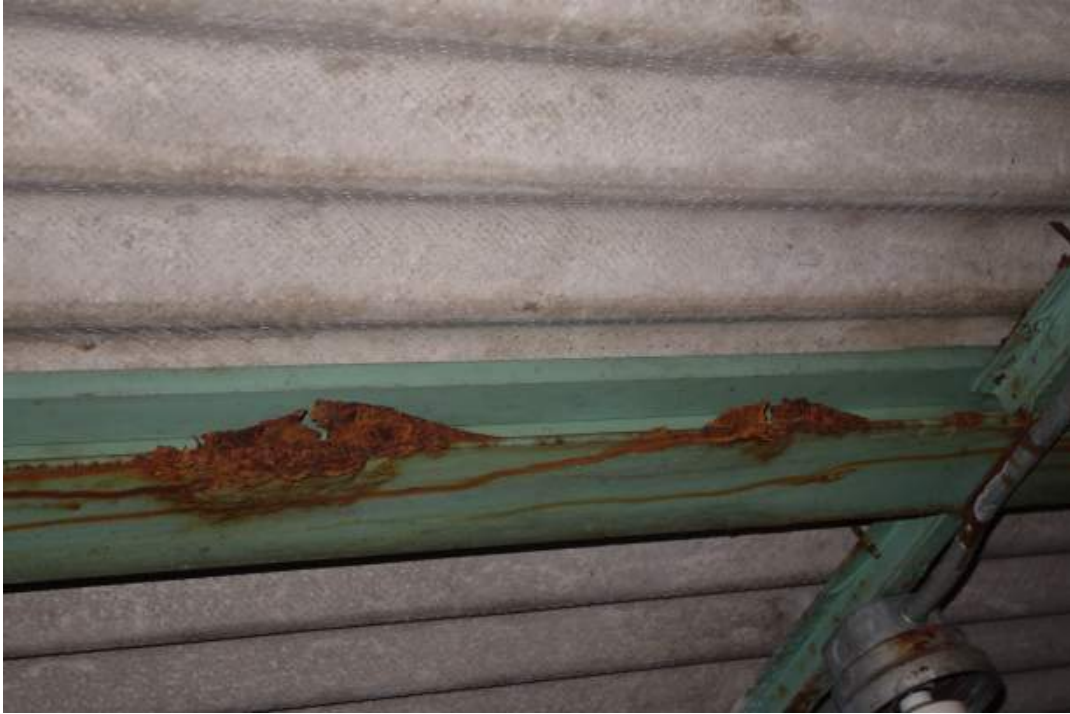
**FIGURE S4K:
SIGNIFICANT STEEL CORROSION AROUND AND IN MECHANICAL ROOM**

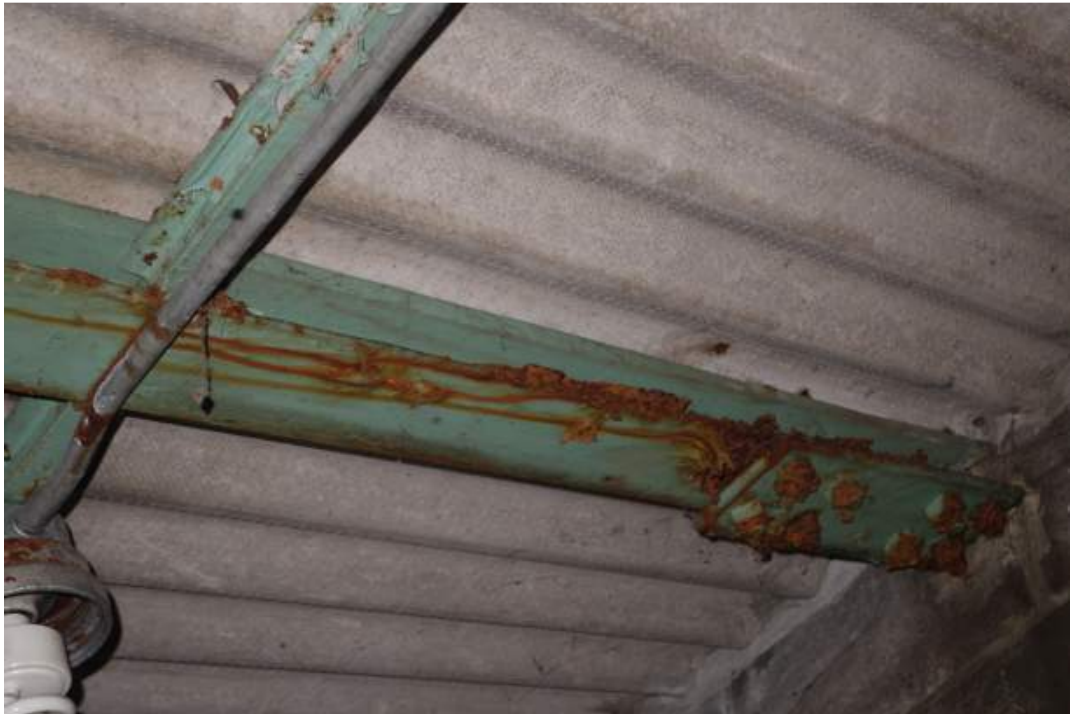
**FIGURE S4L:
SIGNIFICANT STEEL CORROSION AROUND AND IN MECHANICAL ROOM**
