PPS - Madison High School - Grandstand Assessment

West View of Grandstand

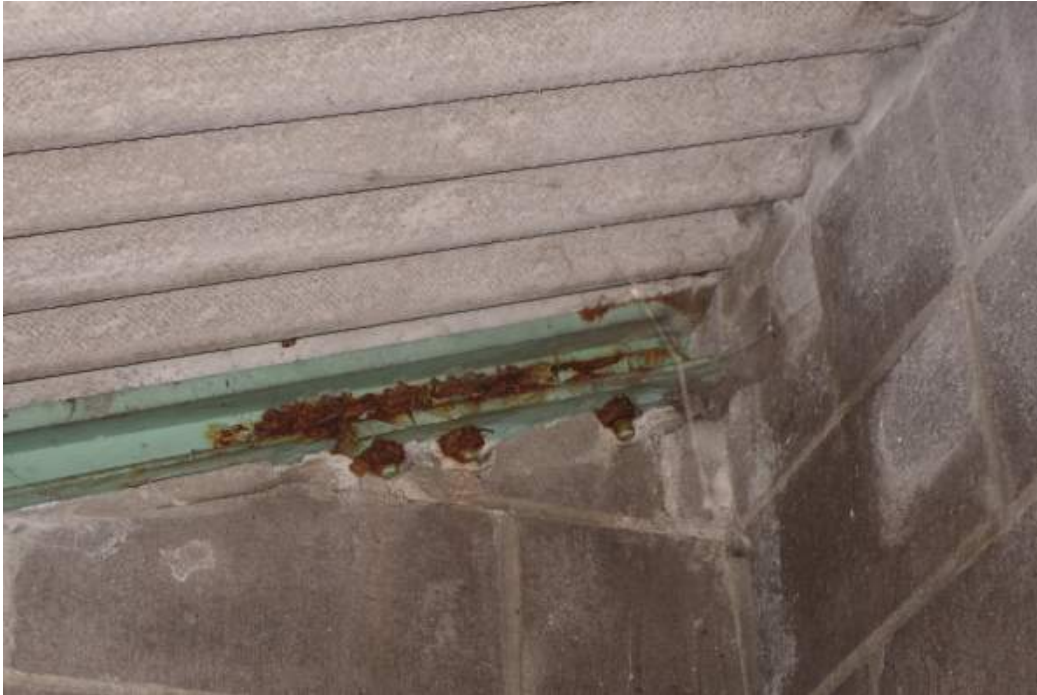
**FIGURE S4M:
SIGNIFICANT STEEL CORROSION AROUND AND IN MECHANICAL ROOM**

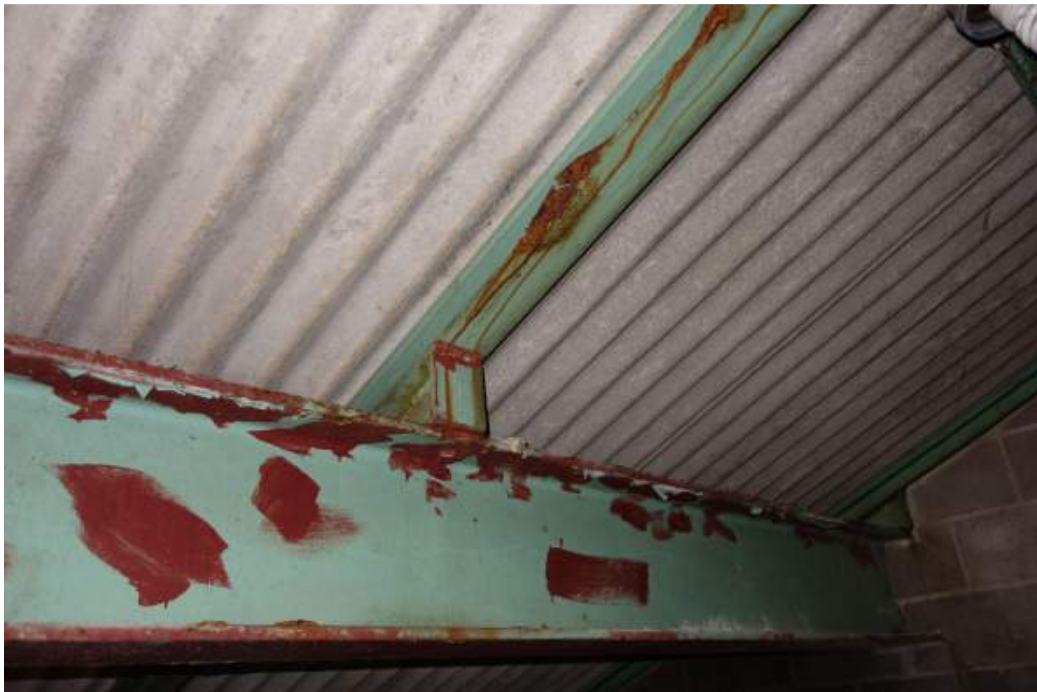
**FIGURE S4N:
SIGNIFICANT STEEL CORROSION AROUND AND IN MECHANICAL ROOM**

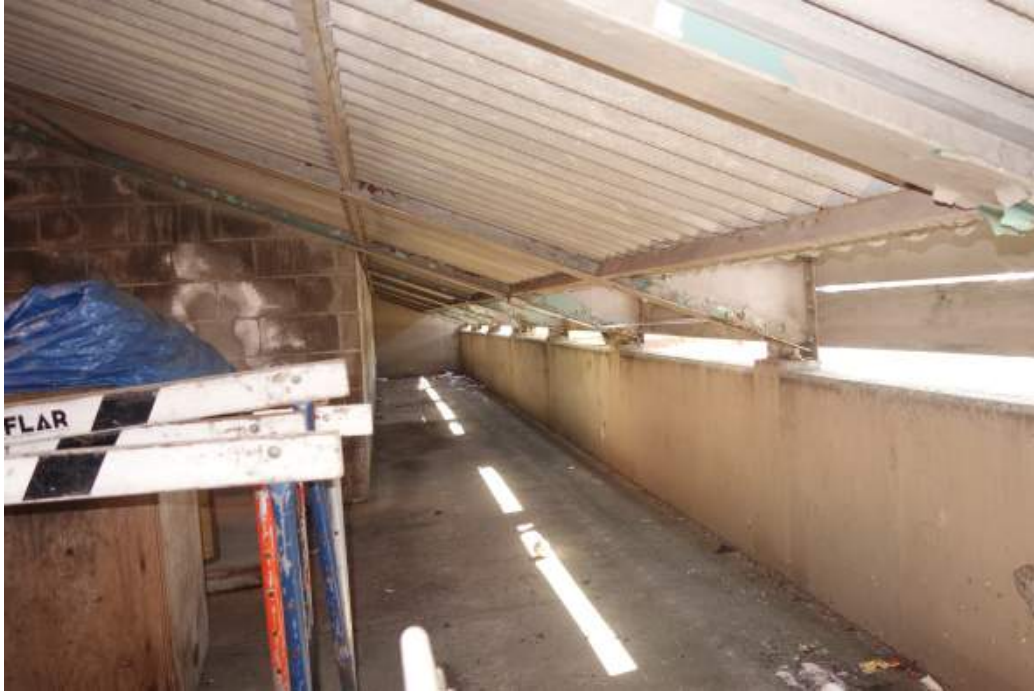
**FIGURE S4O:
SIGNIFICANT STEEL CORROSION AROUND AND IN MECHANICAL ROOM**

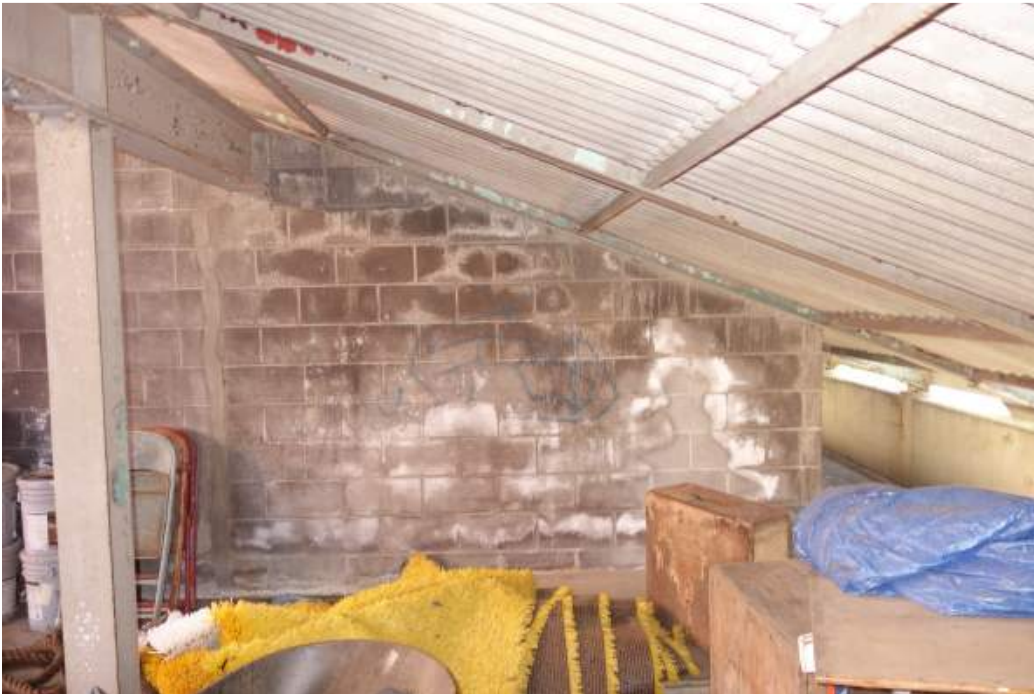
**FIGURE S4P:
SIGNIFICANT STEEL CORROSION AROUND AND IN MECHANICAL ROOM**

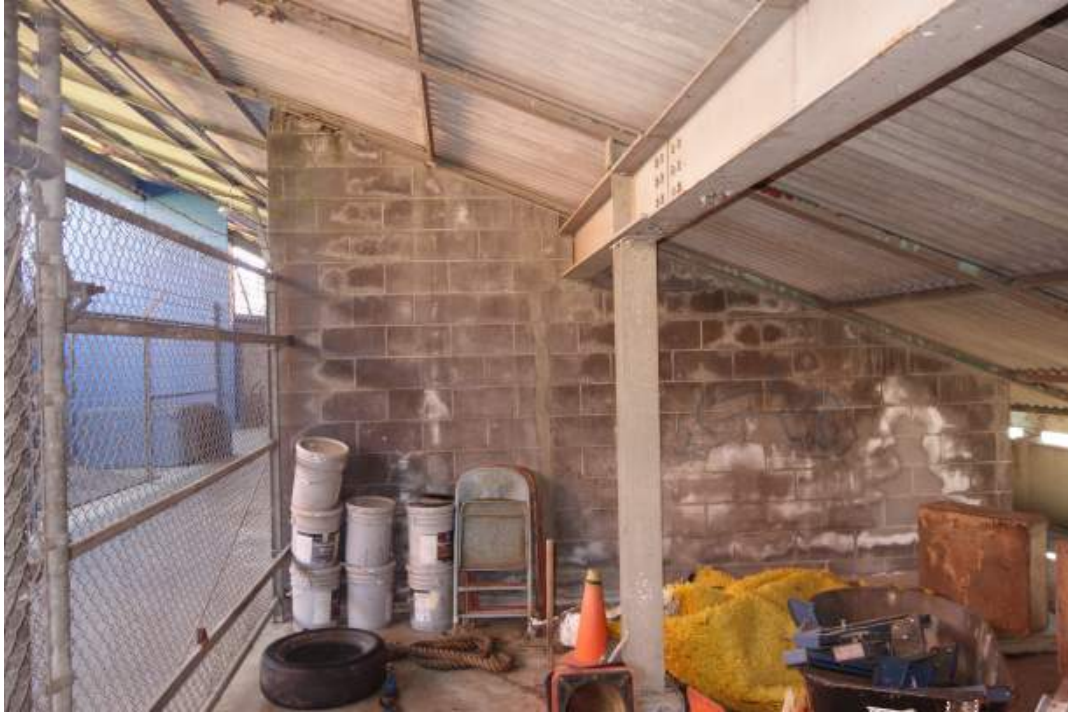
**FIGURE S4Q:
SIGNIFICANT STEEL CORROSION AROUND AND IN MECHANICAL ROOM**

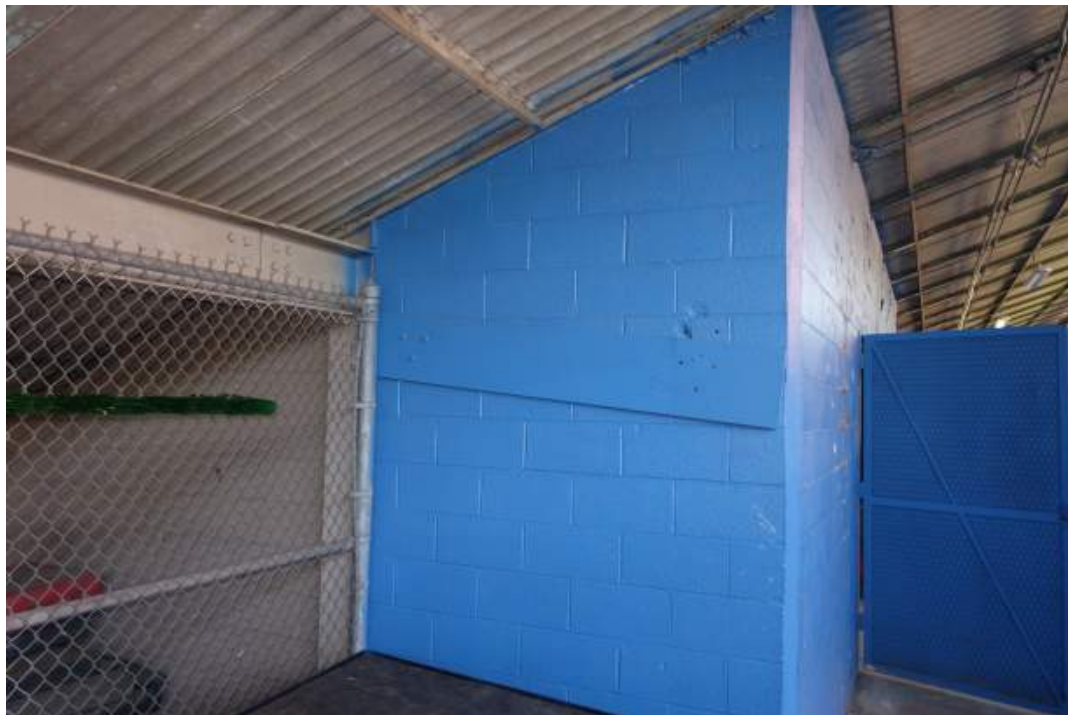
**FIGURE S4R:
SIGNIFICANT STEEL CORROSION AROUND AND IN MECHANICAL ROOM**

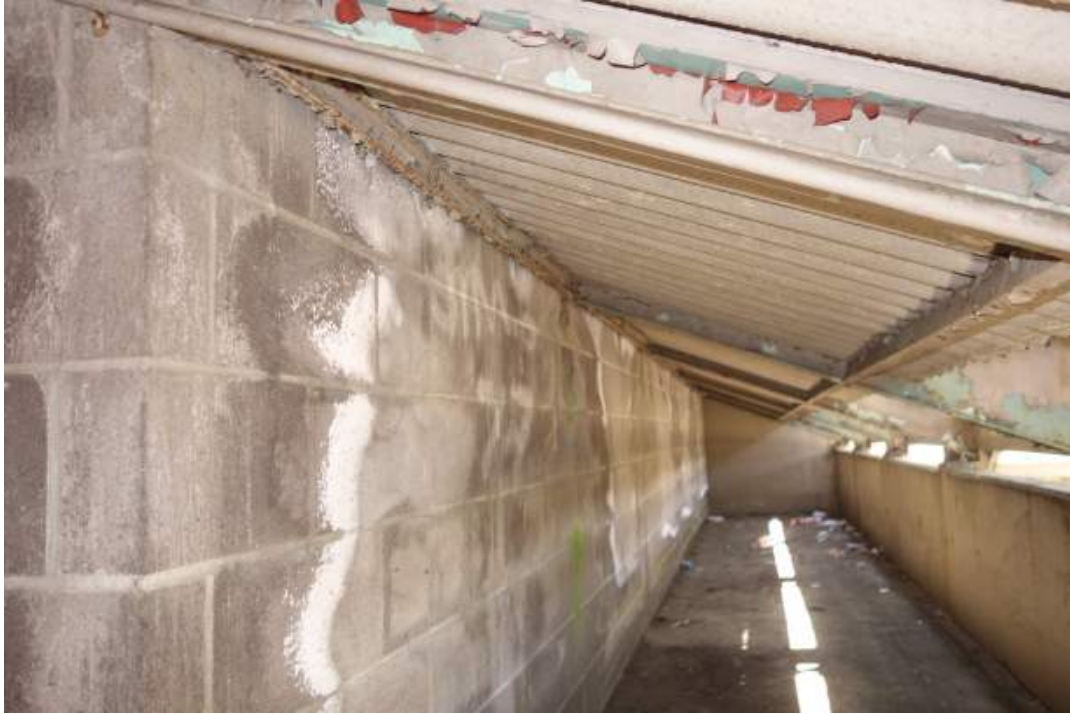
**FIGURE S4S:
SIGNIFICANT STEEL CORROSION AROUND AND IN MECHANICAL ROOM**

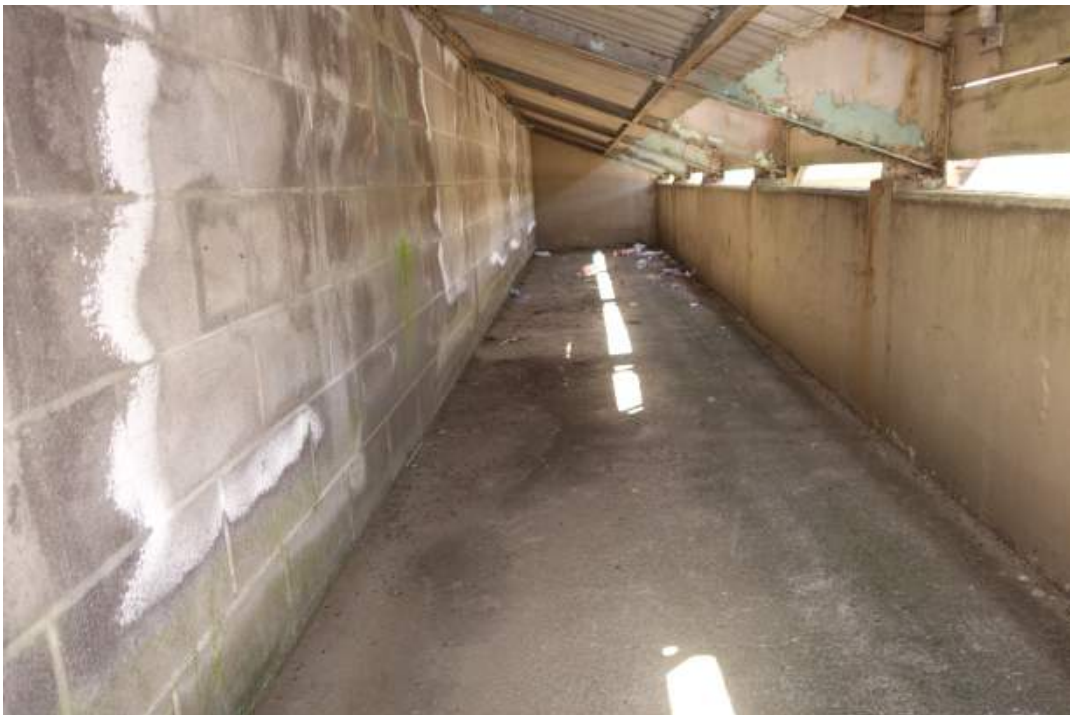
**FIGURE S4T:
SIGNIFICANT STEEL CORROSION AROUND AND IN MECHANICAL ROOM**

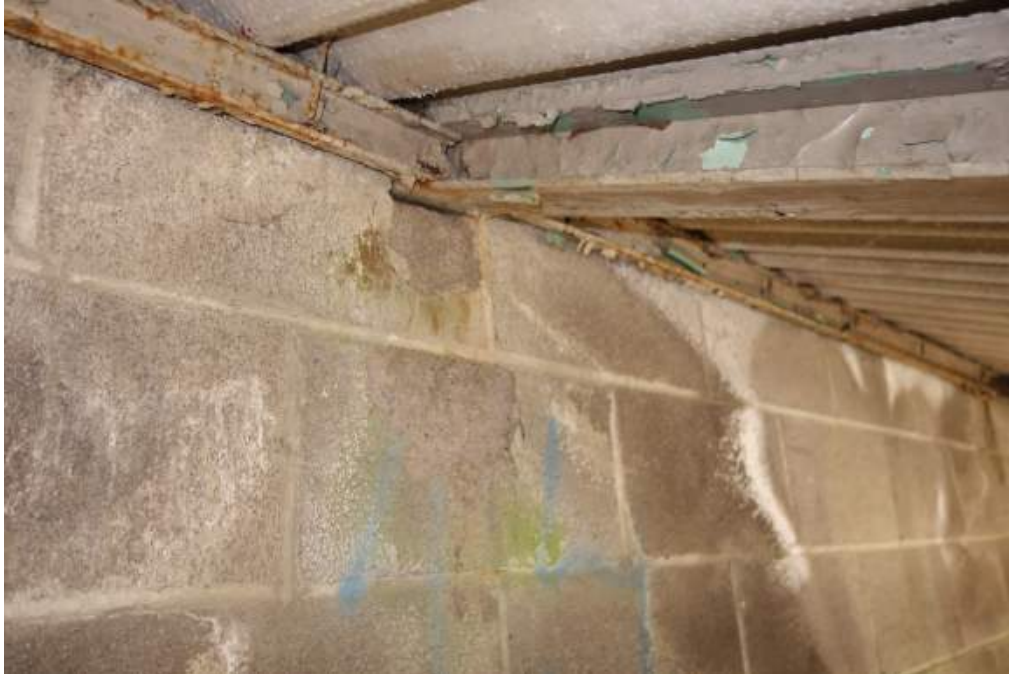
**FIGURE S4U:
SIGNIFICANT STEEL CORROSION AROUND AND IN MECHANICAL ROOM**

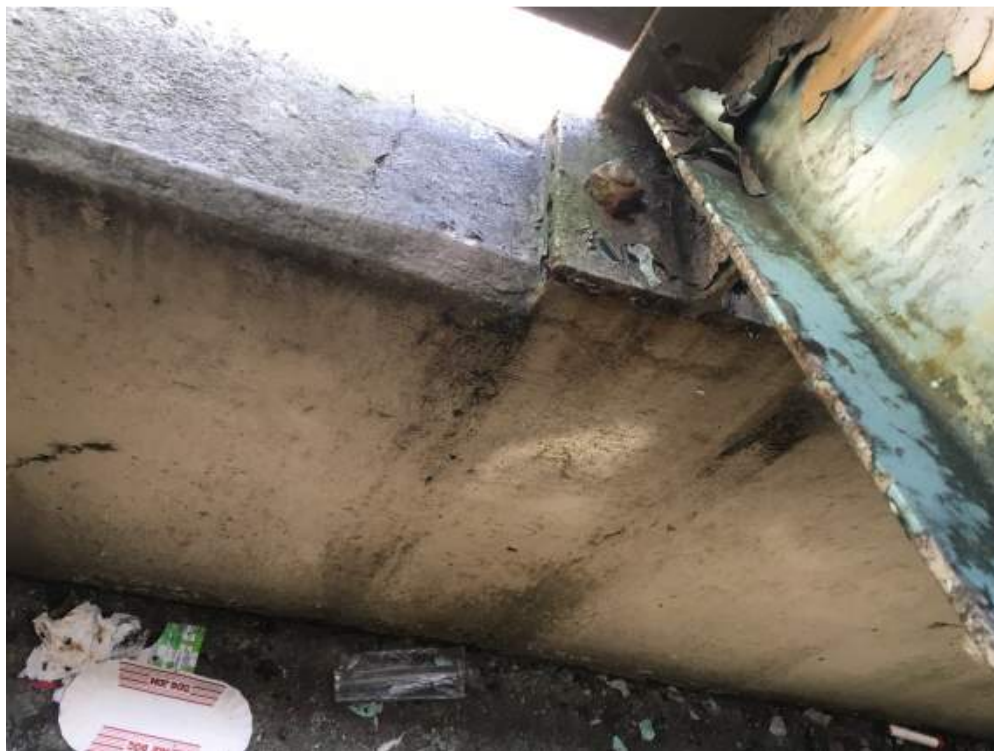
**FIGURE S4V:
SIGNIFICANT STEEL CORROSION AROUND AND IN MECHANICAL ROOM**

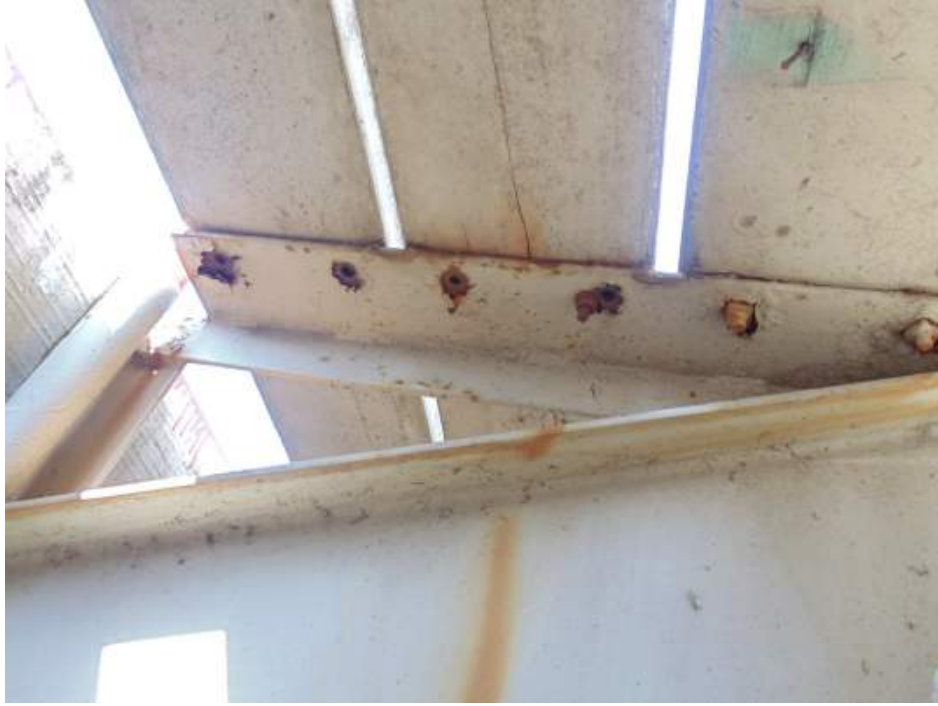
**FIGURE S5A:
BLEACHER BOARD STEEL SUPPORT RUSTING FROM TOP**

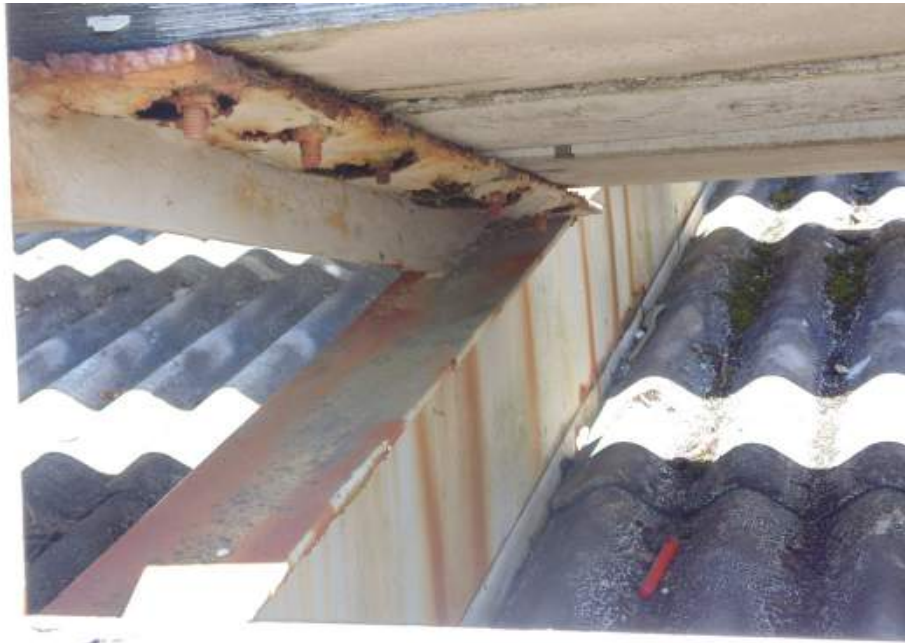
**FIGURE S5B:
BLEACHER BOARD STEEL SUPPORT RUSTING FROM TOP**

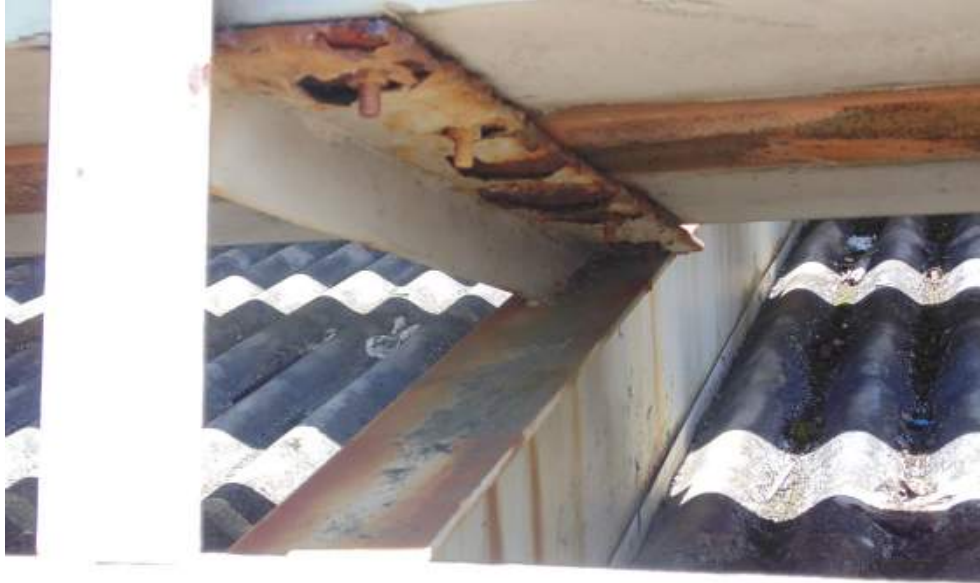
**FIGURE S5C:
BLEACHER BOARD STEEL SUPPORT RUSTING FROM TOP**

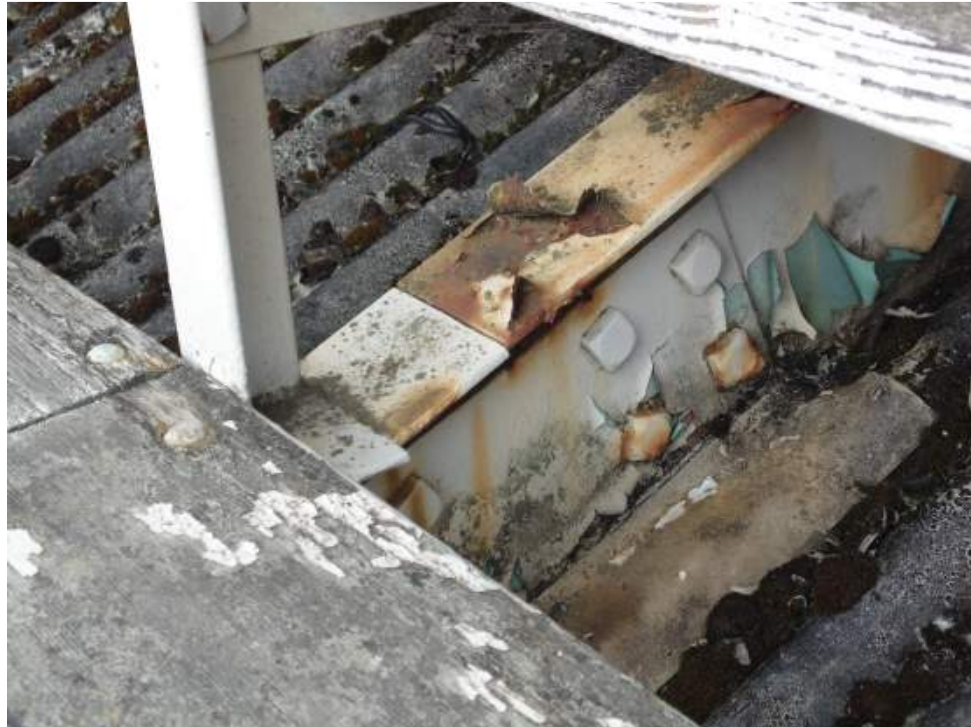
**FIGURE S5D:
BLEACHER BOARD STEEL SUPPORT RUSTING FROM TOP**

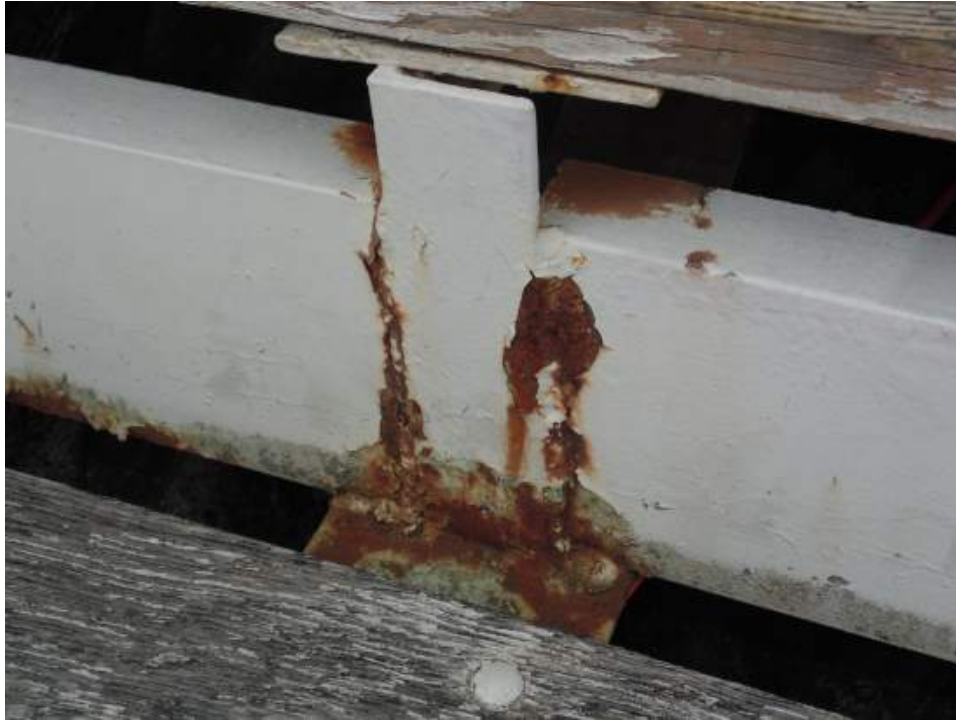
**FIGURE S5E:
BLEACHER BOARD STEEL SUPPORT RUSTING FROM TOP**

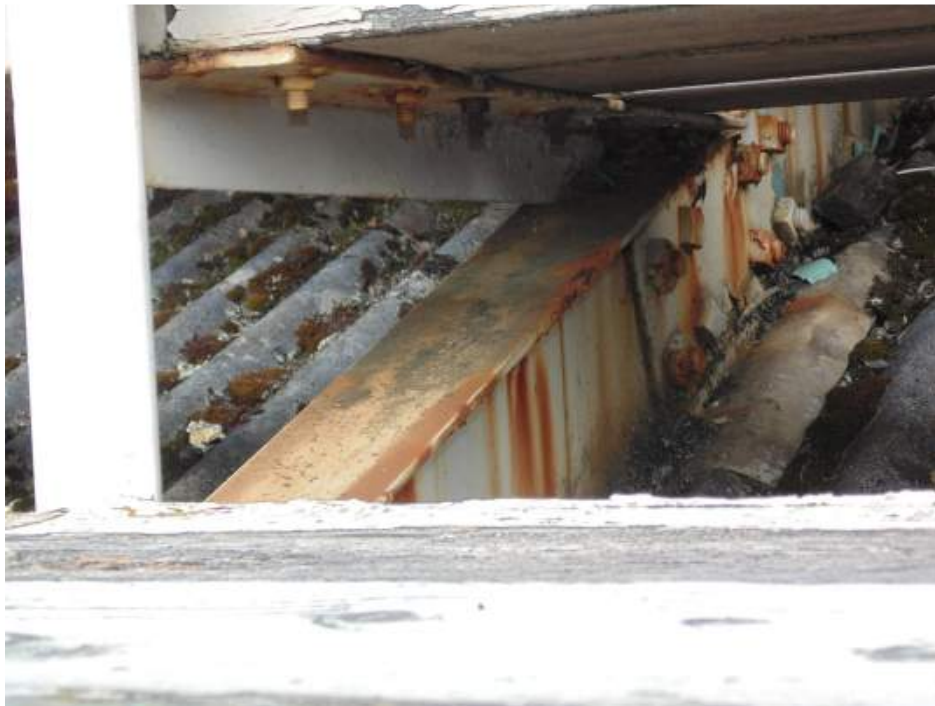
**FIGURE S5F:
BLEACHER BOARD STEEL SUPPORT RUSTING FROM TOP**

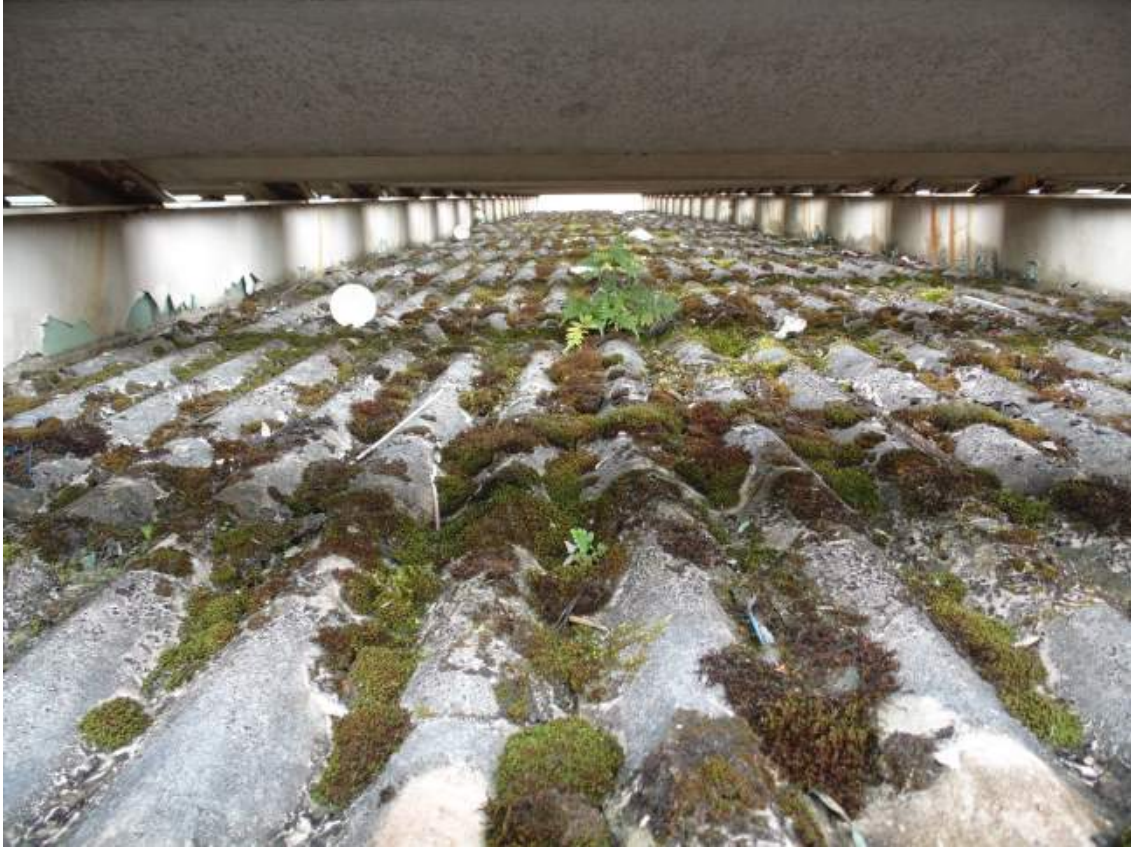
**FIGURE S6A:
HEAVY MOSS GROWTH ON CORRUGATED SOFFIT DECK**

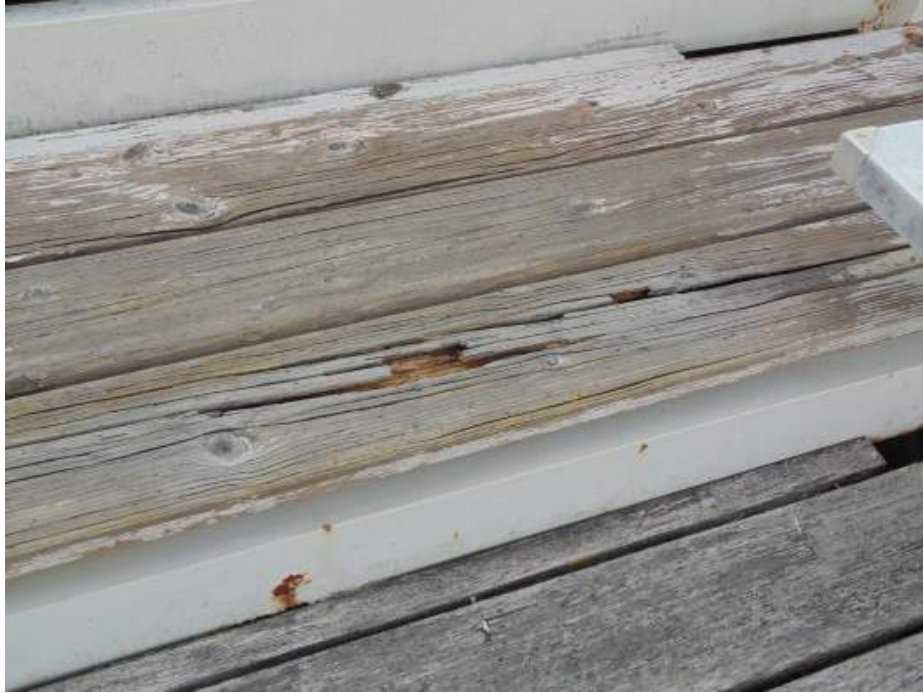
**FIGURE B1A:
SIGNIFICANTLY DAMAGED BLEACHER BOARDS**

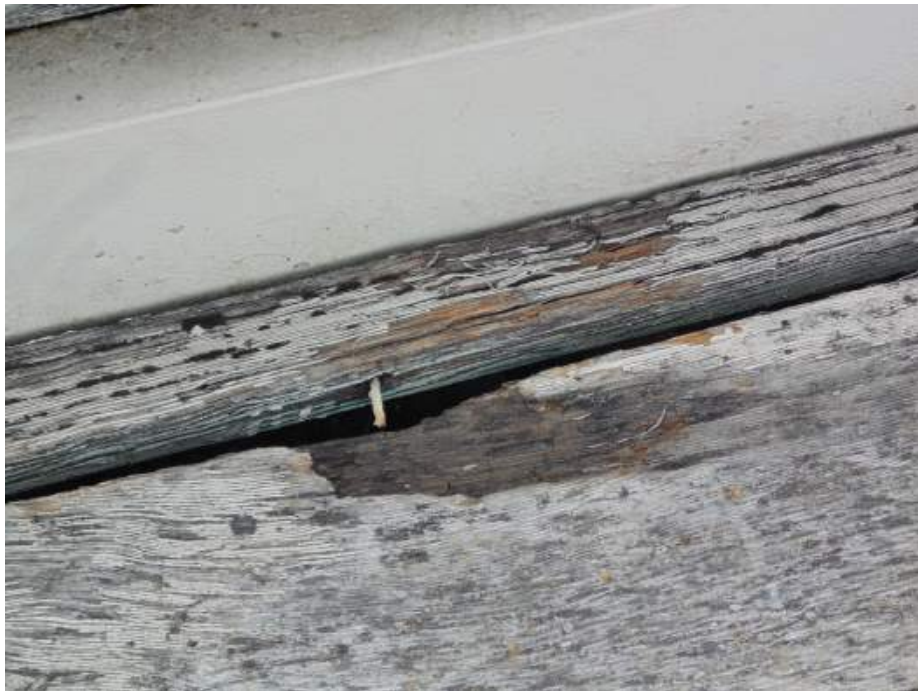
**FIGURE B1B:
SIGNIFICANTLY DAMAGED BLEACHER BOARDS**

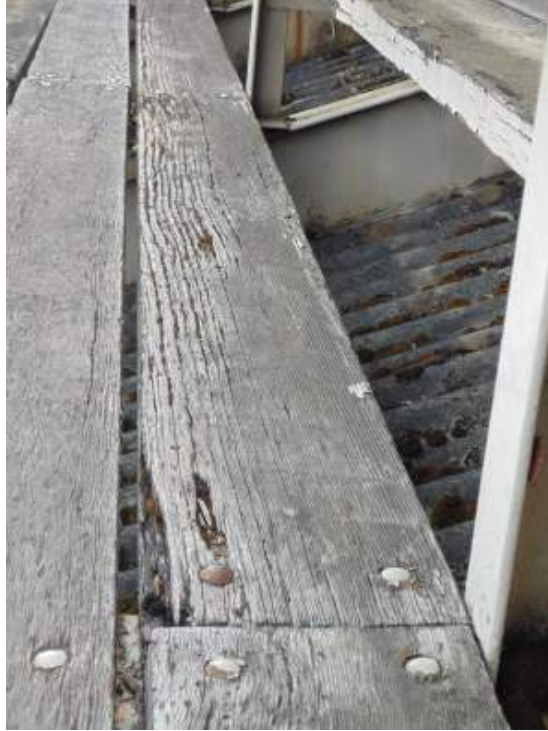
**FIGURE B1C:
SIGNIFICANTLY DAMAGED BLEACHER BOARDS**

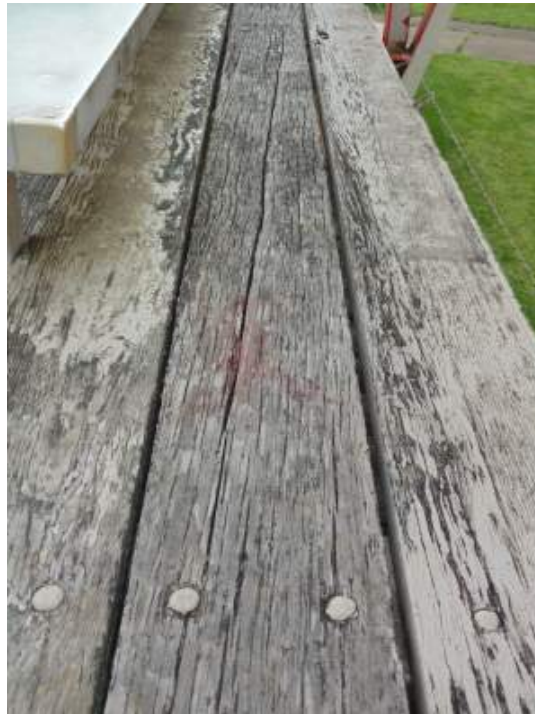
**FIGURE B1D:
SIGNIFICANTLY DAMAGED BLEACHER BOARDS**

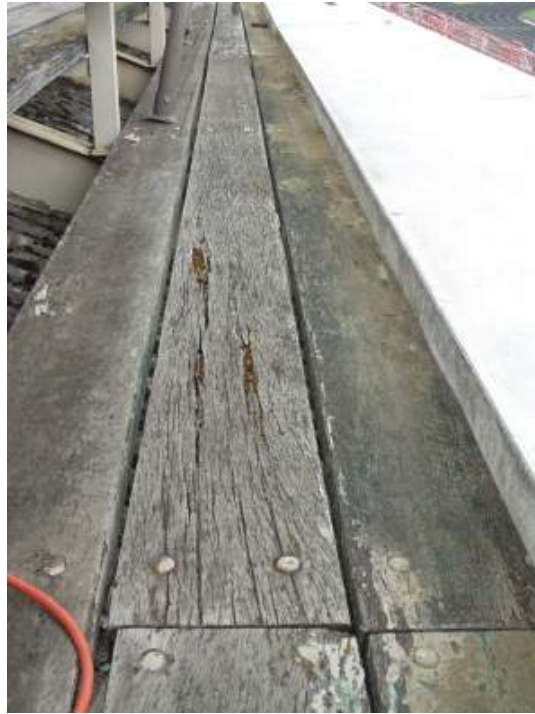
**FIGURE B1E:
SIGNIFICANTLY DAMAGED BLEACHER BOARDS**

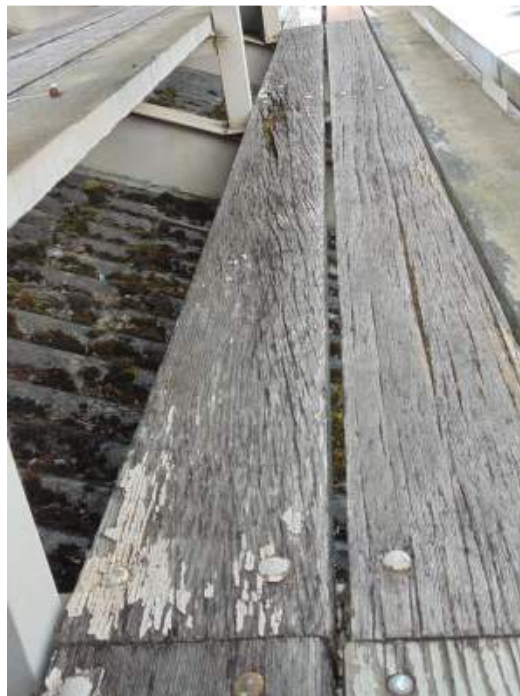
**FIGURE B1F:
SIGNIFICANTLY DAMAGED BLEACHER BOARDS**

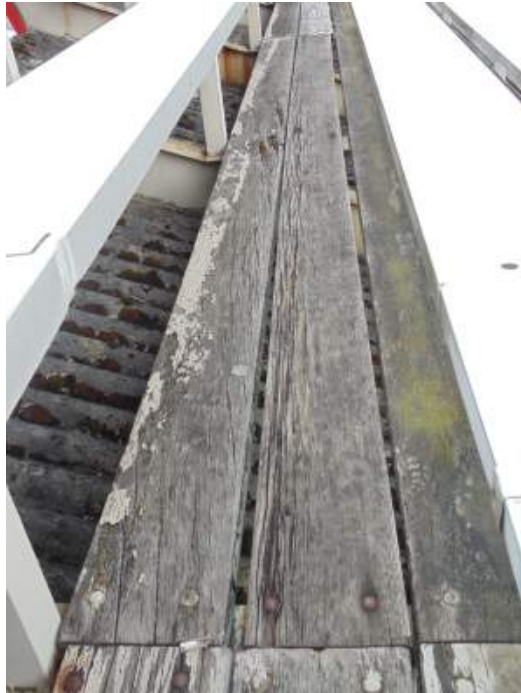
**FIGURE B1G:
SIGNIFICANTLY DAMAGED BLEACHER BOARDS**

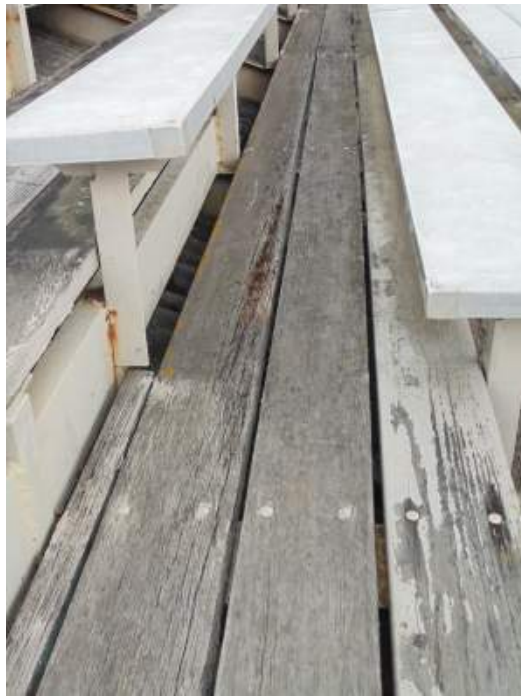
**FIGURE B1H:
SIGNIFICANTLY DAMAGED BLEACHER BOARDS**

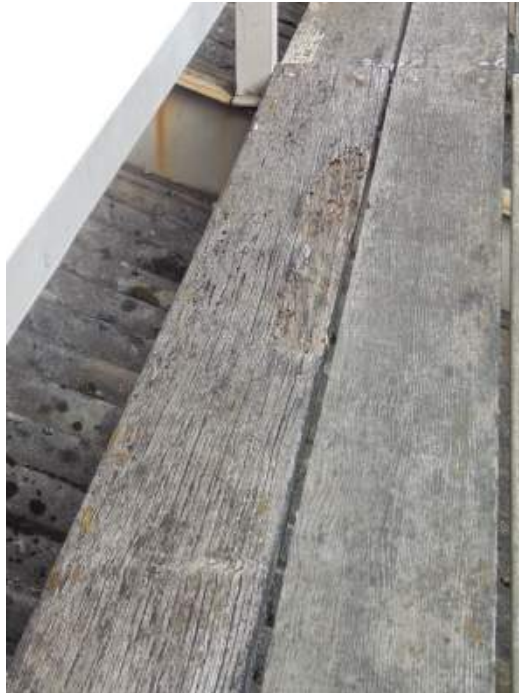
**FIGURE B1:
SIGNIFICANTLY DAMAGED BLEACHER BOARDS**

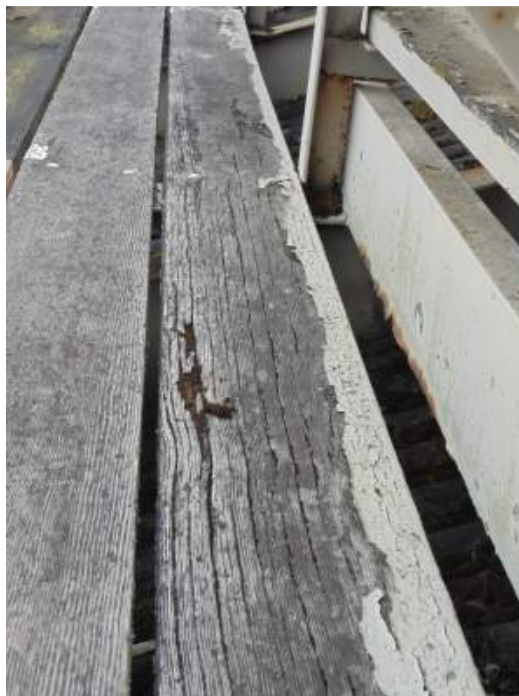
**FIGURE B2A:
DAMAGED / WEATHERED BLEACHER BOARDS**

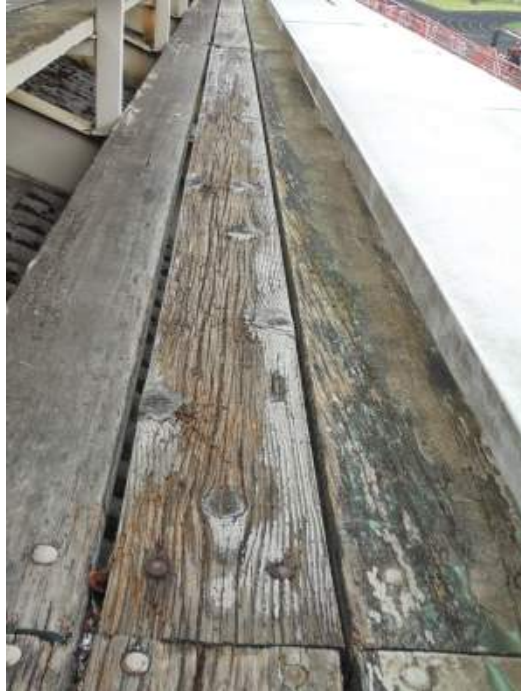
**FIGURE B2B:
DAMAGED / WEATHERED BLEACHER BOARDS**

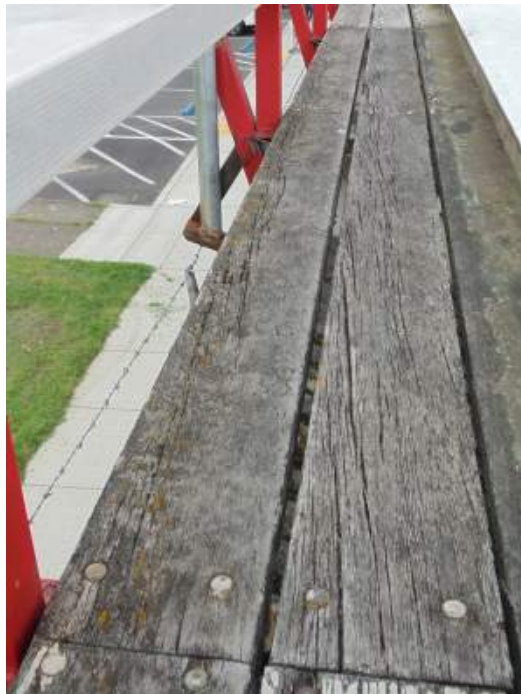
**FIGURE B2C:
DAMAGED / WEATHERED BLEACHER BOARDS**

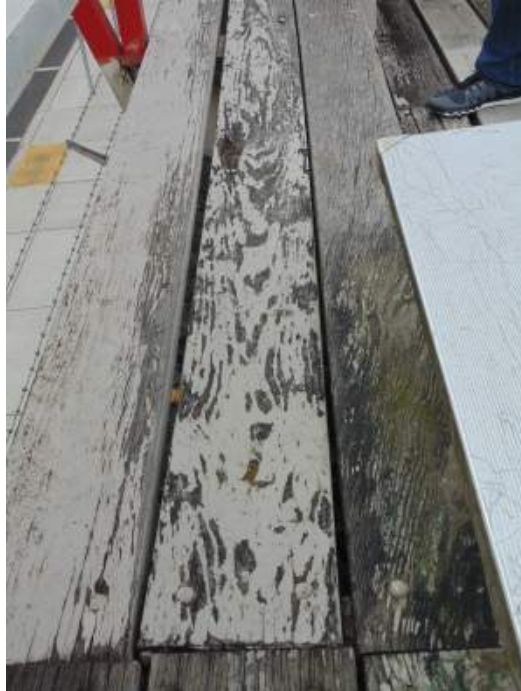
**FIGURE B2D:
DAMAGED / WEATHERED BLEACHER BOARDS**

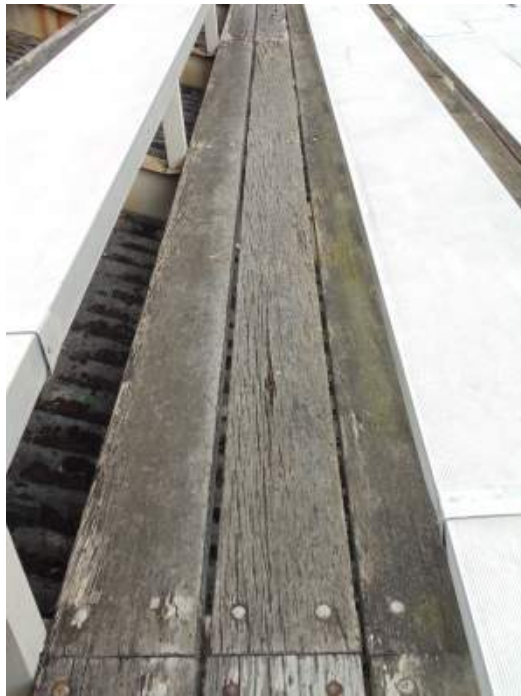
**FIGURE B2E:
DAMAGED / WEATHERED BLEACHER BOARDS**

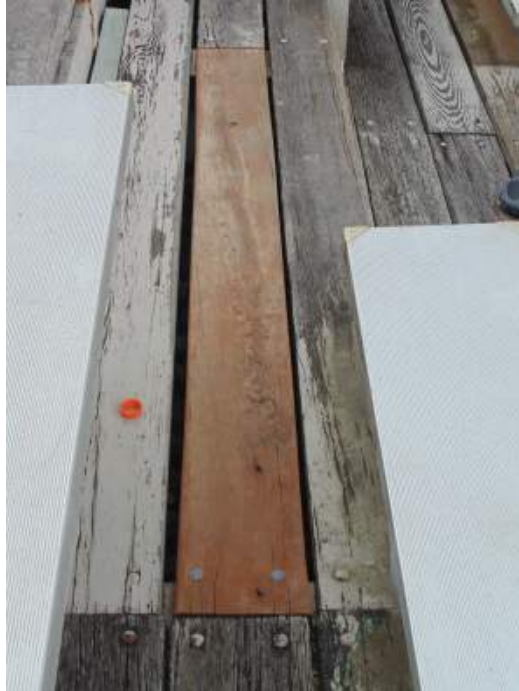
**FIGURE B3A:
REPLACEMENT CEDAR BLEACHER BOARDS**

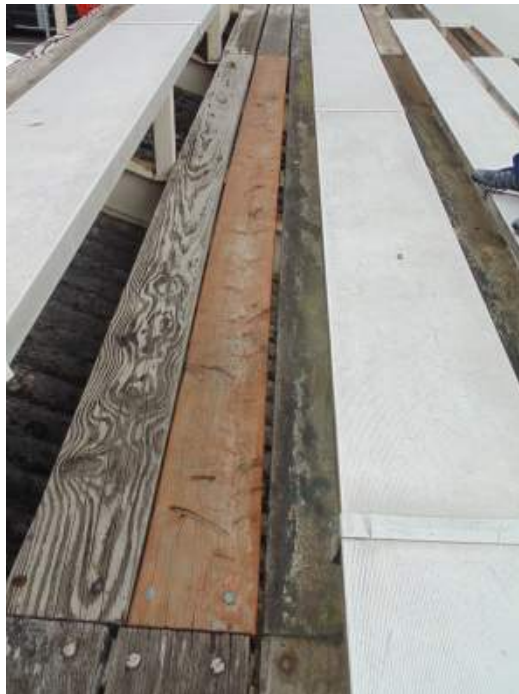
**FIGURE B3B:
REPLACEMENT CEDAR BLEACHER BOARD**

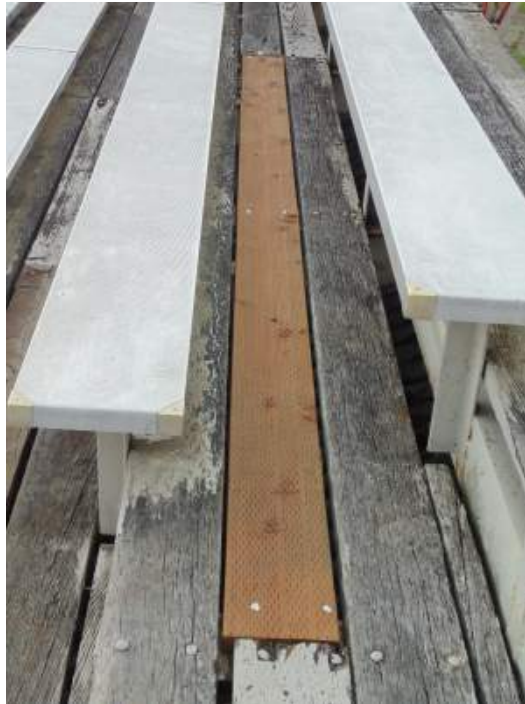
**FIGURE B4A:
REPLACEMENT PRESSURE TREATED BLEACHER BOARD**

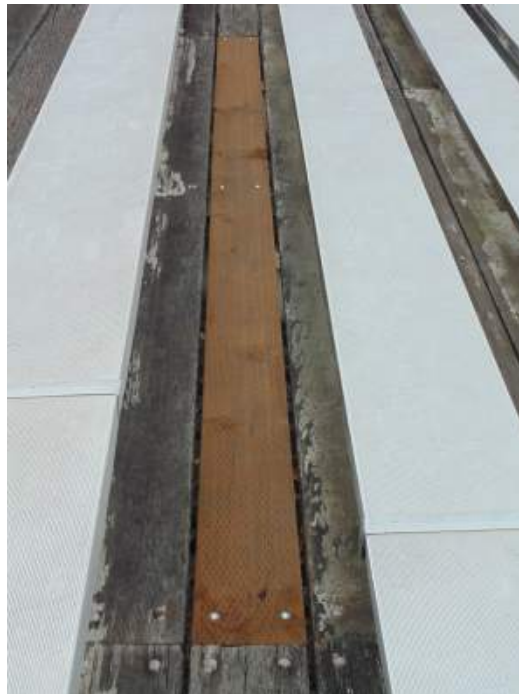
**FIGURE B4B:
REPLACEMENT PRESSURE TREATED BLEACHER BOARD**

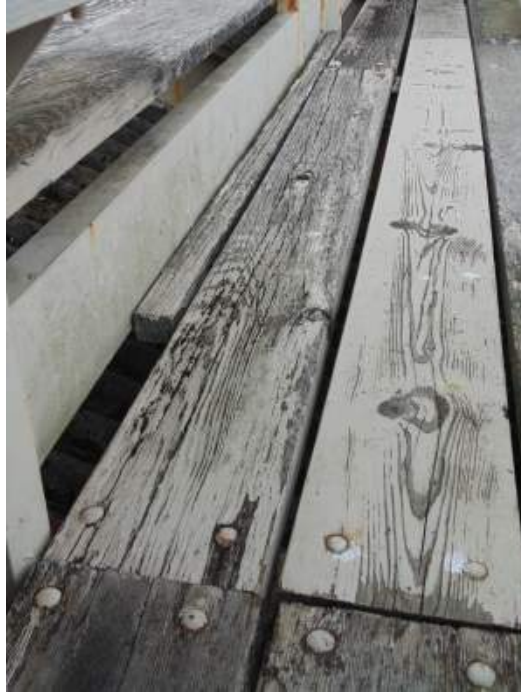
**FIGURE B5A:
ORIGINAL SINGLE SPAN BLEACHER BOARD**

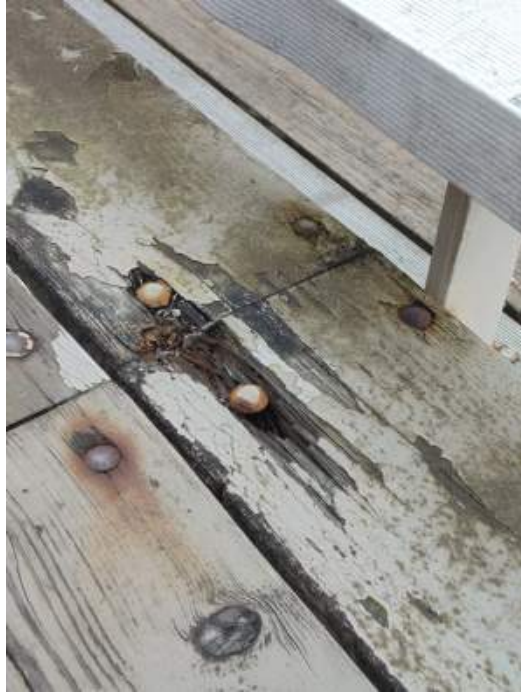
**FIGURE B6A:
SIGNIFICANT DAMAGE AT BLEACHER BOARD CONNECTION**
