## PPS - Marshall High School - Grandstand Assessment

ABHT Project #11516

May 19, 2016

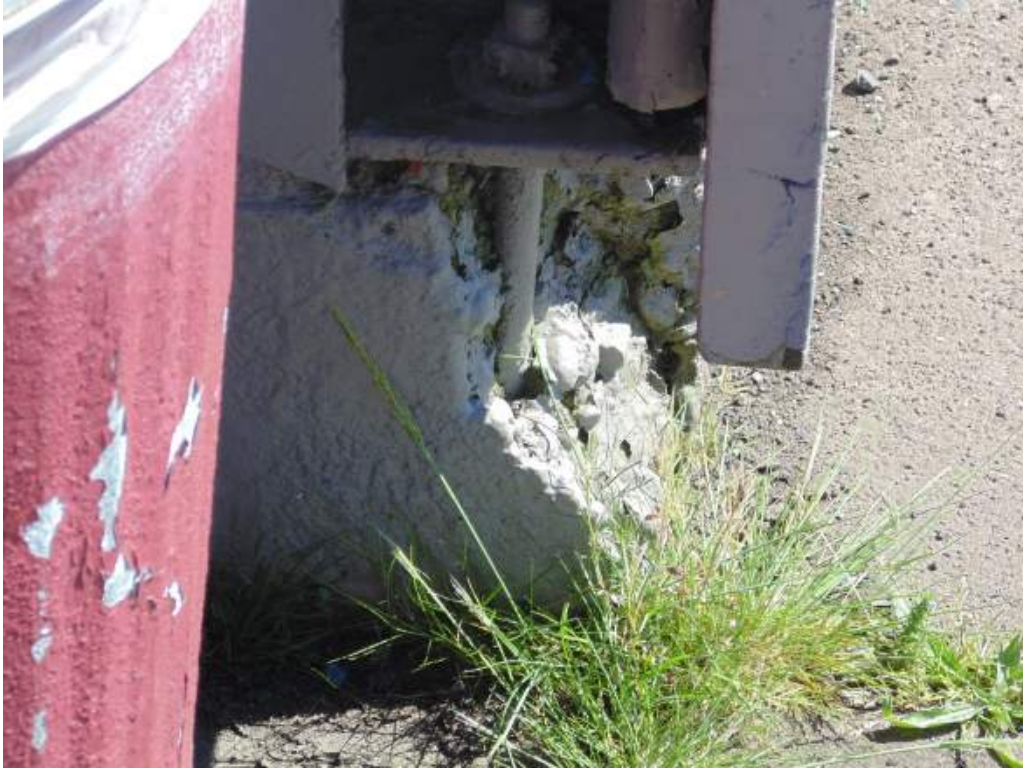
**FIGURE F1A: CONCRETE STEMWALL SPALLING AT NORTH CORNER**

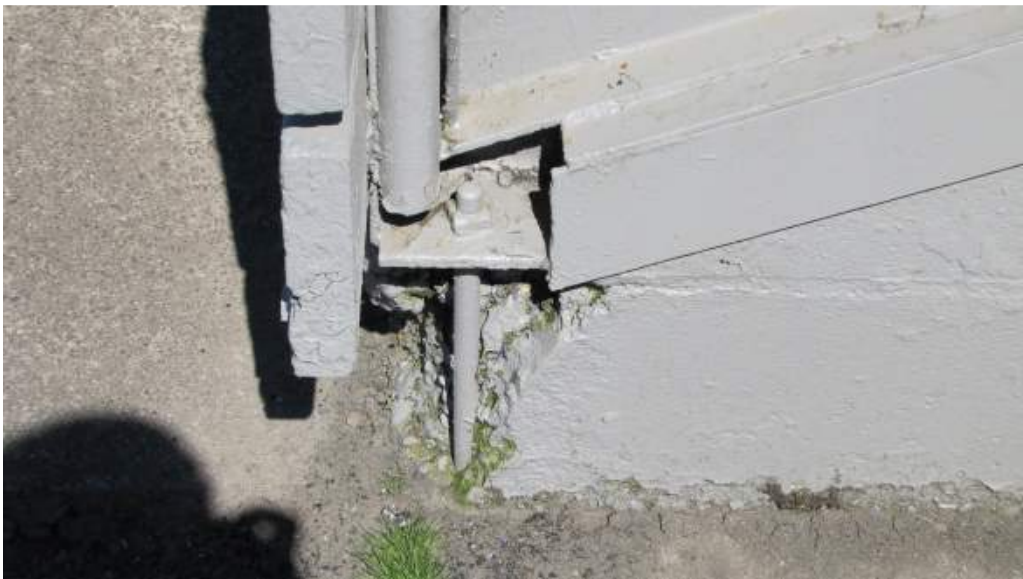
**FIGURE F1B: CONCRETE STEMWALL SPALLING AT SOUTH CORNER**

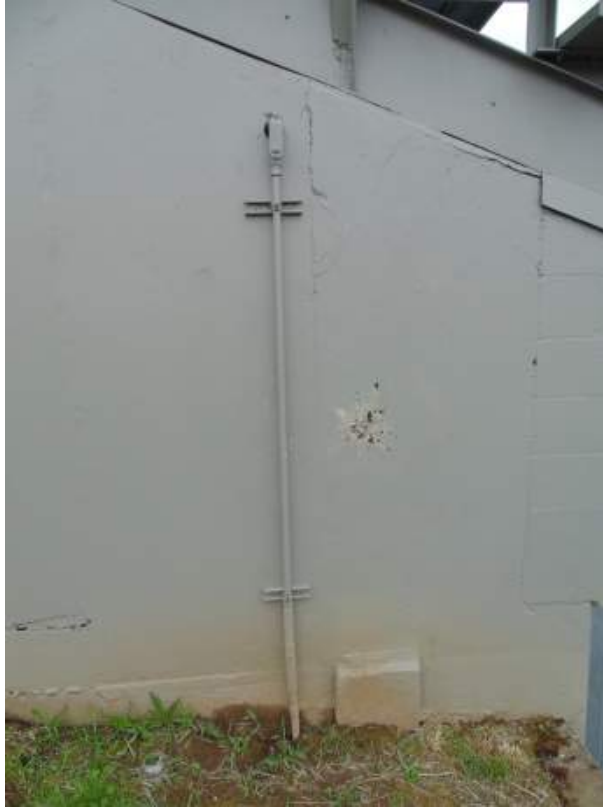
**FIGURE F2: SMALL CONCRETE CRACK AT NORTH WALL PILASTER**

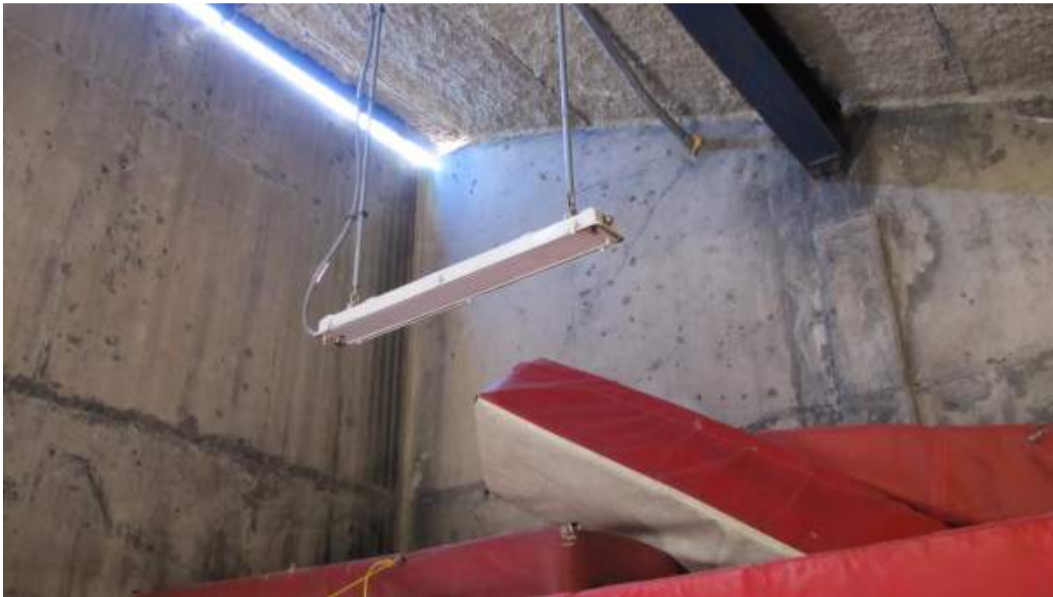
**FIGURE F3: SMALL CONCRETE CRACK AT SOUTH WALL PILASTER**

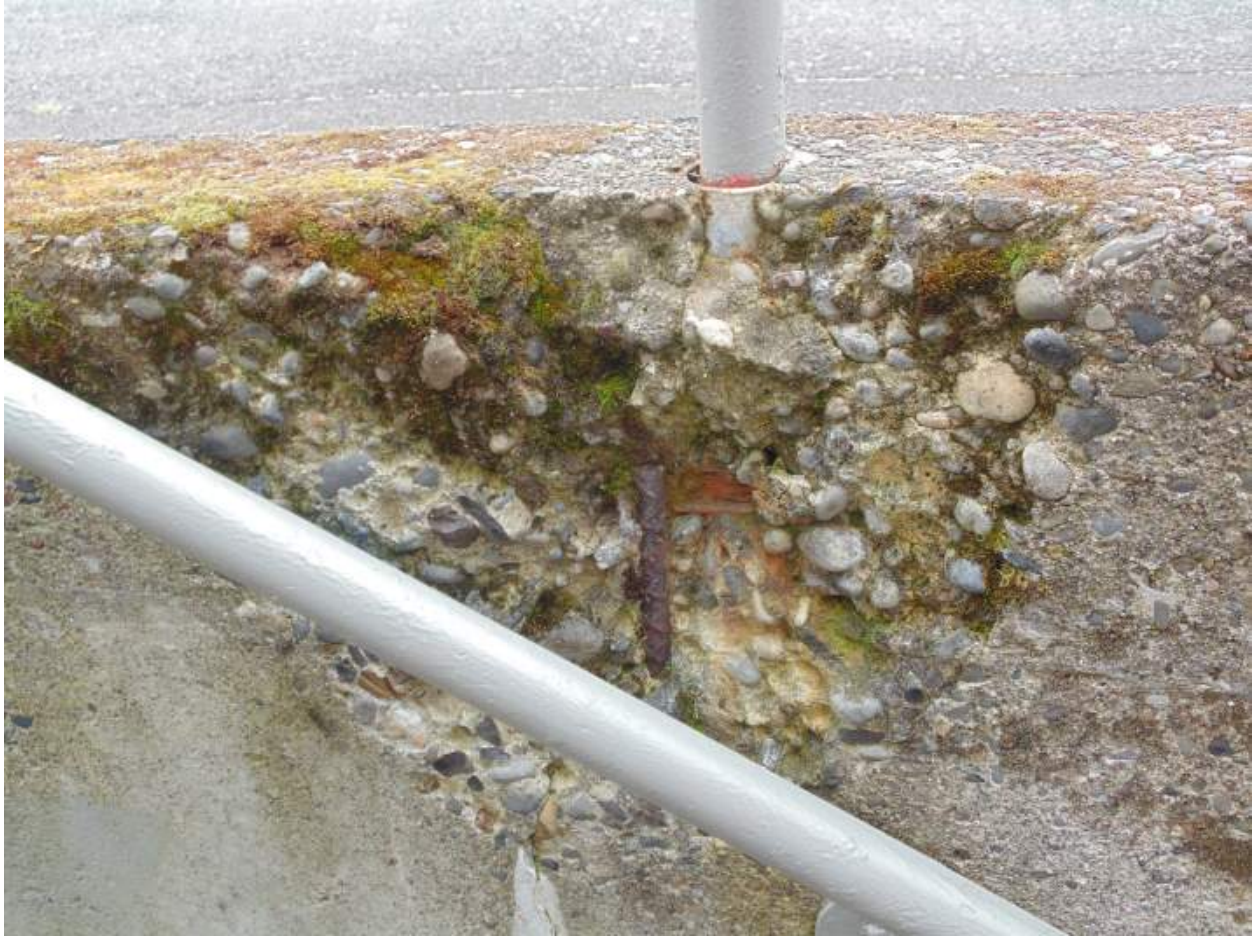
**FIGURE F4: SPALLING AT EAST SIDE**

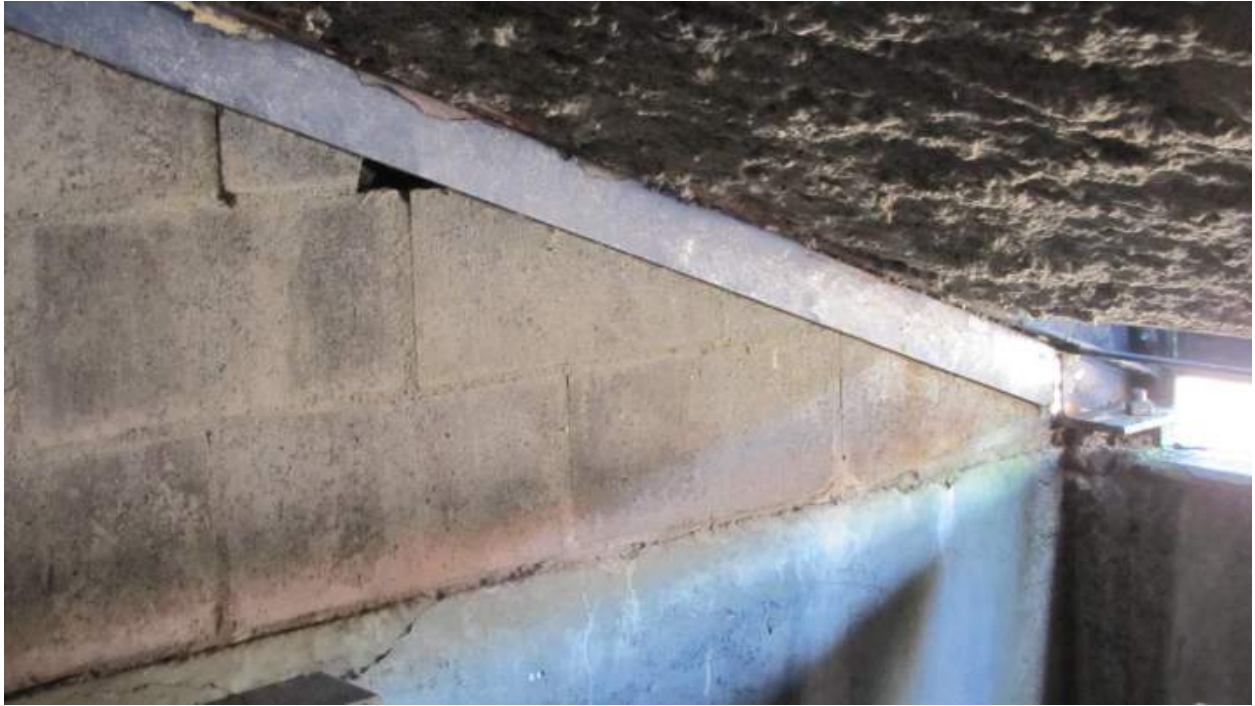
**FIGURE S1A: SPALLING AT FRONT CONCRETE STEMWALL SUPPORTING STEEL RAKER**

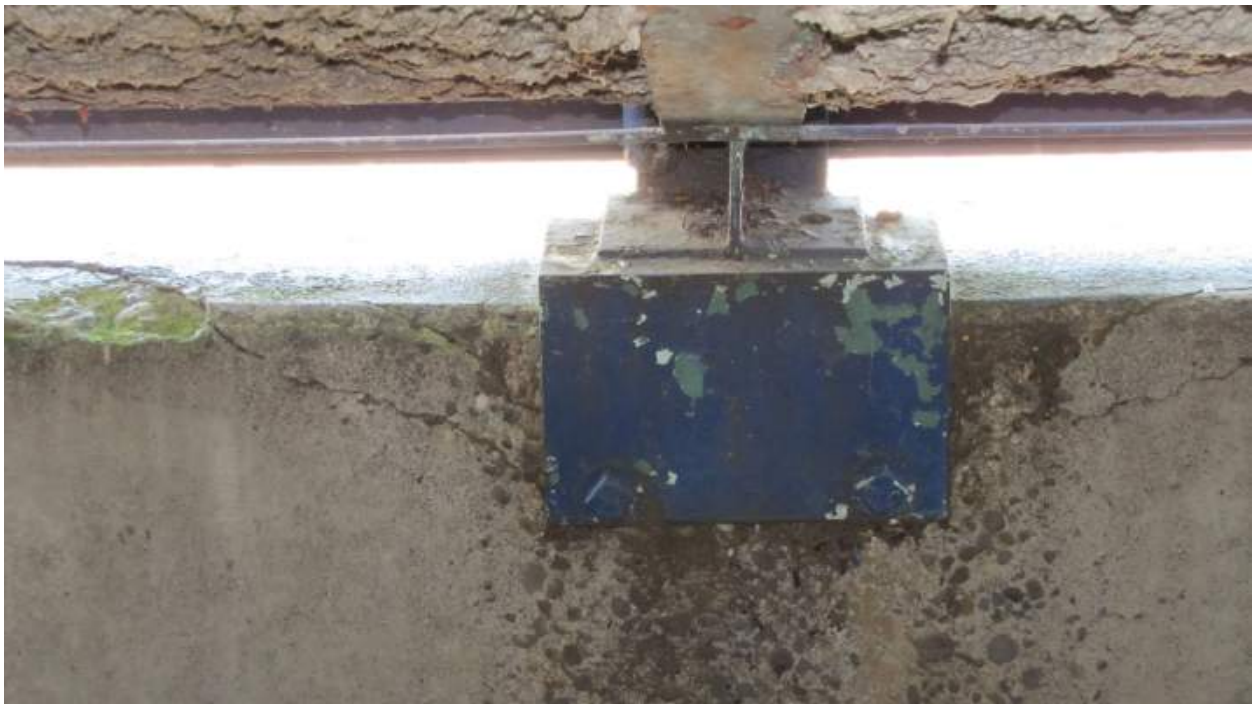
**FIGURE S1B: SPALLING/CRACKING AT CONCRETE STEMWALL SUPPORTING STEEL RAKER**

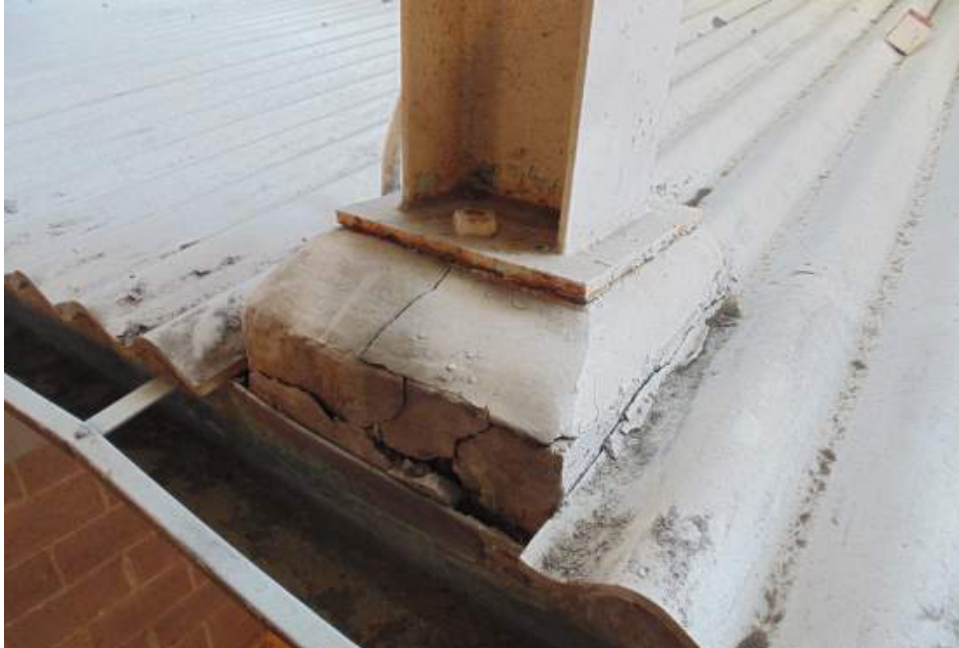
**FIGURE S2: CRACKING OF GROUT AT STEEL COLUMN BASE PLATE**

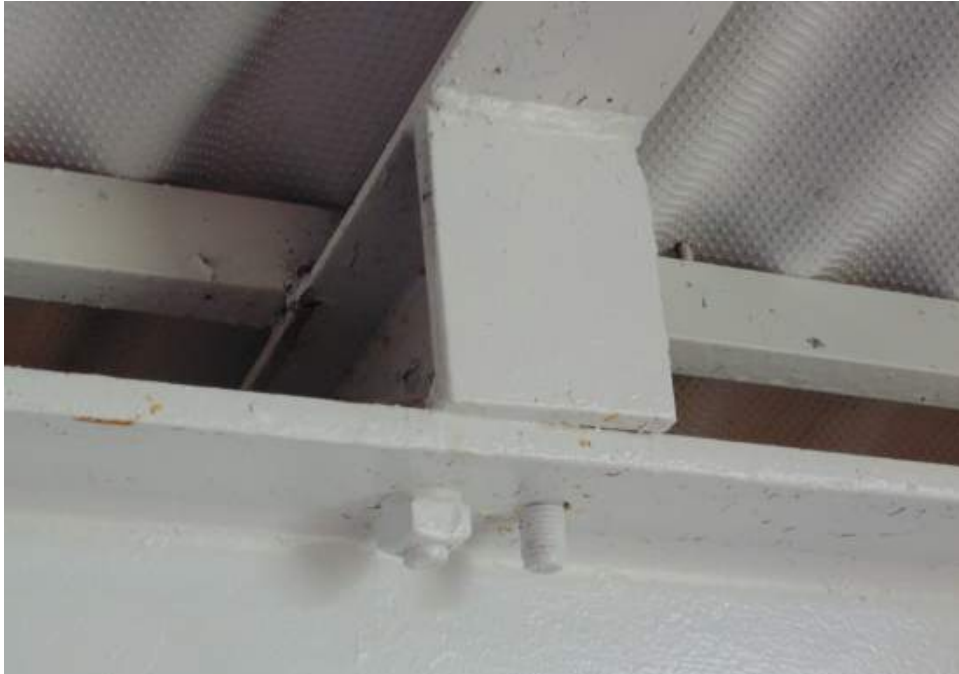
**FIGURE S3: MISSING NUT AT STEEL RAKER TO STEEL BEAM**

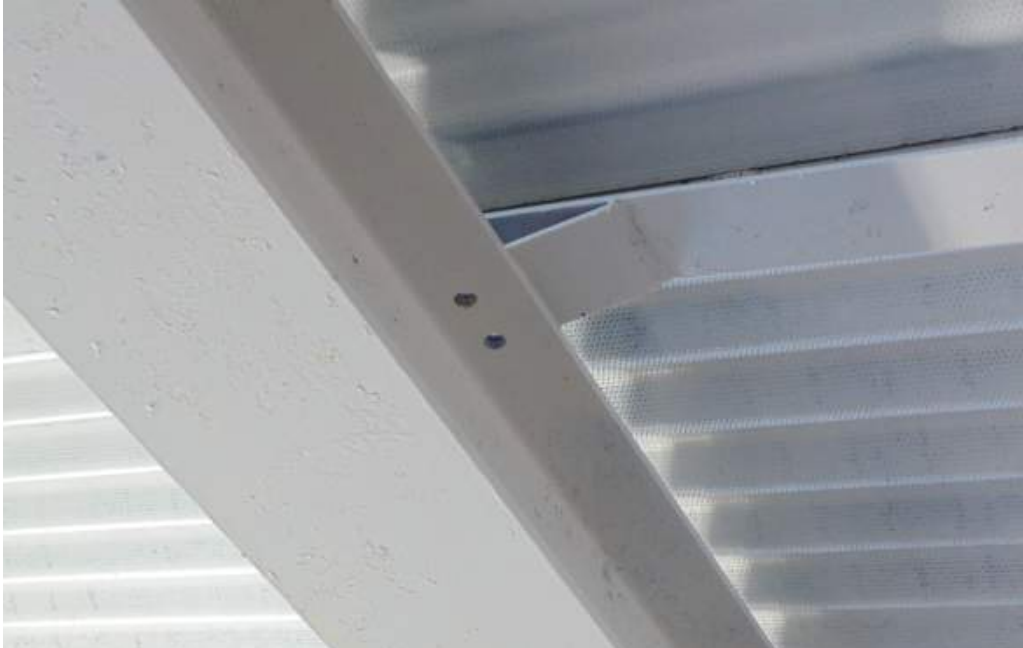
**FIGURE S4: MISSING BOLTS AT STEEL RAKER TO STEEL BEAM**

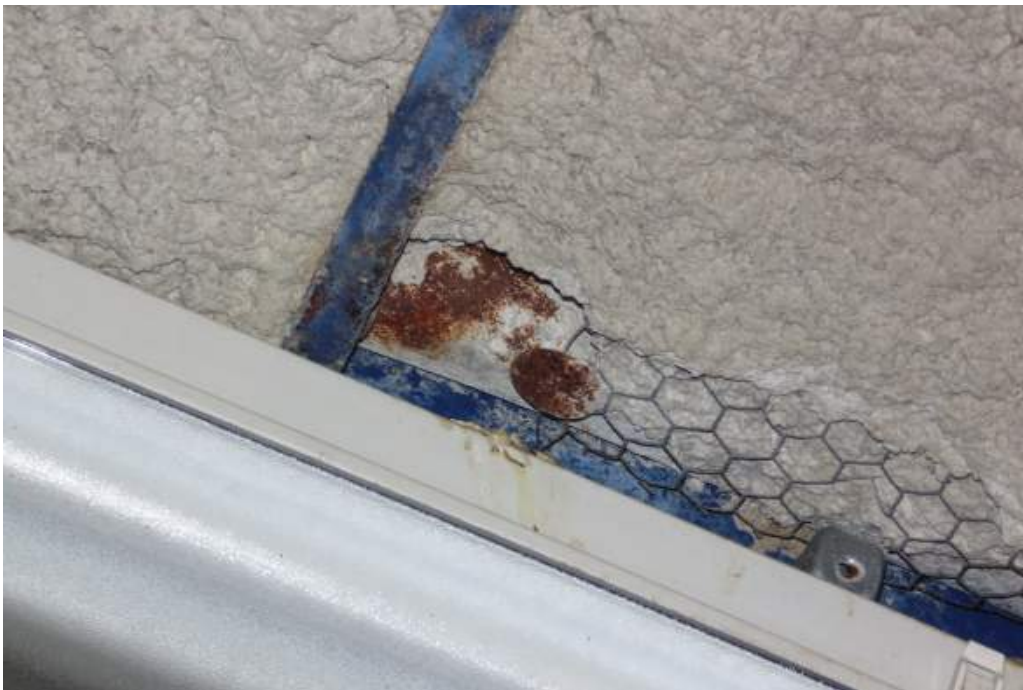
**FIGURE S5A: POTENTIAL STEEL BEAM RUST DUE TO WATER INTRUSION**

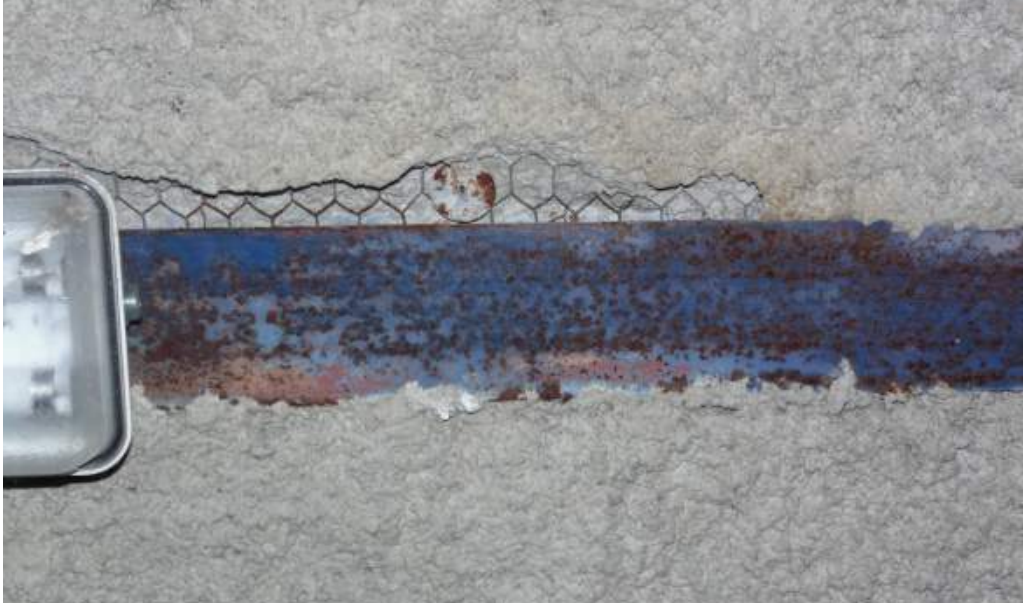
**FIGURE S5B: POTENTIAL STEEL BEAM RUST DUE TO WATER INTRUSION**

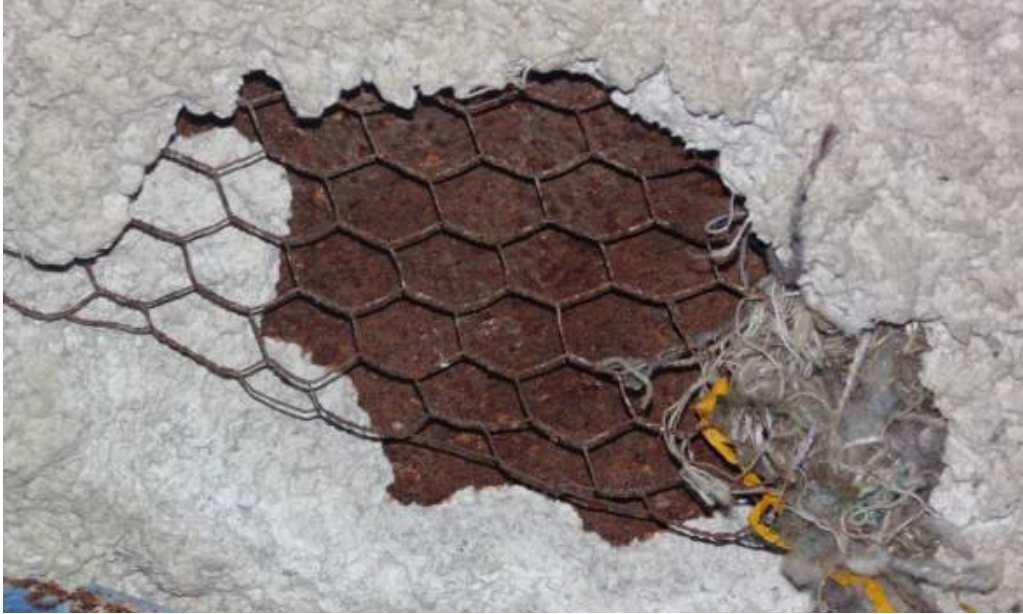
**FIGURE S5C: POTENTIAL STEEL BEAM RUST DUE TO WATER INTRUSION**

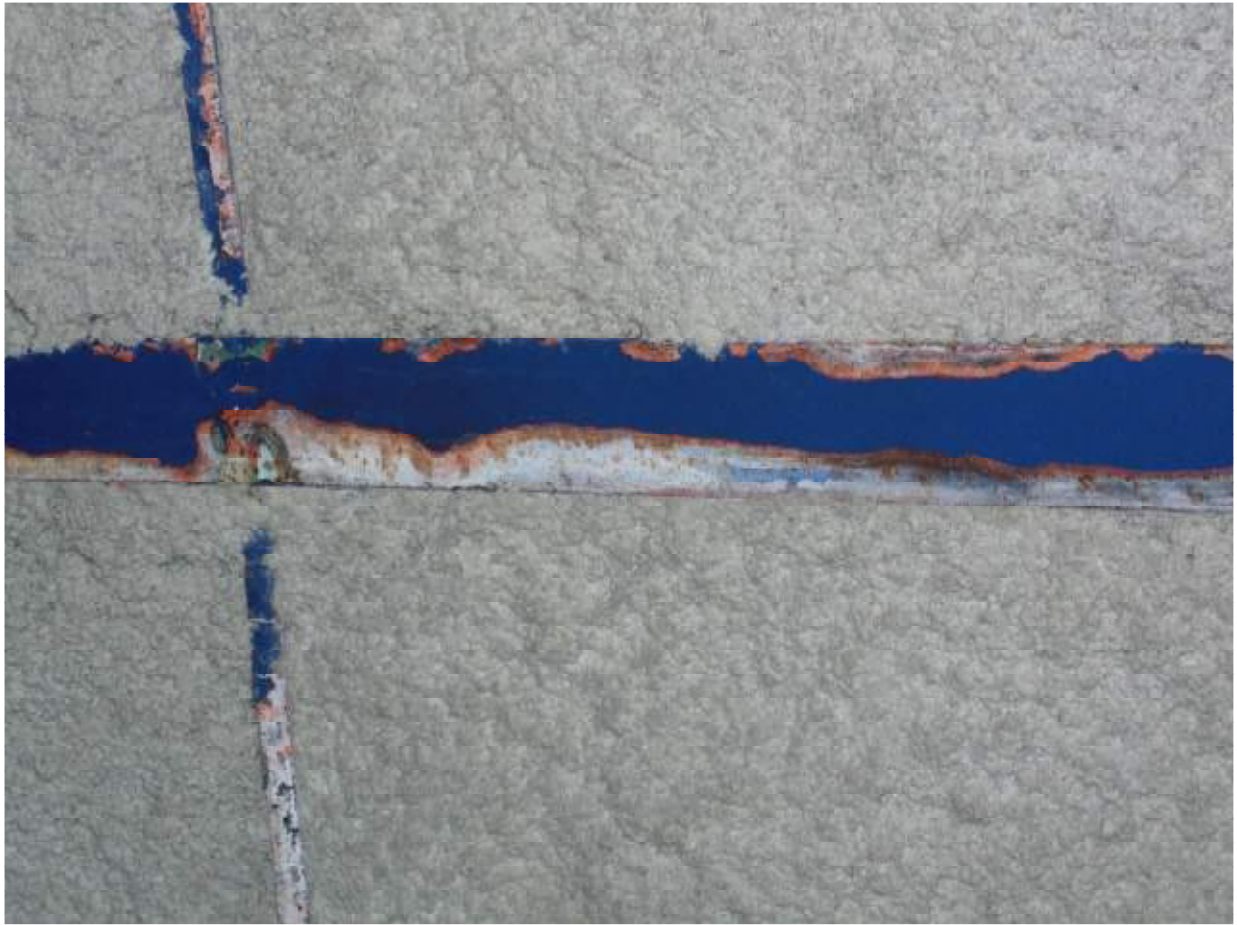
**FIGURE S5D: POTENTIAL STEEL BEAM RUST DUE TO WATER INTRUSION**

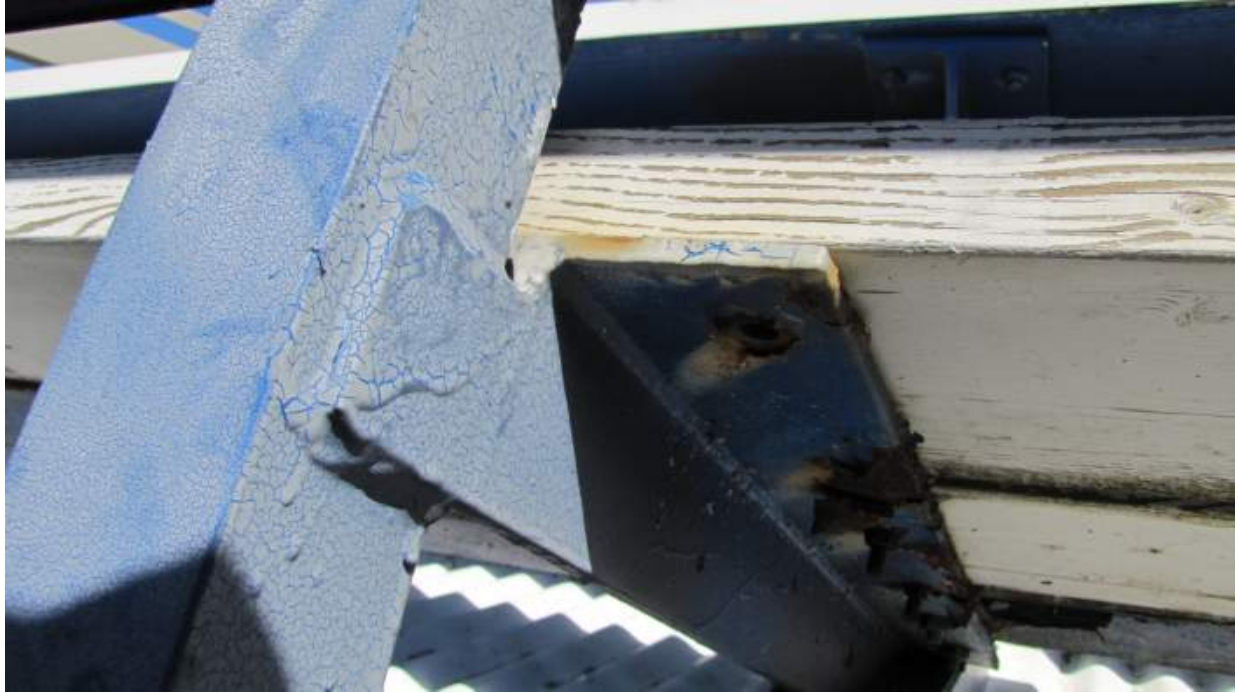
**FIGURE S6: CONNECTION (BOLT AND PLATE) RUST AT BLEACHER BOARD CONNECTIONS**

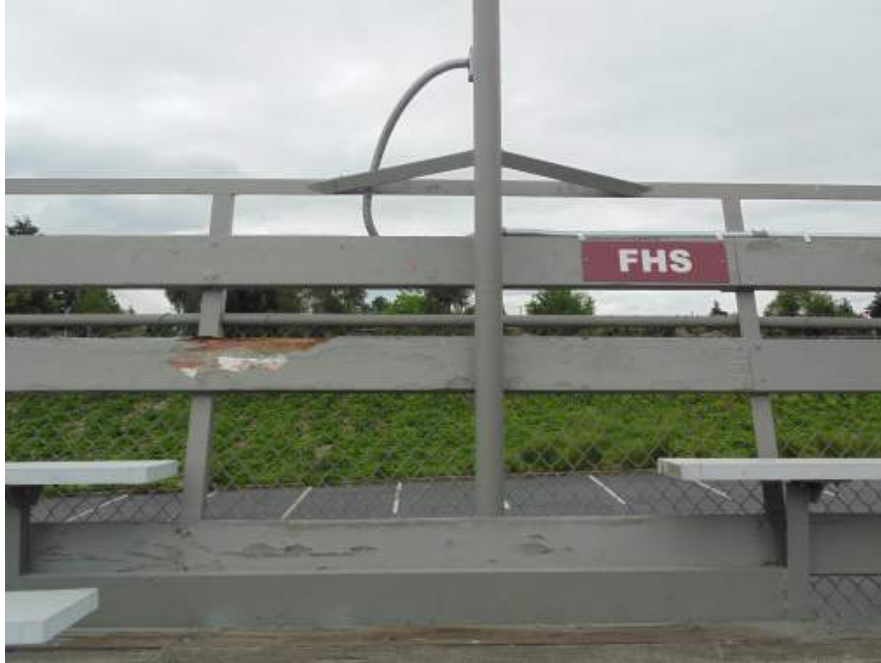
**FIGURE R1A: DAMAGED RAILING**

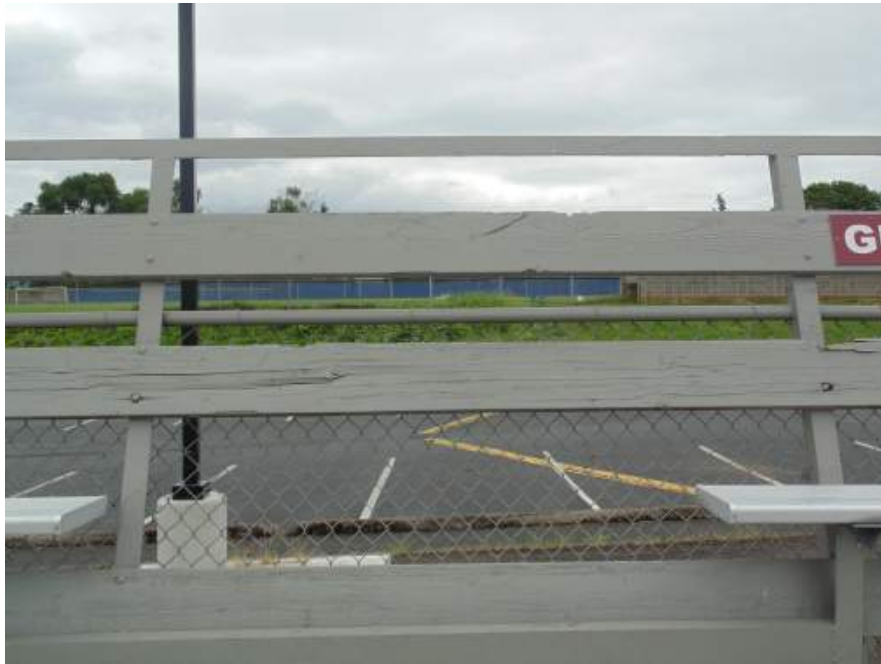
**FIGURE R1B: DAMAGED RAILING**

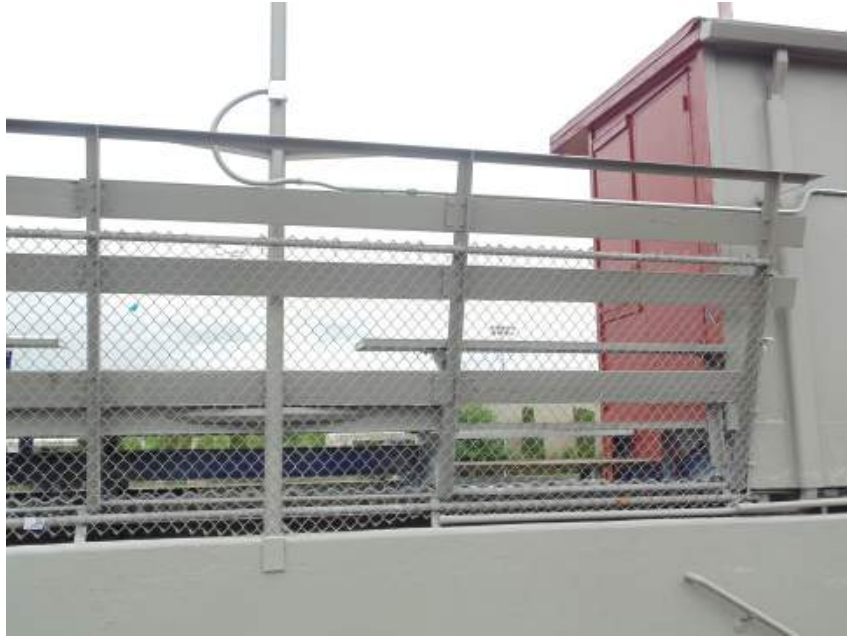
**FIGURE R2: INSUFFICIENT RAILNG SPLICE**

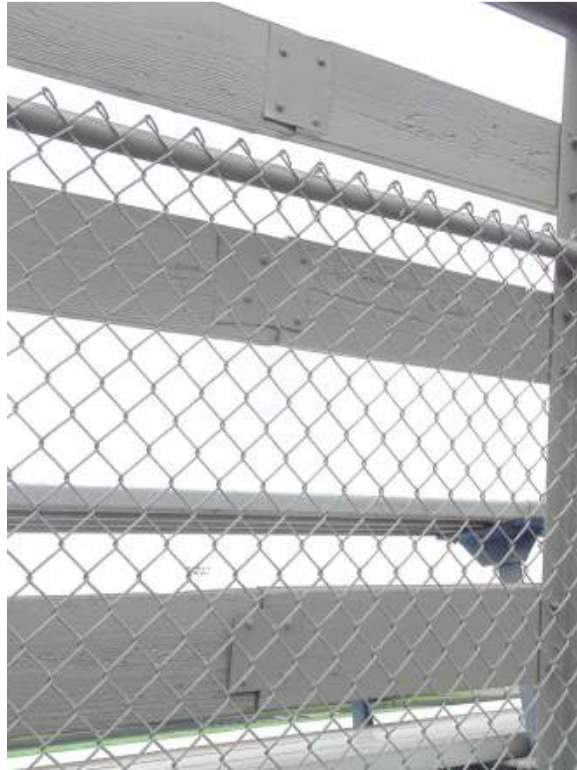
**FIGURE R3A: INSUFFICIENT RAILNG SPLICE**

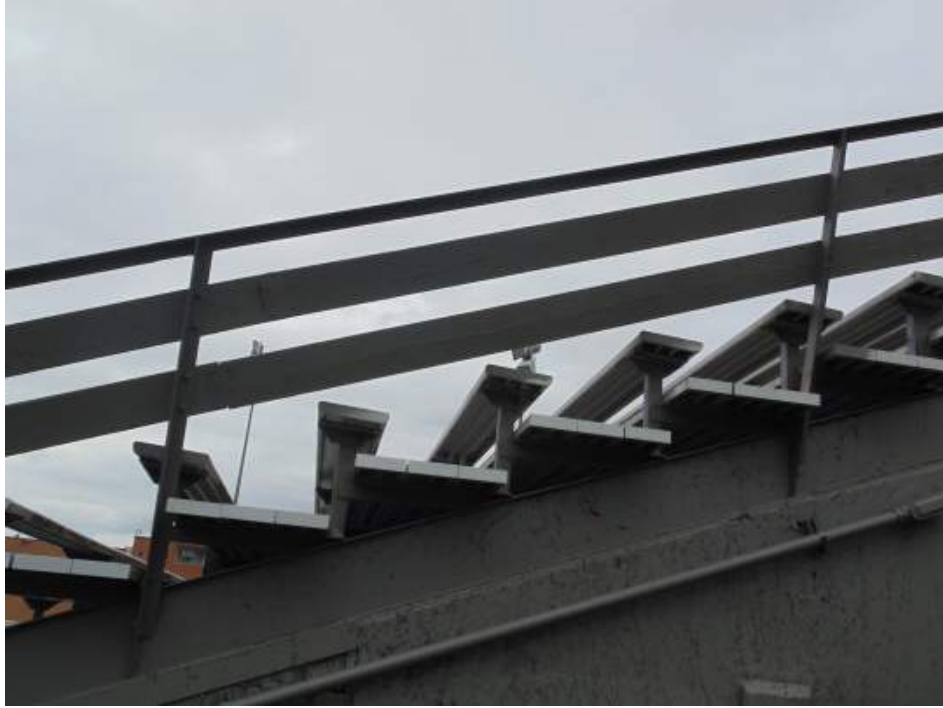
**FIGURE R3B: INSUFFICIENT RAILNG SPLICE**

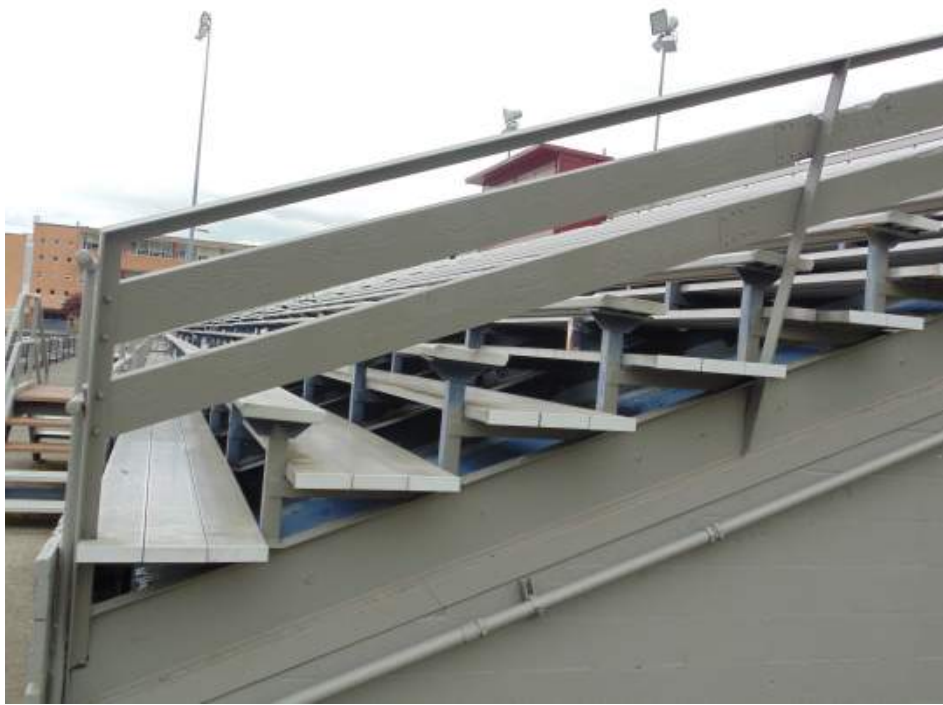
**FIGURE R3C: INSUFFICIENT RAILNG SPLICE**

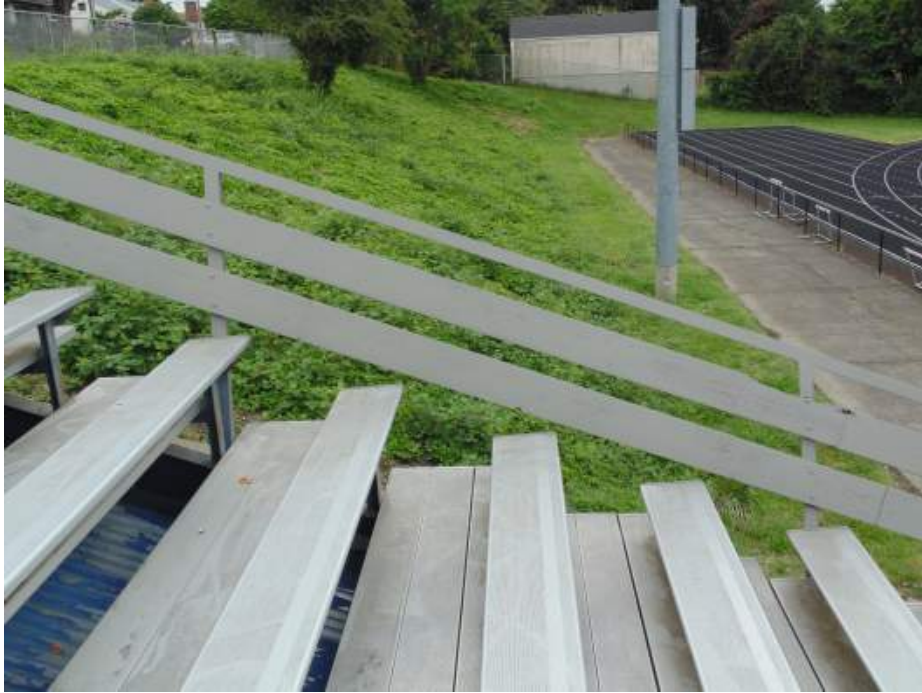
**FIGURE R4: DAMAGED RAILING**

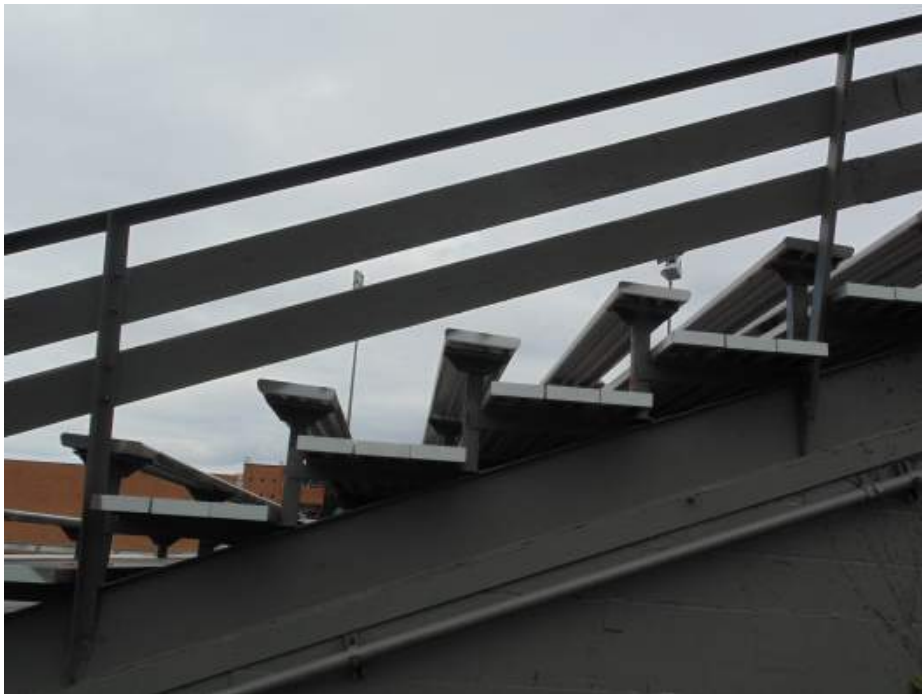
**FIGURE R5A: LARGE SPACE BETWEEN RAILING AND BLEACHERS**

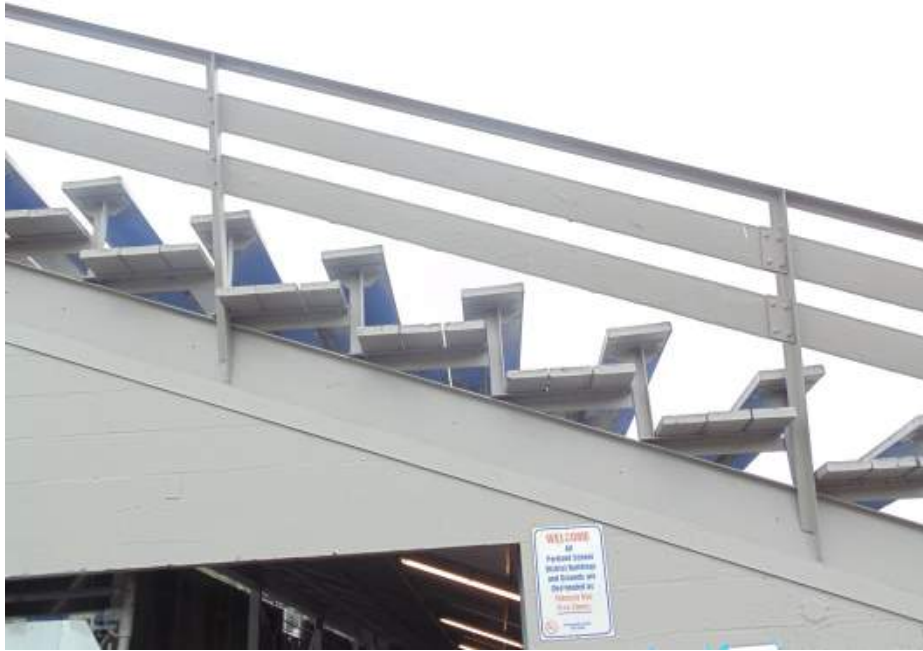
**FIGURE R5B: LARGE SPACE BETWEEN RAILING AND BLEACHERS**

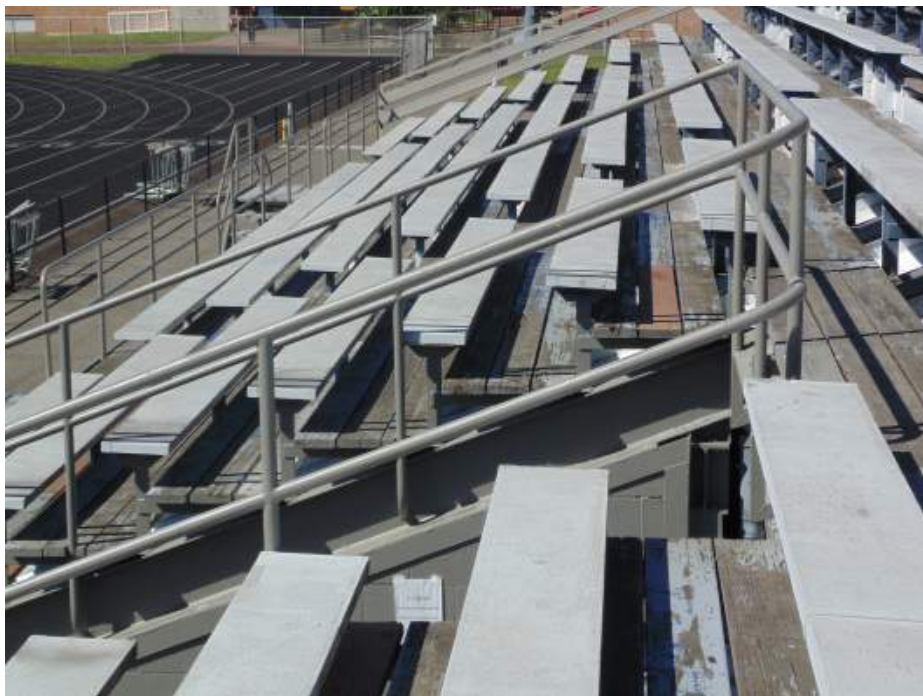
**FIGURE R5C: LARGE SPACE BETWEEN RAILING AND BLEACHERS**

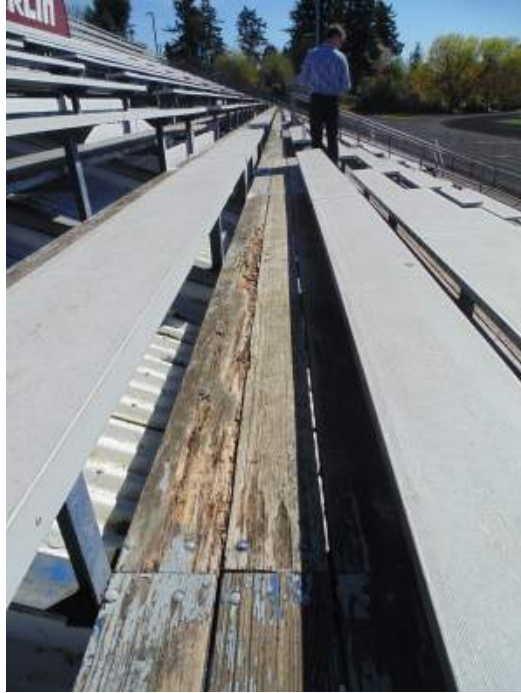
**FIGURE B1A: SIGNIFICANTLY DAMAGED BLEACHER BOARDS**

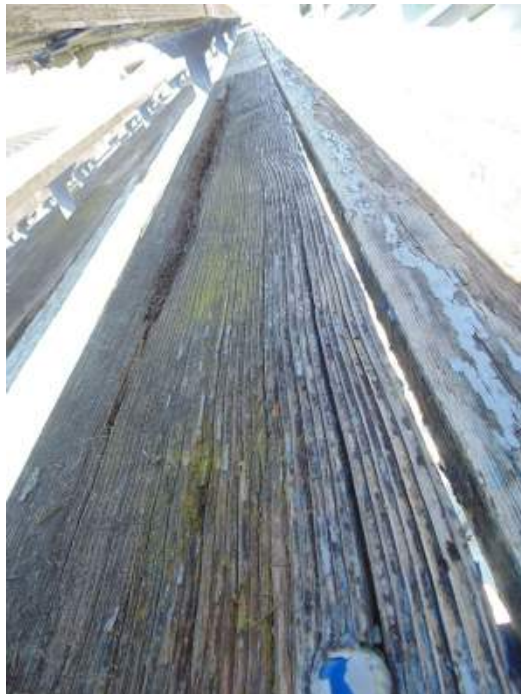
**FIGURE B1B: SIGNIFICANTLY DAMAGED BLEACHER BOARDS**

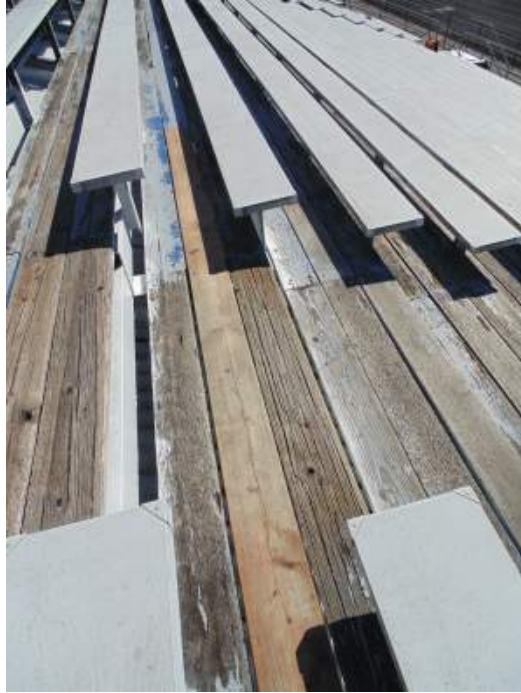
**FIGURE B1C: SIGNIFICANTLY DAMAGED BLEACHER BOARDS AT FRONT OF AISLE**

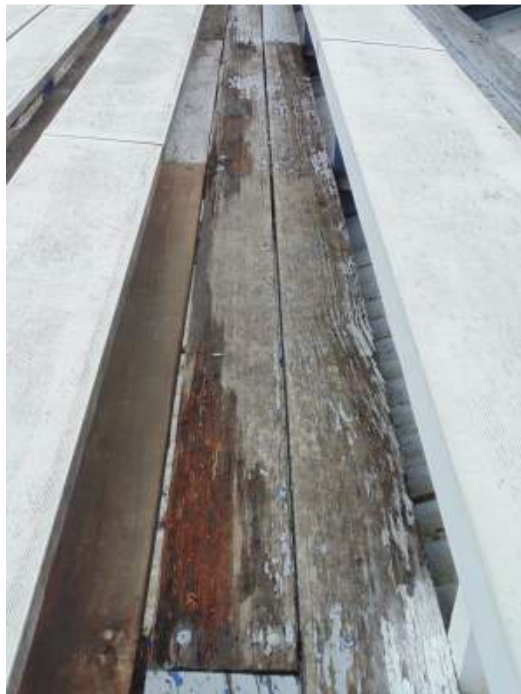
**FIGURE B2A: DAMAGED/WEATHERED BLEACHER BOARDS**

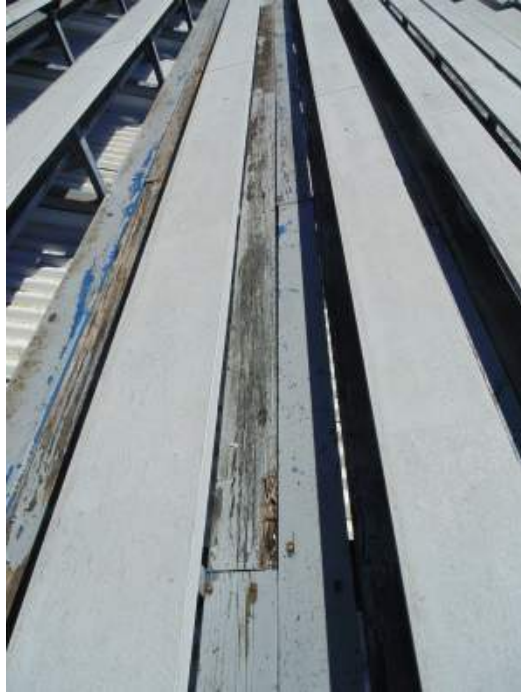
**FIGURE B2B: DAMAGED/WEATHERED BLEACHER BOARDS**

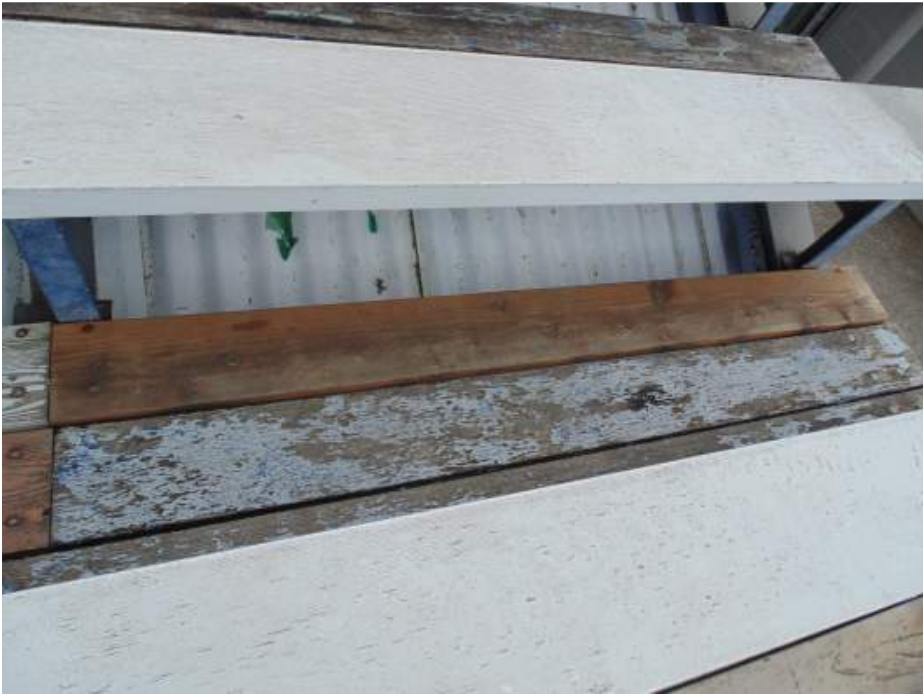
**FIGURE B3A: REPLACED CEDAR BLEACHER BOARD**

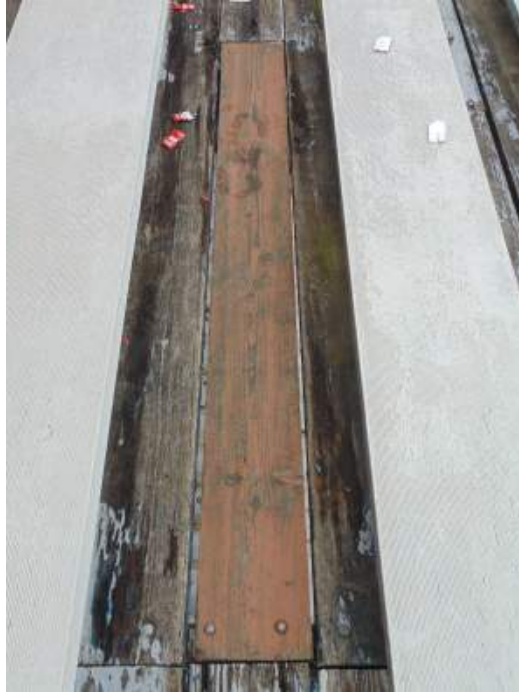
**FIGURE B3B: REPLACED CEDAR BLEACHER BOARD**

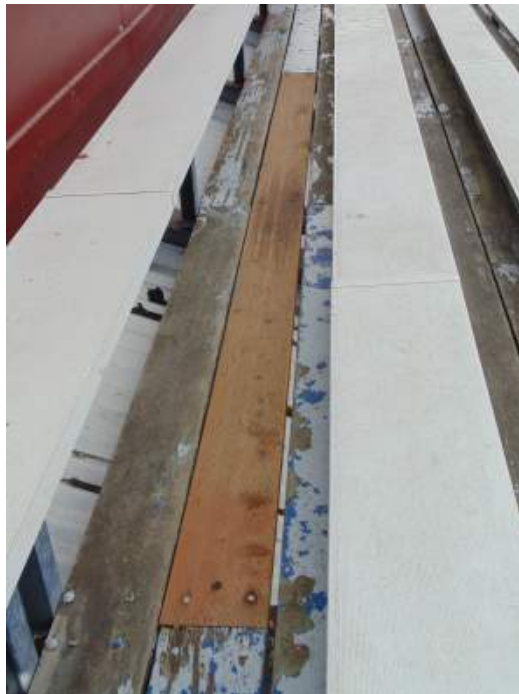
**FIGURE B4A: REPLACED PRESSURE TREATED DFL BLEACHER BOARD**

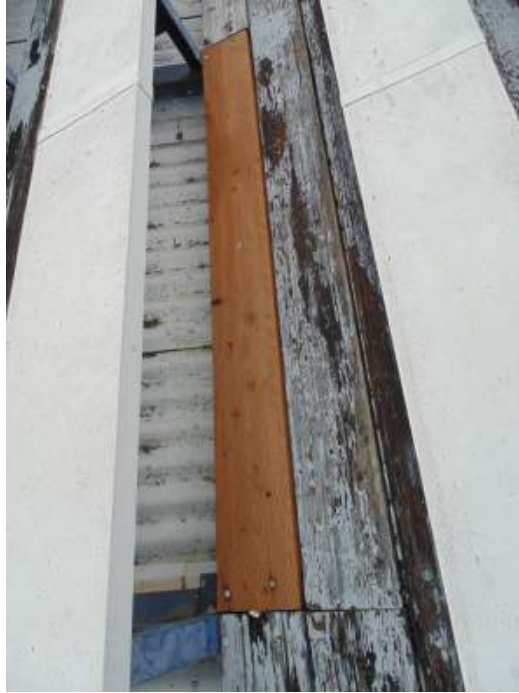
**FIGURE B4B: REPLACED PRESSURE TREATED DFL BLEACHER BOARD**

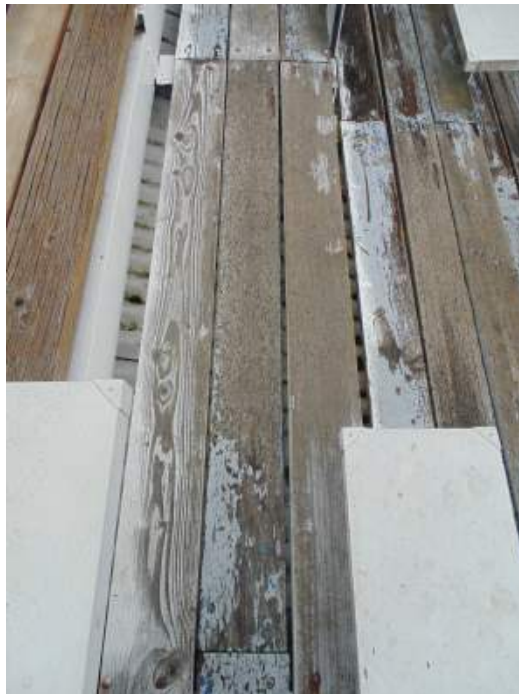
**FIGURE B5A: ORIGINAL SINGLE SPAN BLEACHER BOARD**

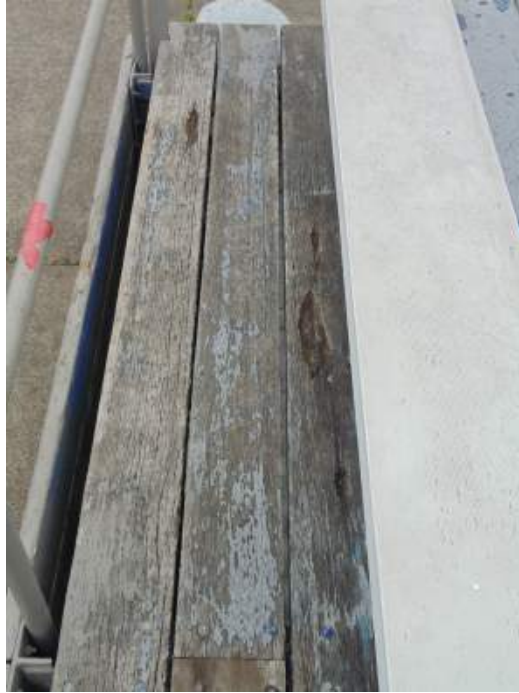
**FIGURE B5B: ORIGINAL SINGLE SPAN BLEACHER BOARD**

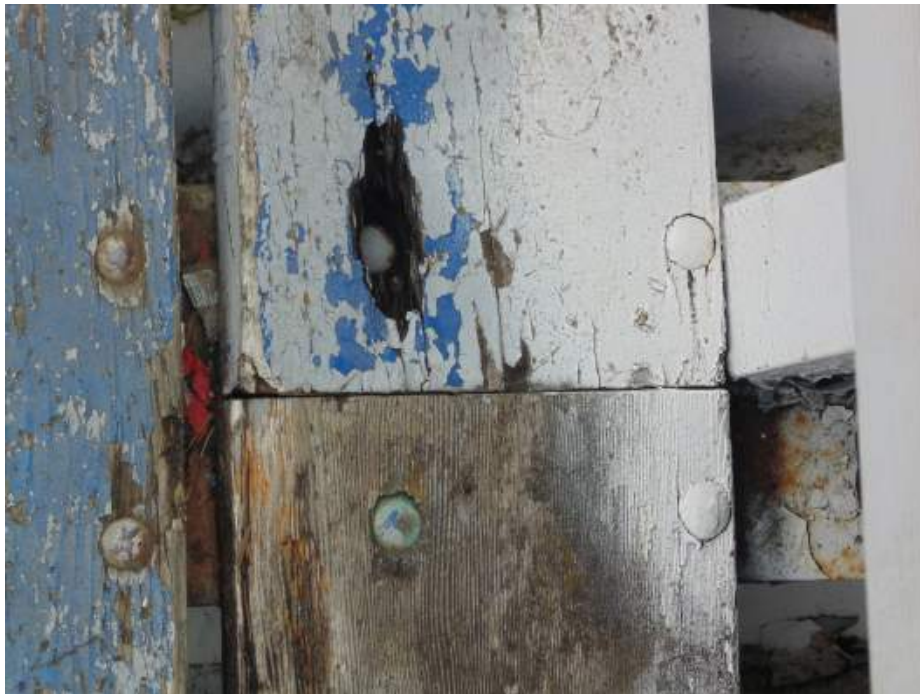
**FIGURE B6A: SIGNIFICANT BLEACHER BOARD DAMAGE AT CONNECTION**
