## PPS - Marshall High School - Grandstand Assessment

ABHT Project #11516

May 19, 2016

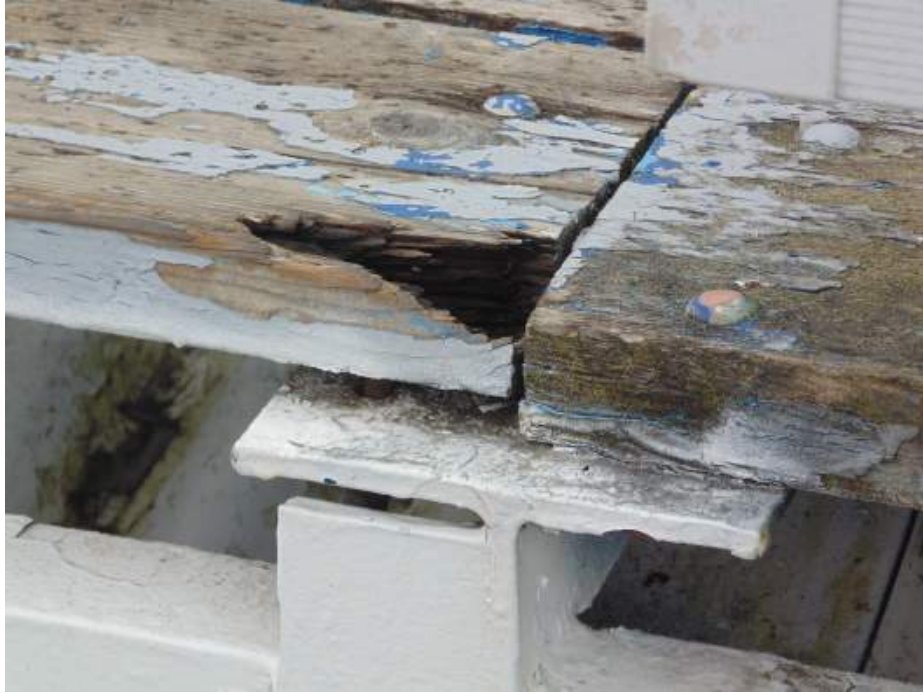
**FIGURE B6B: SIGNIFICANT BLEACHER BOARD DAMAGE AT CONNECTION**

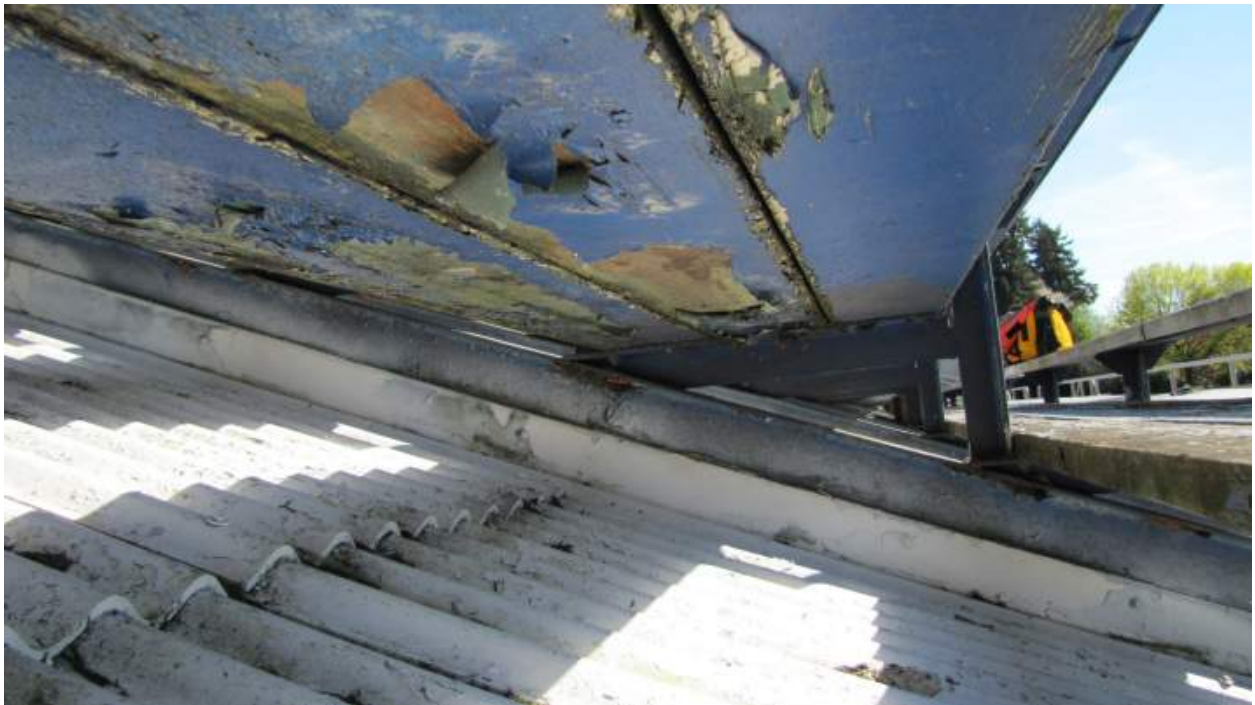
**FIGURE B7: DETERIORATED PAINT AT UNDERSIDE OF BLEACHER BOARDS**
