Ref.: The Ainsworth School
2350 SW Vista Ave, Portland, OR 97201
Foundation Undermine – Observation Report
AAI Project No. A18142

The Ainsworth School – Foundation Observation
August 9, 2018

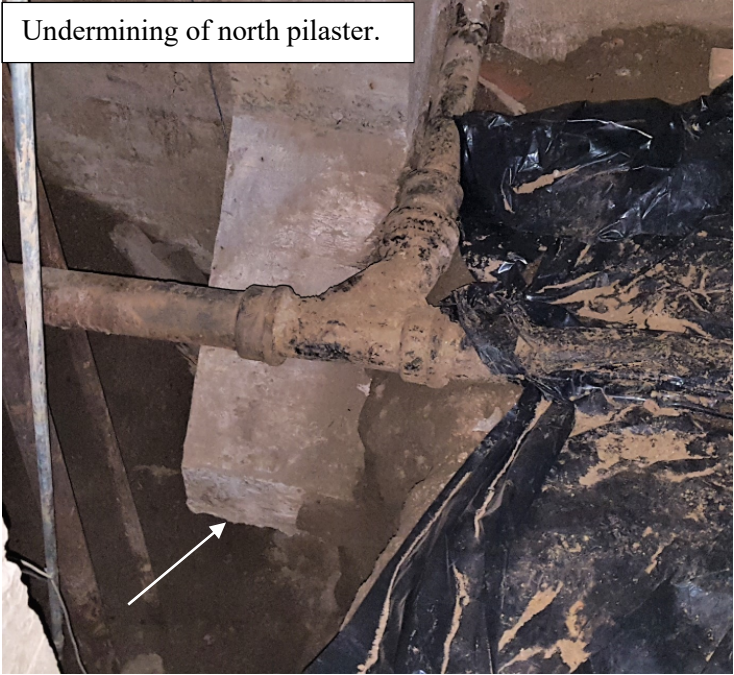
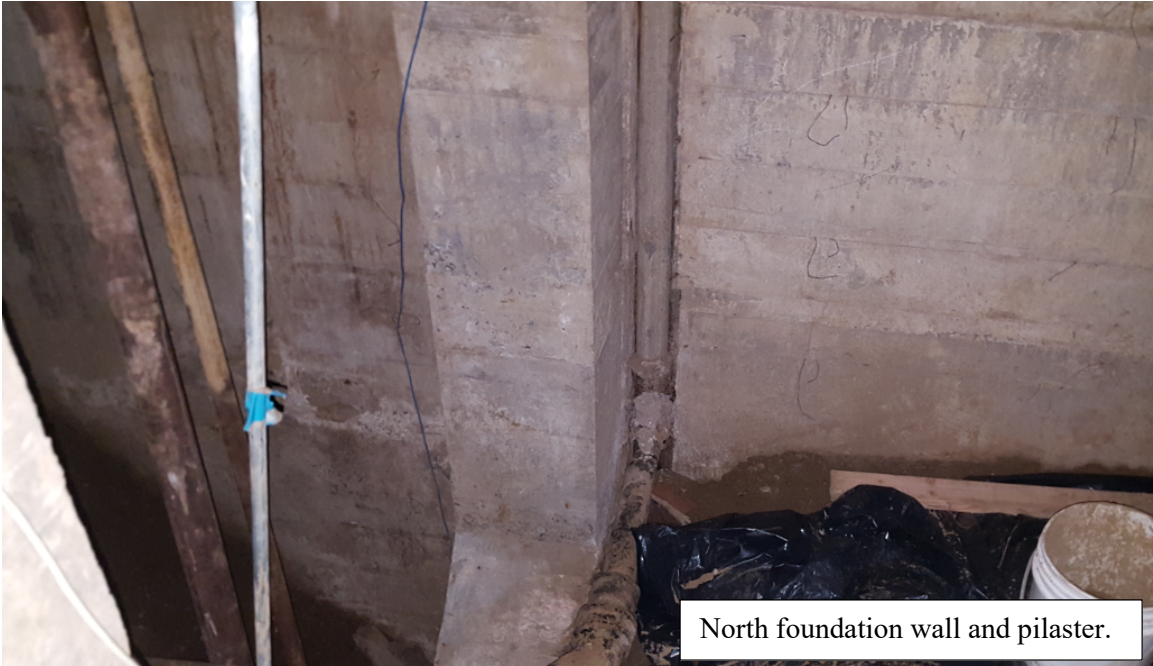
The conditions observed included undermining of concrete pilasters on both the north and south faces of the crawl space. The pilasters are approximately 15 inches wide, and are cast integrally with foundation walls on the north and south sides. The north pilaster widens to approximately 30 inches at its base. The bottom edges of the foundation walls could not be seen and would appear to be in bearing on deeper soil. According to original construction drawings, the foundation walls are no less than 15 inches thick. The soil directly under the pilasters was undermined to approximately one foot below the bottom of concrete, and no soil was in contact with the base of either pilaster.

According to original construction drawings, these pilasters appear to support only the exterior stairs and entryway slab. However, since the pilasters are cast integrally with the north and south foundation walls, they appear to be adequately supported by the walls.

From the appearance of the soil in the area around the pilasters, the undermining looks to have been caused by intentional excavation. Jarod Lillegard had knowledge that such excavation had occurred during previous PPS maintenance work, and confirmed this with Chris and Rajiv during the August 1 visit.

It is AAI's assessment that the condition be restored to its original condition. The area should be filled and compacted to specifications determined by a geotechnical engineer.
