# ASBESTOS ABATEMENT CONTRACTOR BID DOCUMENT AND SPECIFICATION

# Aloha High School Auto Tech Remodel Project

**18550 SW Kinnaman Road** Beaverton, Oregon 97078

TRC Project Number: 301549

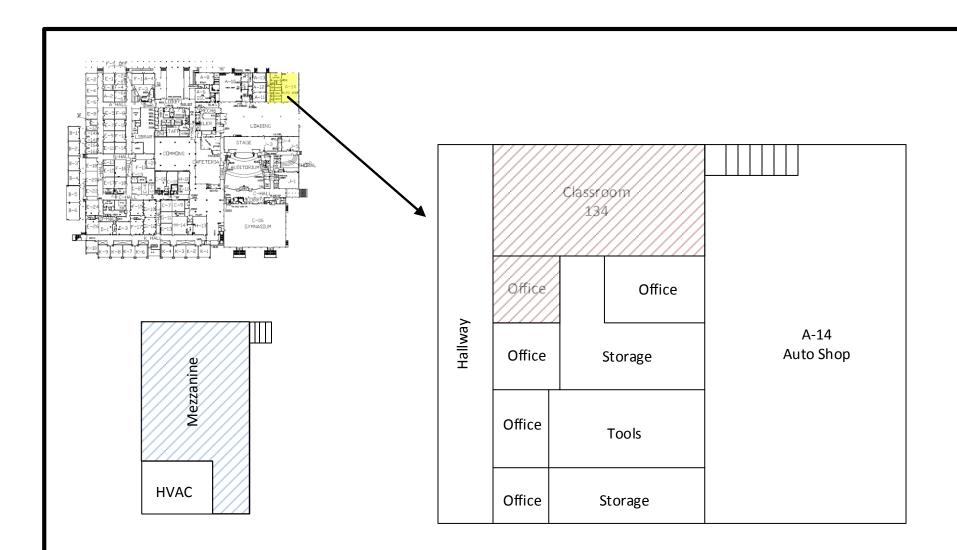
# HAZARDOUS MATERIALS SURVEY REPORT ASBESTOS CONTAINING FLOORING LOCATION DIAGRAM

Description	Material Location(s)	Friable / non- Friable	% ACM (Chrysotile)	Approximate Quantity
12" x 12" Brown Floor Tile with Brown and White Streaks and Associated Glue	Main Shop Mezzanine (on wood)	Non-Friable	Tile – 2% Chrysotile Glue – 5%	450 SF
12" x 12" Light Brown Floor Tile with Tan and Brown Streaks and Associated Glue	Room 134, Office A-14	Non-Friable	Tile – 3% Chrysotile Glue – 5%	225 SF
1' x 1' Ceiling Tile with Fissures and Brown Glue	Room 134, Office A-14	Non-Friable	Tile – ND Glue – 0.7% Tremolite	150 SF
Duct Seam Tape  Mechanical Room and Above Ceiling		Non-Friable	15% Chrysotile	120 LF
Pipe Elbow/Fitting Hard Insulation	Throughout	Friable	Previously Sampled	80 Each
Mirror Mastic	Shop Storage Area	Non-Friable	Assumed	6 SF
Fire Rated Doors	Throughout Work Area	Friable	Assumed	10 Doors

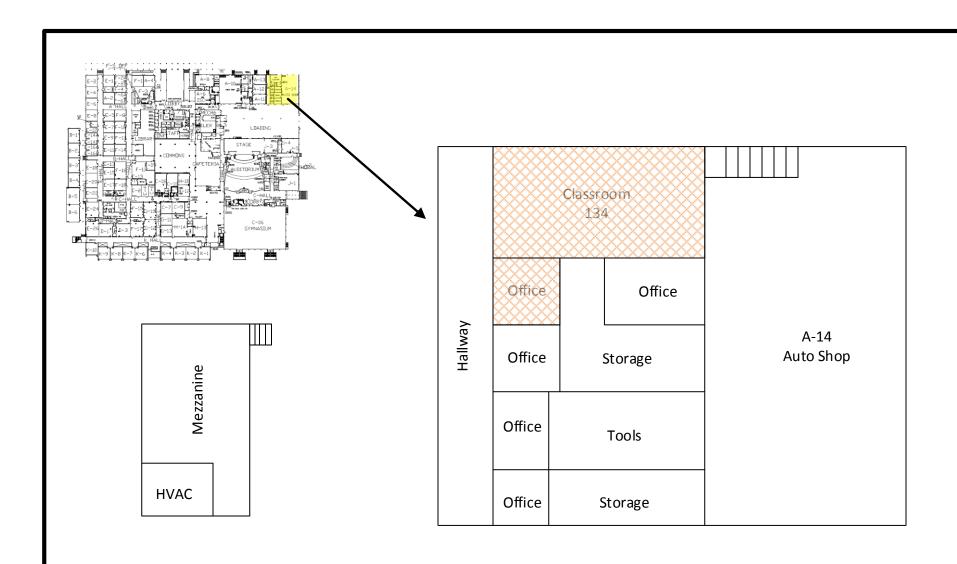
# HAZARDOUS MATERIALS SURVEY REPORT OSHA REGULATED CEILING LOCATION DIAGRAM

OSHA Regulated Brown Glue Associated with 1' x 1' Ceiling Tile with Fissures

Material	Approximate Location(s)	Approximate Quantity
Brown Glue Associated with 1' x 1' Ceiling Tile with Fissures	Room 134, Office A-14	150 SF
