# ASBESTOS ABATEMENT CONTRACTOR BID DOCUMENT AND SPECIFICATION

# Aloha High School Auto Tech Remodel Project

**18550 SW Kinnaman Road** Beaverton, Oregon 97078

TRC Project Number: 301549

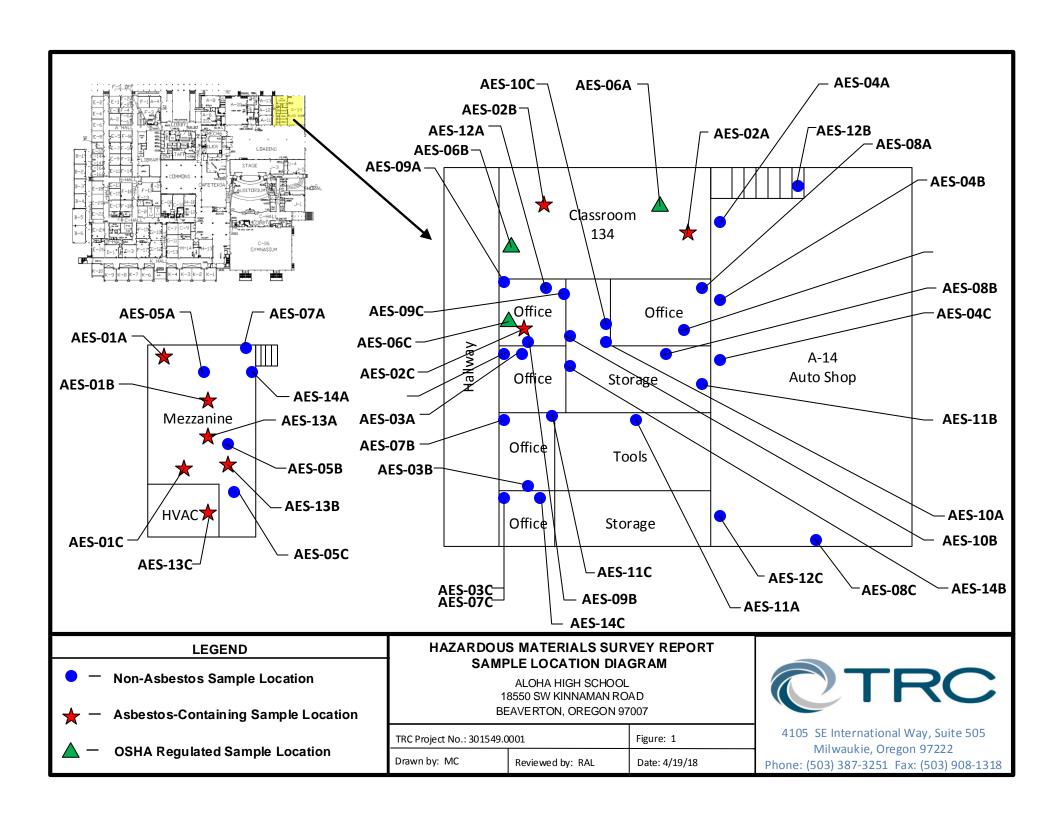
# HAZARDOUS MATERIALS SURVEY REPORT OSHA REGULATED CEILING LOCATION DIAGRAM

OSHA Regulated Brown Glue Associated with 1' x 1' Ceiling Tile with Fissures

Material	Approximate Location(s)	Approximate Quantity
Brown Glue Associated with 1' x 1' Ceiling Tile with Fissures	Room 134, Office A-14	150 SF
